## Streamflow Monitoring in the Walla Walla Basin

2018 Water Year

### FINAL REPORT

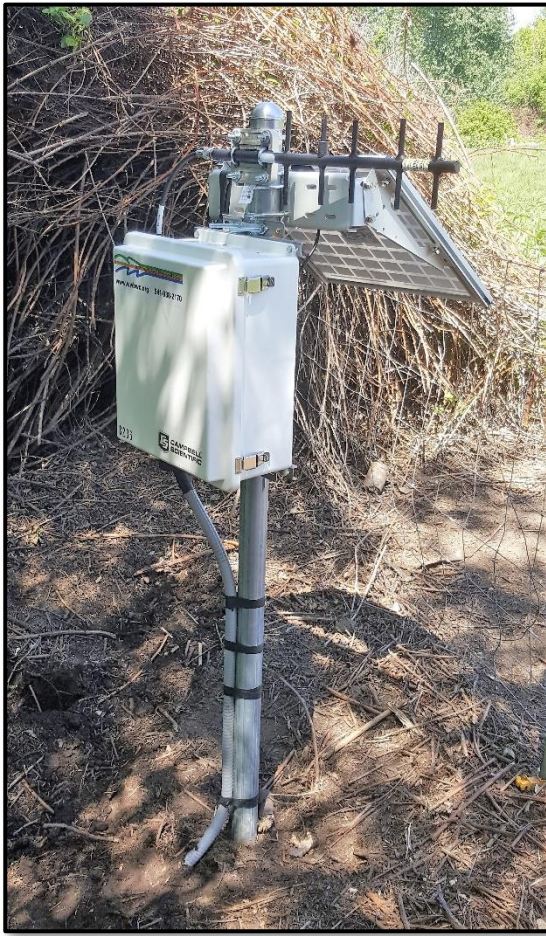
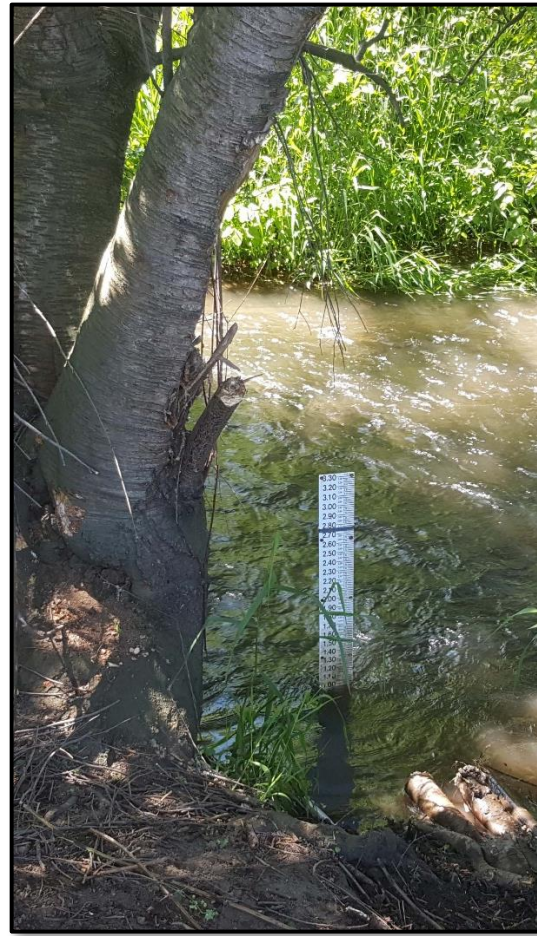
**Figure 4.** At this near real-time monitoring site on the East Little Walla Walla River, a cabled sensor secured to a T-post and staff gauge in the channel collects water level data. A communication cable transmits the information to a data logger and radio housed on the streambank. Using radio telemetry, water level and temperature data are sent to the WWBWC office to be processed and published online.

Since 2013, WWBWC has worked to strategically install real-time flow monitoring sites where hourly flow data can benefit the public, state and federal agency staff and local resource managers. Figure 4 shows an example of a near real-time monitoring site. During the 2018 water year, 25 stream sites were monitored using near real-time telemetry equipment. WWBWC used electronic sensors and data loggers manufactured by Campbell Scientific, WaterLog, and In-Situ, Inc. to record gauge height at a programmed interval (typically every 15 minutes). These stage data were relayed to the WWBWC office using satellite, radio or cellular telemetry and then processed through customized rating equations (see details below) to produce discharge values that were published hourly online.

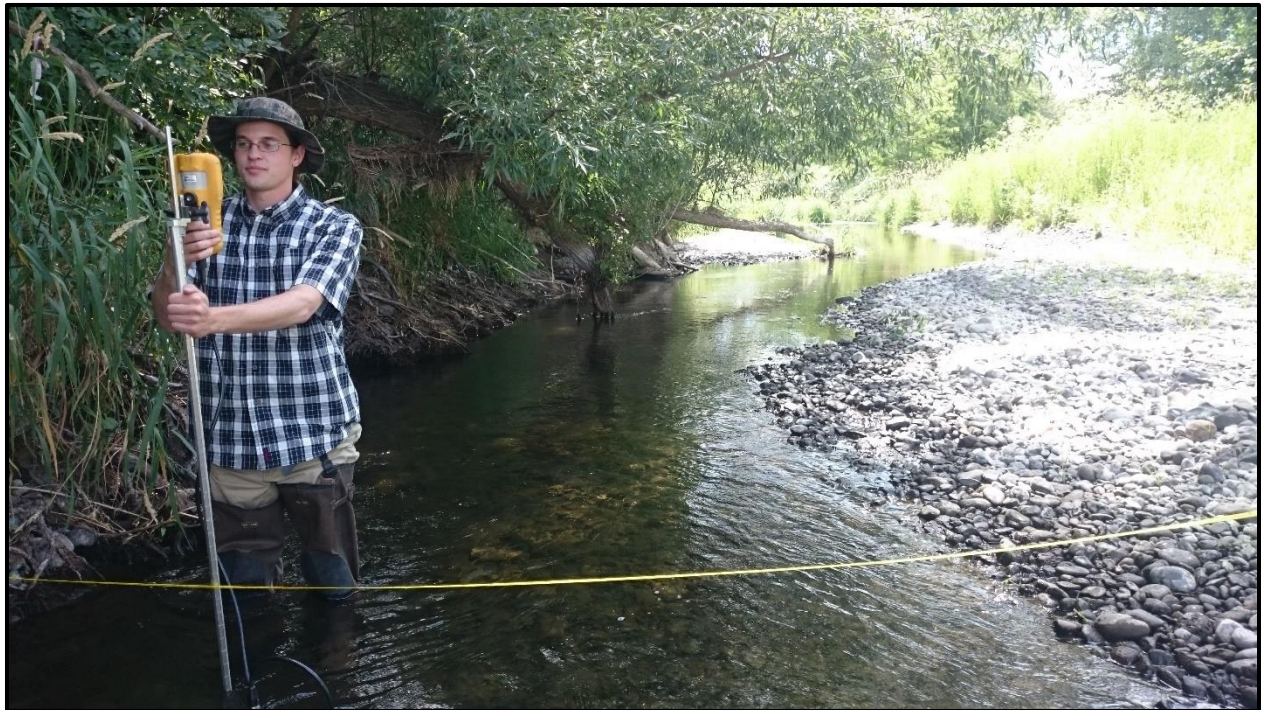
**Figure 5.** Staff taking a wading flow measurement on Mill Creek using a FlowTracker2 acoustic Doppler velocimeter.

Monitoring staff visited the near real-time sites twice a month to read the staff gauges and visually inspect equipment. Manual discharge measurements were taken approximately every 6 weeks using either a SonTek FlowTracker Handheld Acoustic Doppler Velocimeter (Figure 5), Marsh-McBirney Flo-Mate 2000 pressure sensor, or Price AA current meter. Water temperature was measured using a calibrated NIST traceable YSI 30 handheld meter ([www.ysi.com](http://www.ysi.com)).

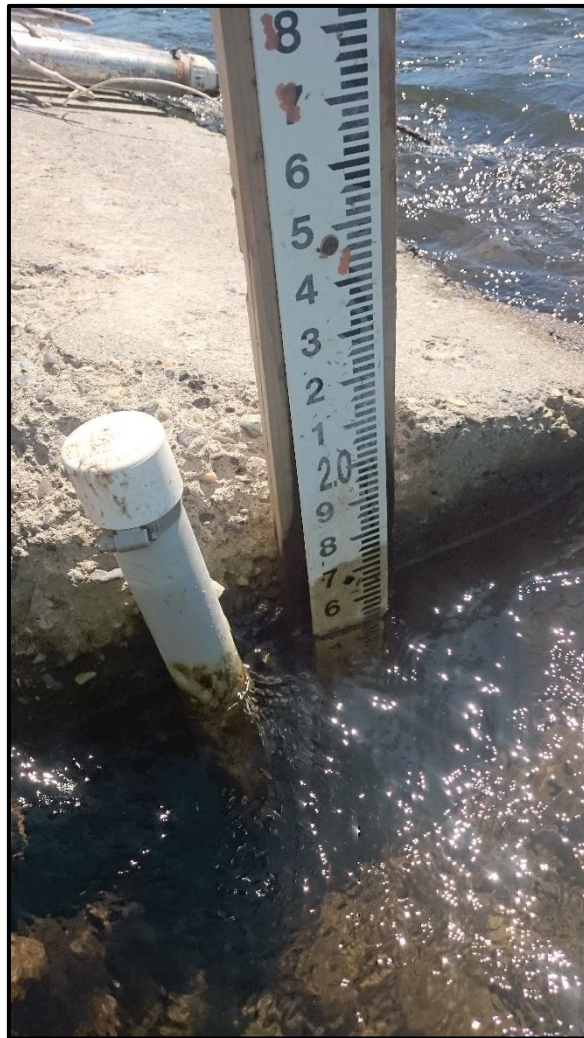
**Figure 6. Typical equipment installed at stand-alone monitoring sites that were visited quarterly for manual data download: a staff gauge and perforated PVC stilling well with a suspended pressure transducer.**

Many of WWBWC's streamflow monitoring sites are stand-alone stations we visit quarterly to take stage and discharge measurements and to download data. For the 2018 monitoring period, these sites were equipped with Solinst or In-Situ, Inc pressure transducers programmed to log a water level measurement at a set interval (typically every 15 or 30 minutes). Figure 6 shows an example of data logger deployment in a perforated PVC stilling well anchored to an ecology block in the Walla Walla River.
