**OWEB-Funded Streamflow Monitoring in the Walla Walla Basin**  
**2019 Water Year**  
**FINAL REPORT**

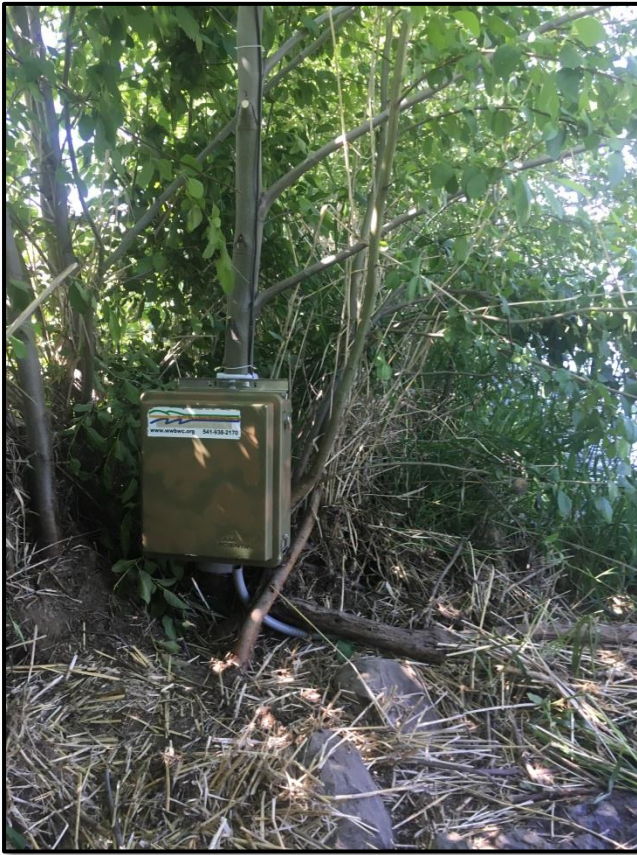
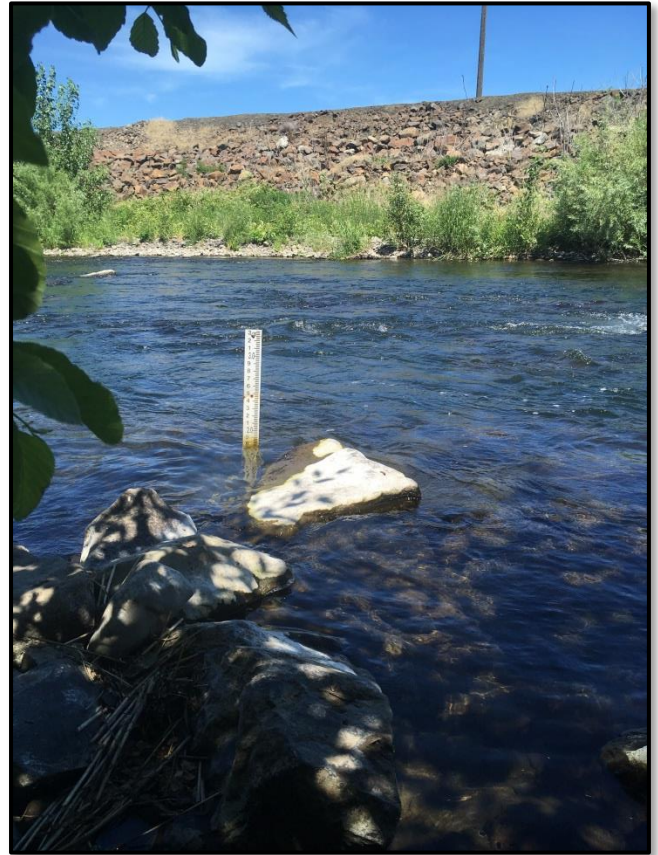
**Figure 4. At this near real-time monitoring site on the Walla Walla River (S-106), a cabled sensor secured to a T-post and staff gauge in the channel collects water level data. A communication cable transmits the information to a data logger and radio housed on the streambank. Using radio telemetry, water level and temperature data are sent to the WWBWC office to be processed and published online.**

Since 2013, WWBWC has worked to strategically install real-time flow monitoring sites where hourly flow data can benefit the public, tribal, state and federal agency staff and local resource managers. Figure 4 shows an example of a near real-time monitoring site. During the 2019 water year, 13 stream sites were monitored using near real-time telemetry equipment. WWBWC used electronic sensors and data loggers manufactured by Campbell Scientific, WaterLog, and In-Situ, Inc. to record gauge height at a programmed interval (typically every 15 minutes). These stage data were relayed to the WWBWC office using satellite or radio telemetry and then processed through customized rating equations (see details below) to produce discharge values that were published hourly online.

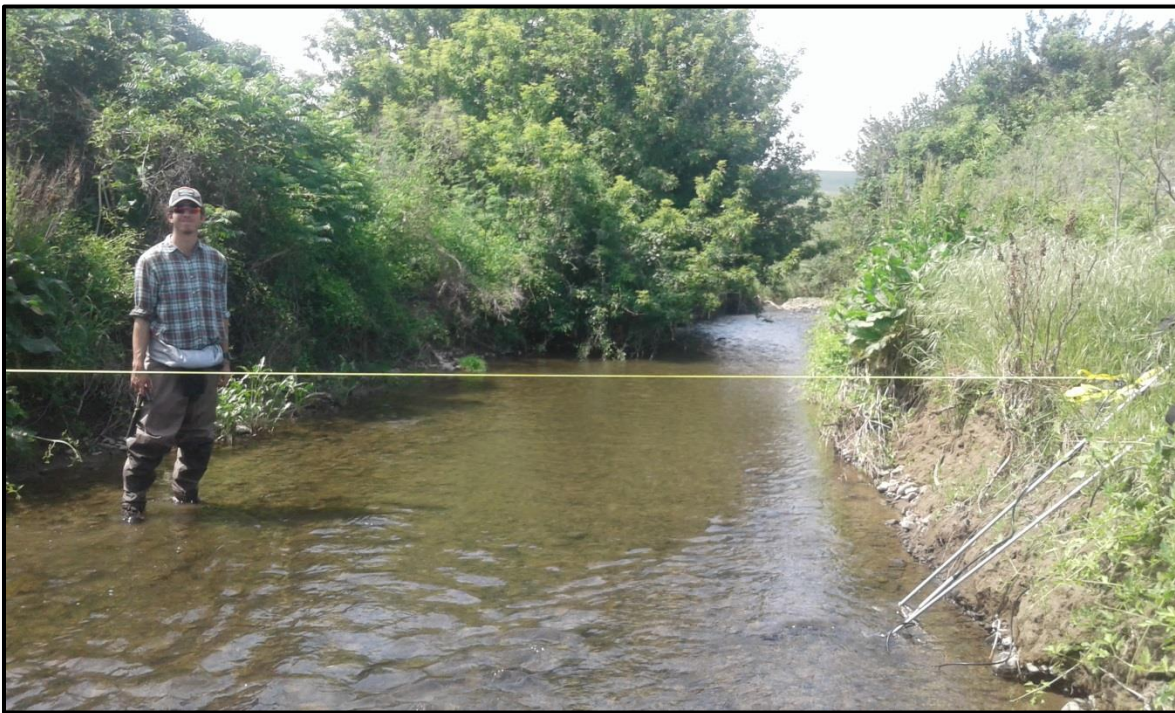
**Figure 5. Staff setting up a flow measurement on Pine Creek (S-416T) using a FlowTracker2 acoustic Doppler velocimeter.**

Monitoring staff visited the near real-time sites twice a month to read the staff gauges and visually inspect equipment. Manual discharge measurements were taken approximately every 6 weeks using either a SonTek FlowTracker Handheld Acoustic Doppler Velocimeter (Figure 5), Marsh-McBirney Flo-Mate 2000 flow meter, or Price AA current meter. Water temperature was measured using a calibrated NIST traceable YSI 30 handheld meter ([www.ysi.com](http://www.ysi.com)).

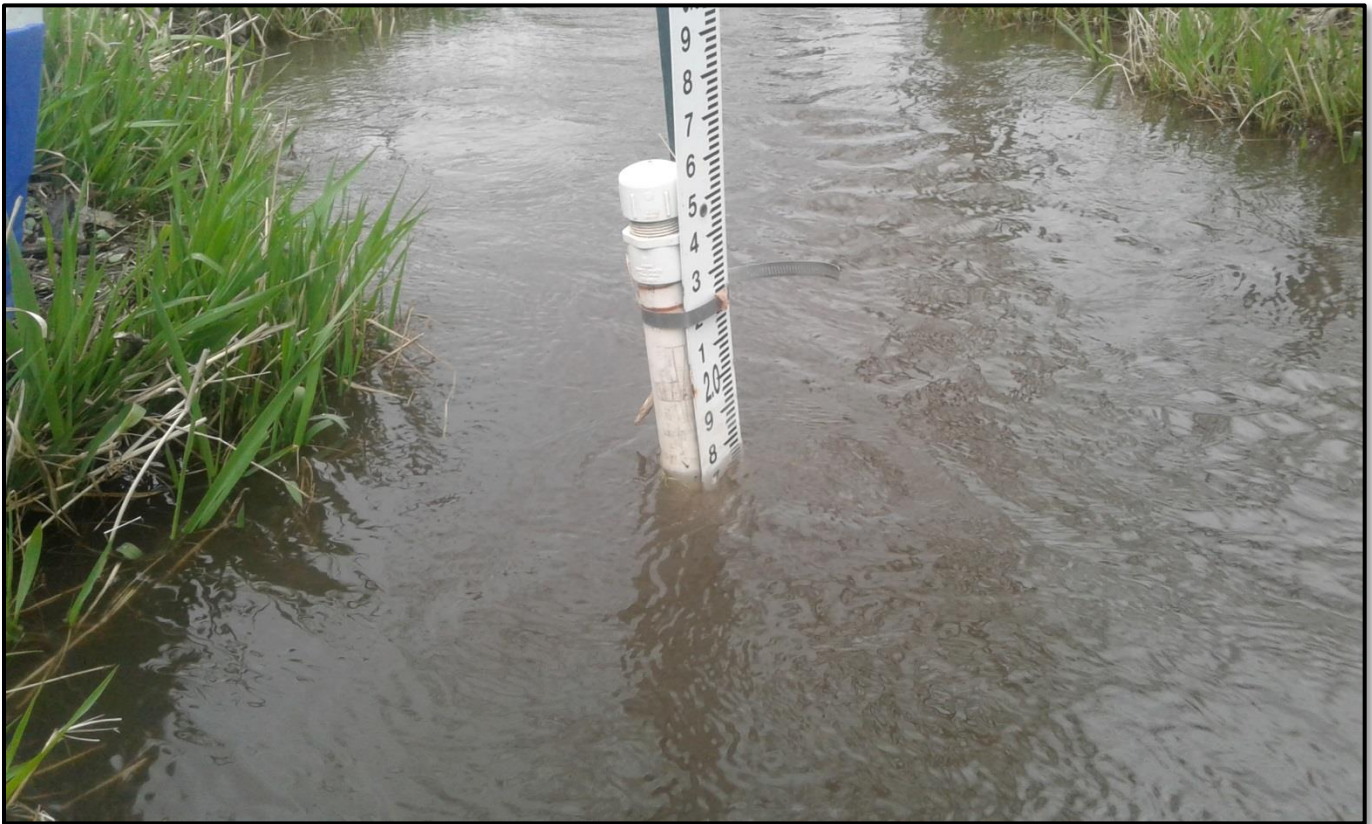
**Figure 6. At this stand-alone monitoring site on the West Little Walla Walla River (S-222), a staff gauge and perforated PVC stilling well with a suspended pressure transducer. Typical equipment installed at stand-alone monitoring sites that were visited quarterly for manual data download**

Many of WWBWC's streamflow monitoring sites are stand-alone stations we visit quarterly to take stage and discharge measurements and to download data. For the 2019 monitoring period, these sites were equipped with Solinst or In-Situ, Inc pressure transducers programmed to log water level and temperature measurements at a set interval (typically every 15 or 30 minutes). Figure 6 shows an example of data logger deployment in a perforated PVC stilling well anchored to an ecology block in the Walla Walla River.

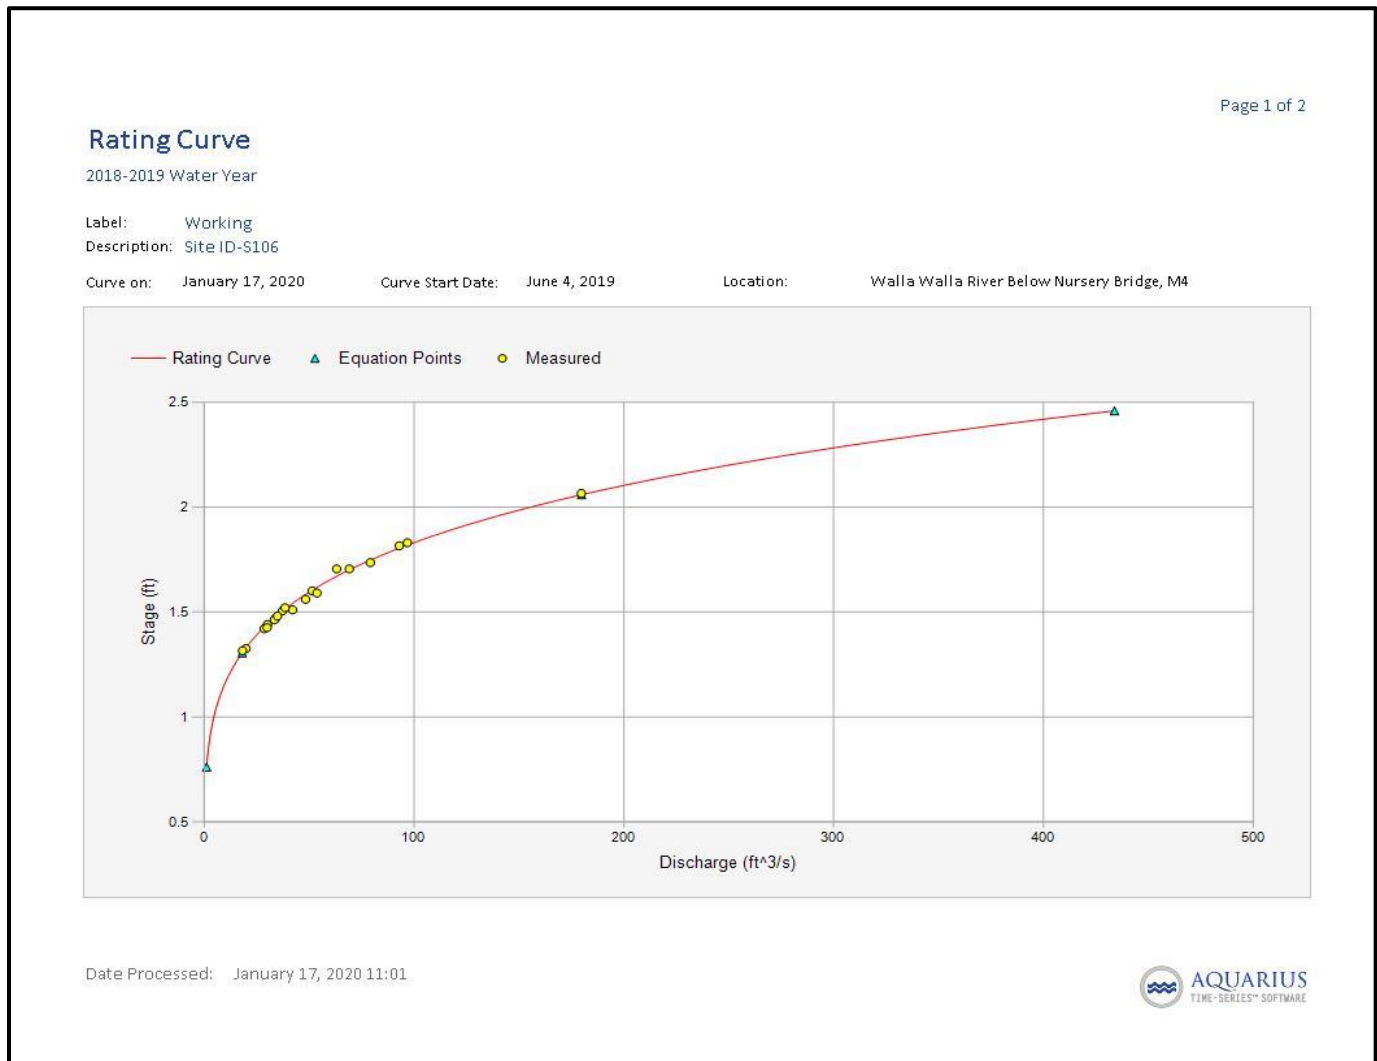
**Figure 7. Rating Curve for the Walla Walla River below Nursery Bridge. Yellow dots represent manual discharge measurements. Blue triangles show rating points.**

Customized stage-discharge relationship equations were developed using the AQUARIUS rating curve tool. The tool utilized a logarithmic plot of stage and discharge measurements to produce a rating equation describing the relationship (Figures 7-8). Based on that equation, a rating table was created to calculate discharge values for each datum in the logger file and produce a continuous discharge signal for the monitoring period (Figure 9). Rating curves were shifted to reflect channel changes caused by high water events and/or seasonal vegetation growth. Figure 8 displays Walla Walla River below Nursery Bridge flow data calculated by processing stage values through the rating curve equation created for that site (Figures 7-8). Discharge values higher than manual measurements were produced by the rating equation and were included in the graph but cannot be considered as accurate as those flows that lie within the boundaries of the points used to generate the curve. The manual flow measurements were plotted with the flow data in the output graphs so that a viewer can see which calculated flows are above those measurements.
