## Streamflow Monitoring in the Walla Walla Basin

*2019-2020 Water Year*

### FINAL REPORT

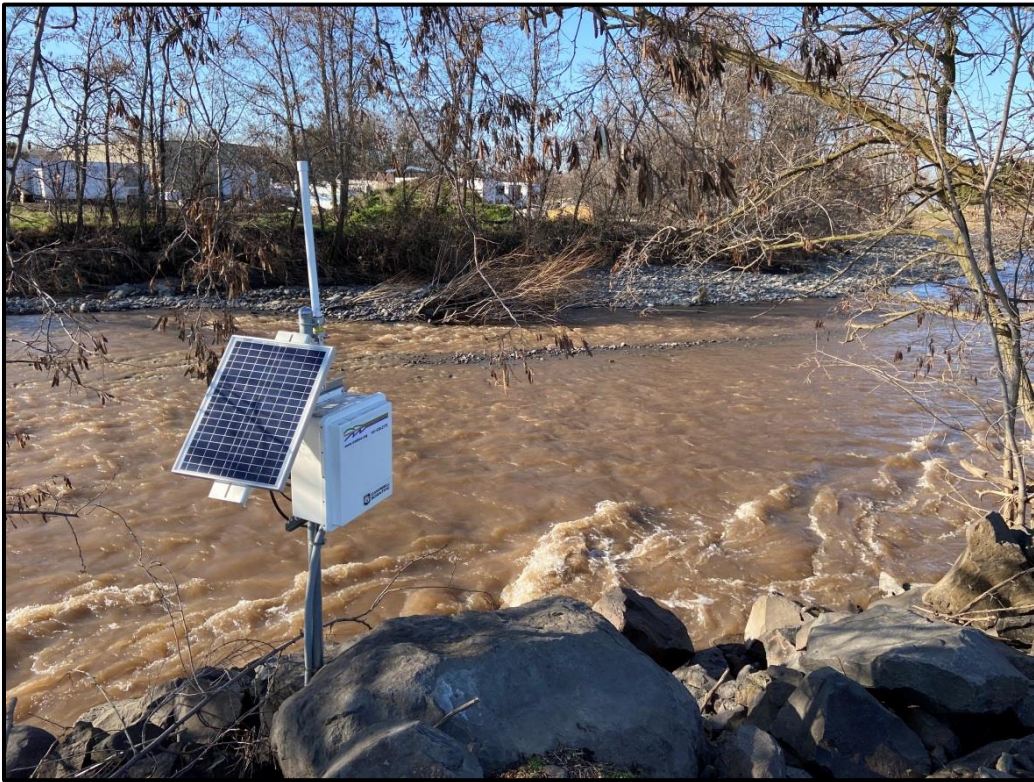
Figure 4. At this near real-time monitoring site on the Walla Walla River (S-107), a cabled sensor, secured to a boulder in the channel, collects water level data. A communication cable transmits the information to a data logger and radio housed in the gauge box. Using radio telemetry, water level and temperature data are sent to the WWBWC office to be processed and published online.

Since 2013, WWBWC has worked to strategically install real-time flow monitoring sites where hourly flow data can benefit the public, tribal, state and federal agency staff and local resource managers. Figure 4 shows an example of a near real-time monitoring site. During the 2020 water year, 12 stream sites were monitored using near real-time telemetry equipment. WWBWC used electronic sensors and data loggers manufactured by Campbell Scientific, WaterLog, and In-Situ, Inc. to record gauge height at a programmed interval (typically every 15 minutes). These stage data were relayed to the WWBWC office using satellite or radio telemetry and then processed through customized rating equations (see details below) to produce discharge values that were published hourly online.

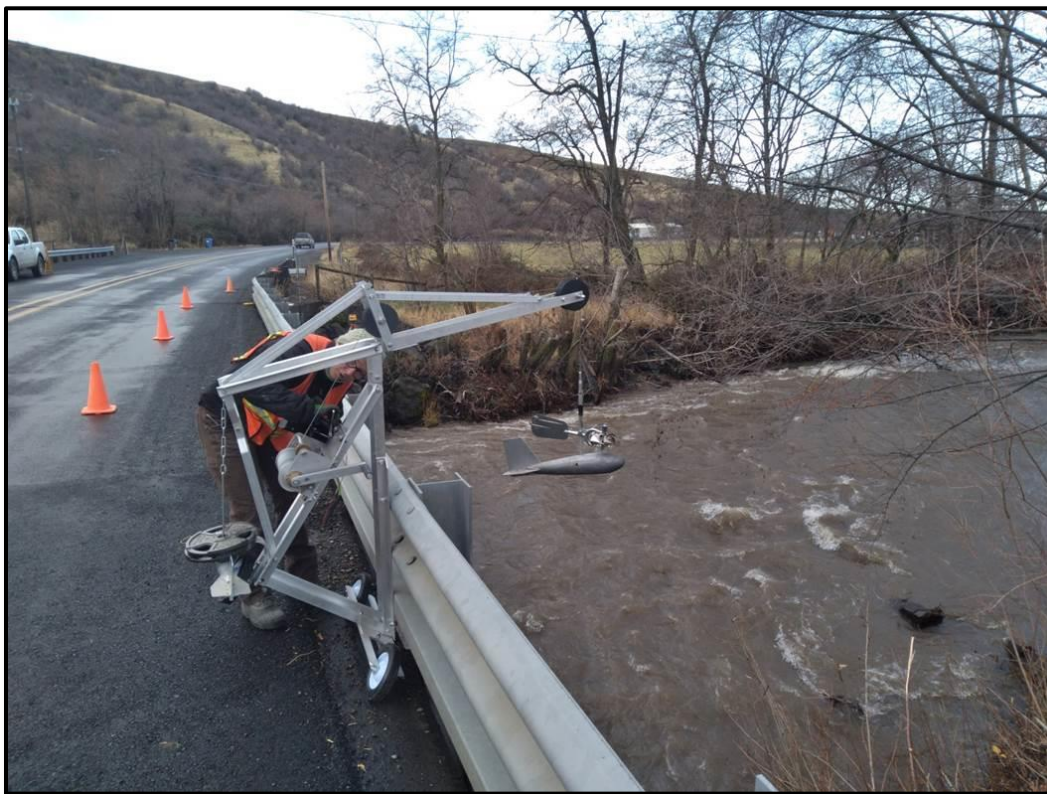
Figure 5. Staff setting up a bridge board flow measurement on South Fork Walla Walla River (S-103) using a Price AA current meter and AquaCalc Pro Plus.

Monitoring staff visited the near real-time sites twice a month to read the staff gauges and visually inspect equipment. Manual discharge measurements were taken approximately every 6 weeks using a SonTek FlowTracker Handheld Acoustic Doppler Velocimeter, Marsh-McBirney Flo-Mate 2000 flow meter, or Price AA current meter (Figure 5). Water temperature was measured using a calibrated NIST-traceable YSI 30 handheld meter ([www.ysi.com](http://www.ysi.com)).

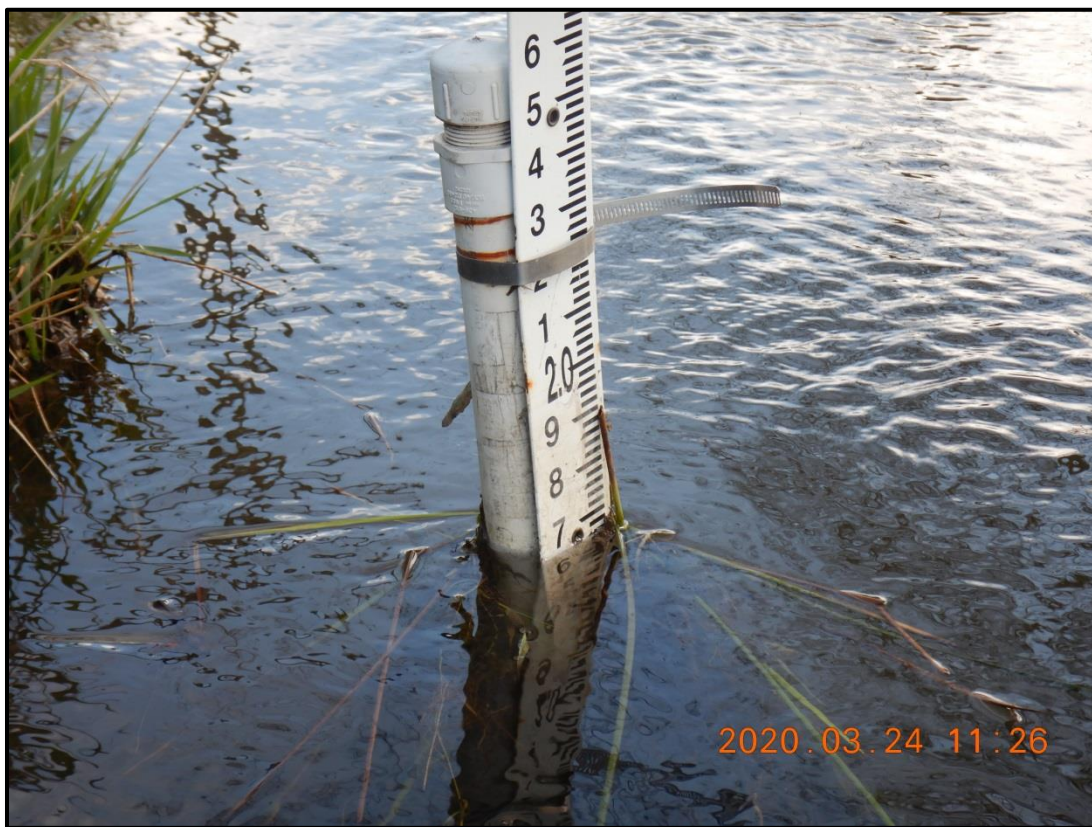
Figure 6. At this stand-alone monitoring site on the West Little Walla Walla River (S-222), a staff gauge and perforated PVC stilling well enclose a suspended pressure transducer. These are the typical components installed at stand-alone monitoring sites that were visited quarterly for manual data download

Many of WWBWC's streamflow monitoring sites are stand-alone stations not equipped with telemetry capability. We visit these sites quarterly to take stage and discharge measurements and to download data. For the 2020 monitoring period, these sites were equipped with Solinst or In-Situ, Inc pressure transducers programmed to log water level and temperature measurements at a set interval (typically every 15). Figure 6 shows an example of data logger deployment in a perforated PVC stilling well anchored to an ecology block in the Walla Walla River.

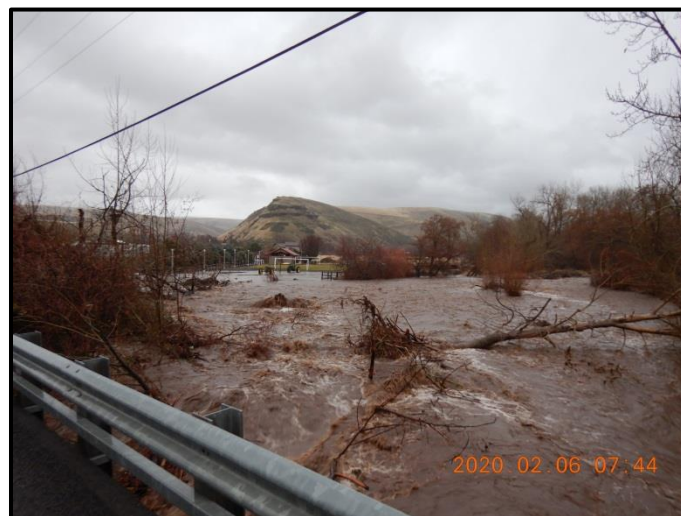
Figure 11. South Fork Walla Walla River near Confluence (S-103) during the 2020 flood.

Most of the stream gauging sites experienced channel changes from the flood. The South Fork Walla Walla River near the confluence (S-103), Walla River at Tum-A-Lum Bridge (S-107), Couse Creek at river mile 1.1 (S-142), Dry Creek at Seven Hills Road (S-415), and Pine Creek at Schubert Road (S-416T) experienced scouring while the North Fork Walla Walla River near the confluence (S-104) and Walla Walla River at Milton-Freewater (S-105) experienced deposition based on photos and measurements taken before and after the February flood event. The measurements taken after the event were used to create a shift in the rating curve. The damage to our equipment varied during the 2020 flood. The metal conduit housing the orifice line broke at a joint and the end of the orifice line was buried at South Fork Walla Walla River near the confluence (S-103). New metal conduit and orifice line were deployed under the bridge for better protection. The t-post, staff gauge, PVC, and pressure transducer at the North Fork Walla Walla River near the confluence (S-104) were washed away and new equipment were installed. The pressure transducer at Couse Creek at river mile 1.1 (S-142) moved during the flood event and was anchored back to its original position. The t-post, staff gauge, PVC, and pressure transducer at Dry Creek at Seven Hills Road (S-415) were washed away but were recovered after the event except for the pressure transducer and equipment were re-installed along the wing wall of the bridge for better protection.
