# Streamflow Monitoring in the Walla Walla Basin

*2020-2021 Water Year*

## FINAL REPORT

Submitted: February 2022

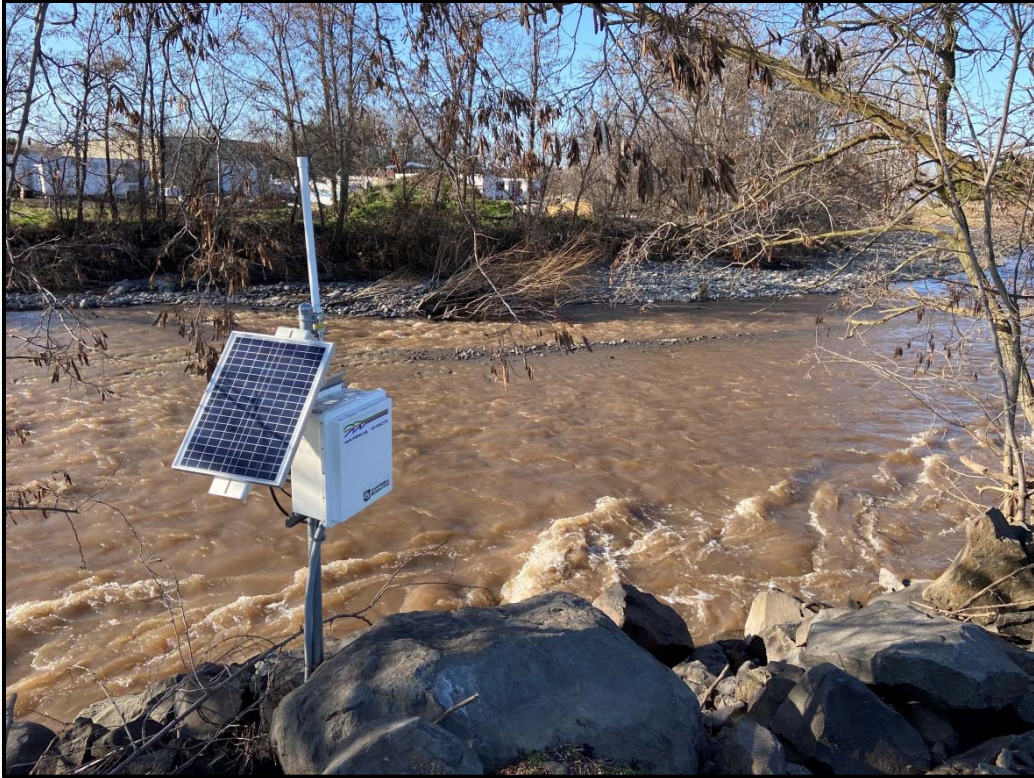
**Figure 4. At this near real-time monitoring site on the Walla Walla River (S-107), a cabled sensor, secured to a boulder in the channel, collects water level data. A communication cable transmits the information to a data logger and radio housed in the gauge box. Using radio telemetry, water level and temperature data are sent to the WWBWC office to be processed and published online.**

Monitoring staff visited the near real-time sites every two weeks to read the staff gauges and visually inspect equipment. Manual discharge measurements were taken approximately every six weeks using a SonTek FlowTracker Handheld Acoustic Doppler Velocimeter, Marsh-McBirney Flo-Mate 2000 flow meter, or Price AA current meter (Figure 5). Water temperature was measured using a calibrated NIST-traceable YSI 30 handheld meter ([www.ysi.com](http://www.ysi.com)).

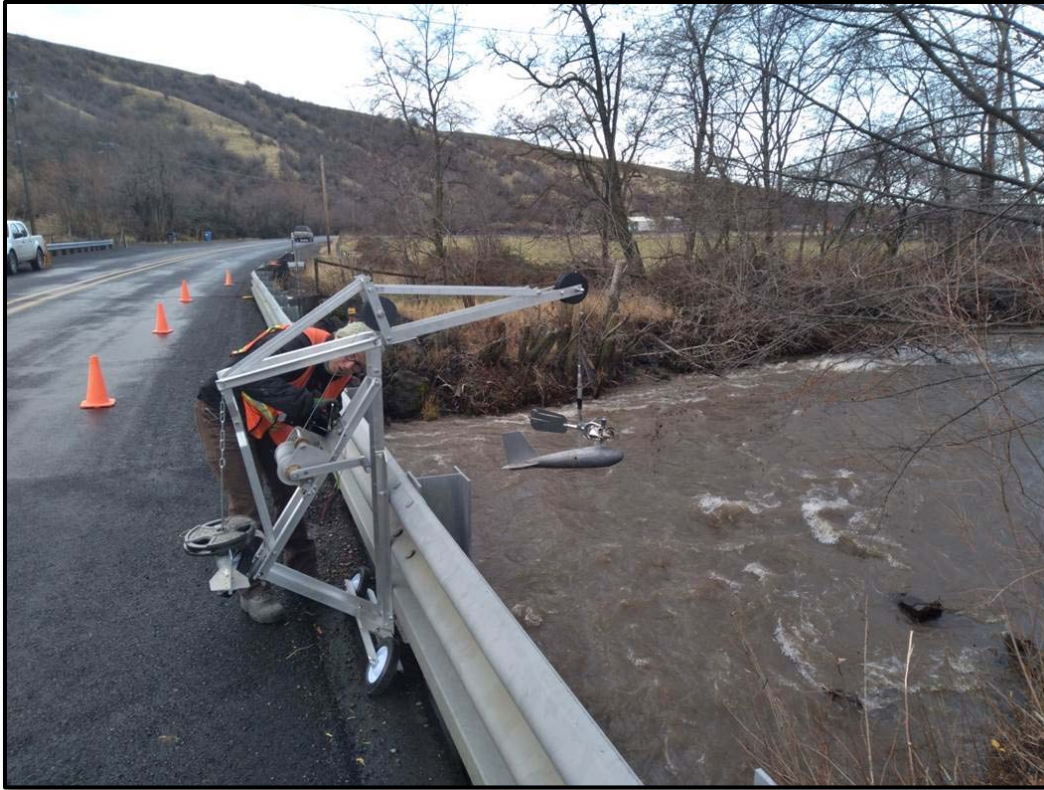
**Figure 5. Staff setting up a bridge board flow measurement on South Fork Walla Walla River (S-103) using a Price AA current meter and AquaCalc Pro Plus.**

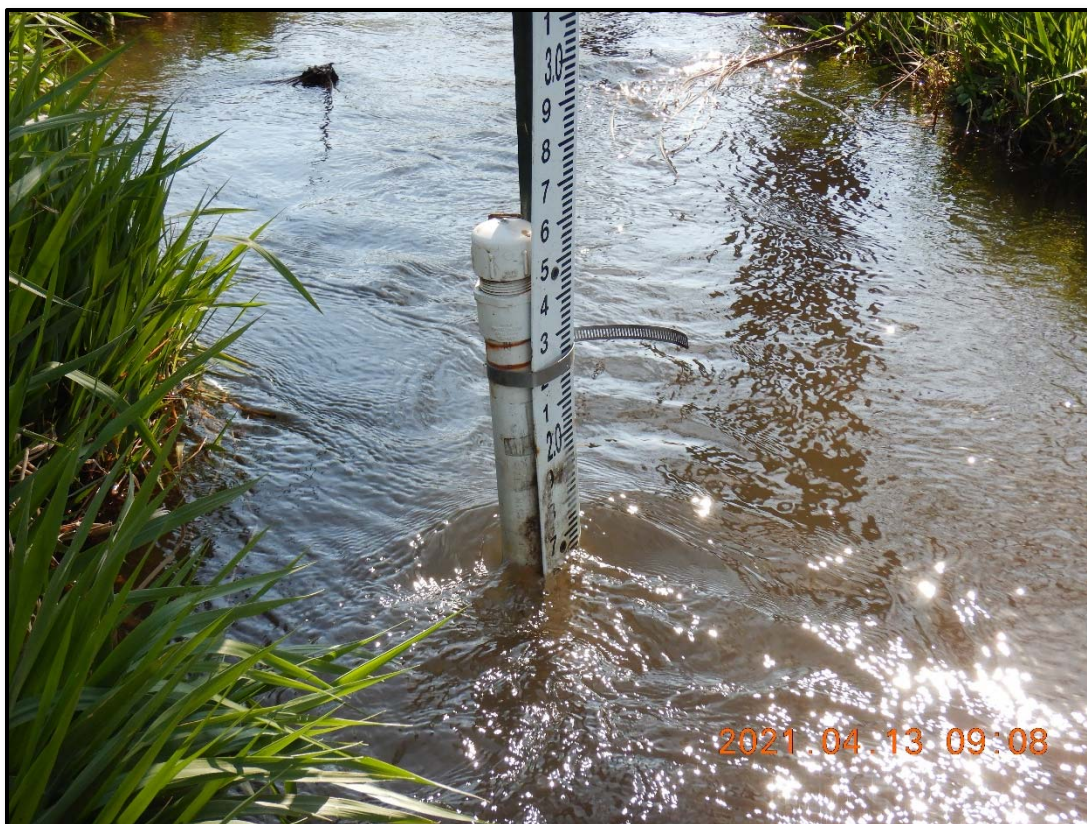
**Figure 6. At this stand-alone monitoring site on the West Little Walla Walla River (S-222), a staff gauge and perforated PVC stilling well enclose a suspended pressure transducer. These are the typical components installed at stand-alone monitoring sites that were visited quarterly for manual data download**

Many of WWBWC's streamflow monitoring sites are stand-alone stations not equipped with telemetry capability. We visit these sites quarterly to take stage and discharge measurements and to download data. For the 202 monitoring period, these sites were equipped with Solinst or In-Situ, Inc pressure transducers programmed to log water level and temperature measurements at a set interval (typically every 15). Figure 6 shows an example of data logger deployment in a perforated PVC stilling well anchored to an ecology block in the Walla Walla River.

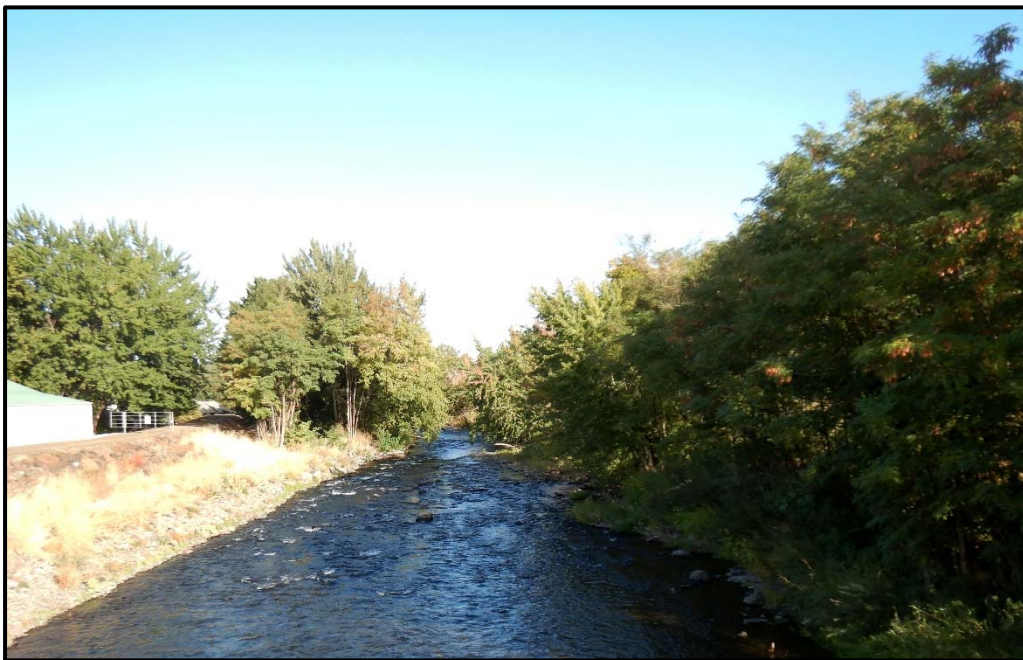
**Figure 21 Walla Walla River at S-105 looking river.**

At the beginning of October 2021, WWBWC decommissioned S-105, Walla Walla River at Milton-Freewater, OR. United States Geological Survey (USGS) obtained funding through the Confederated Tribes of the Umatilla Indian Reservation (CTUIR) to gauge at that location. To provide continuity in the gauging record, the WWBWC continued monitoring to overlap the USGS gaging record at the site until the end of the water year.
