# Streamflow Monitoring in the Walla Walla Basin

*2021-2022 Water Year*

## FINAL REPORT

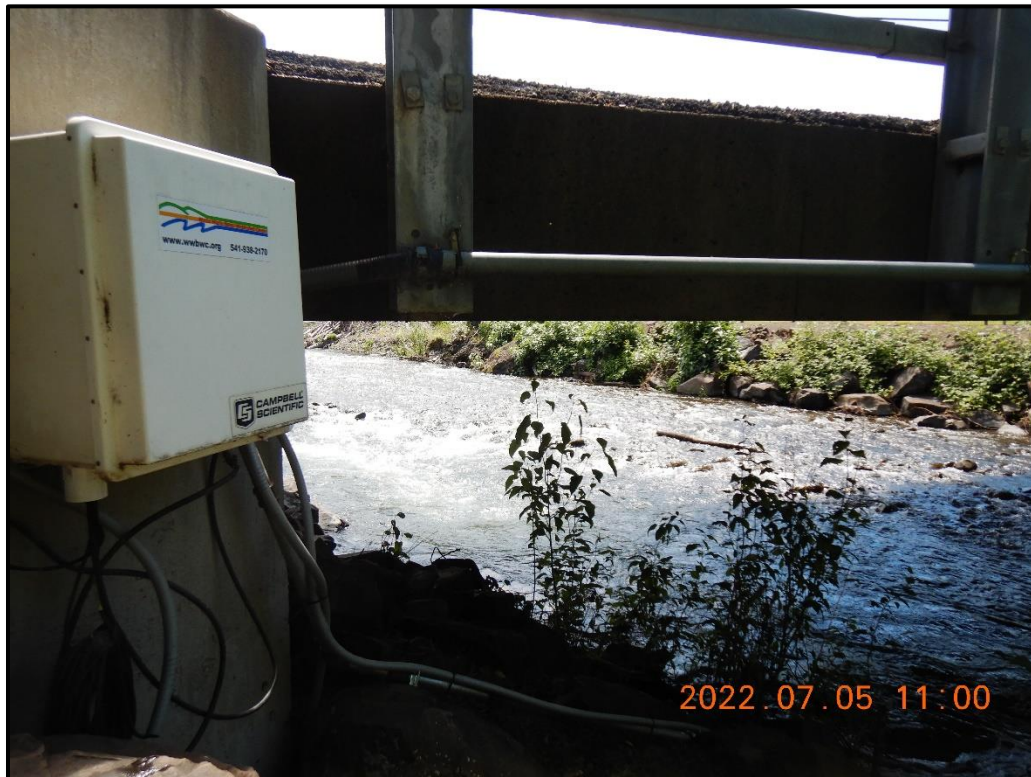
**Figure 4. At this near real-time monitoring site on the South Fork Walla Walla River (S-103), a cabled sensor, secured to posts, collects water level data. A communication cable transmits the information to a data logger and radio housed in the gauge box. Using radio telemetry, water level and temperature data are sent to the WWBWC office to be processed and published online.**

Since 2013, WWBWC has strategically installed real-time flow monitoring sites where hourly flow data can benefit the public, tribal, state, and federal agency staff and local resource managers. Figure 4 shows an example of a near real-time monitoring site. Twelve stream sites were monitored during the 2022 water year using near real-time telemetry equipment. WWBWC used electronic sensors and data loggers manufactured by Campbell Scientific to record gauge height at a programmed interval (typically every 15 minutes). These stage data were relayed to the WWBWC

office using satellite or radio telemetry and then processed through customized rating equations (see details below) to produce discharge values that were published hourly online.

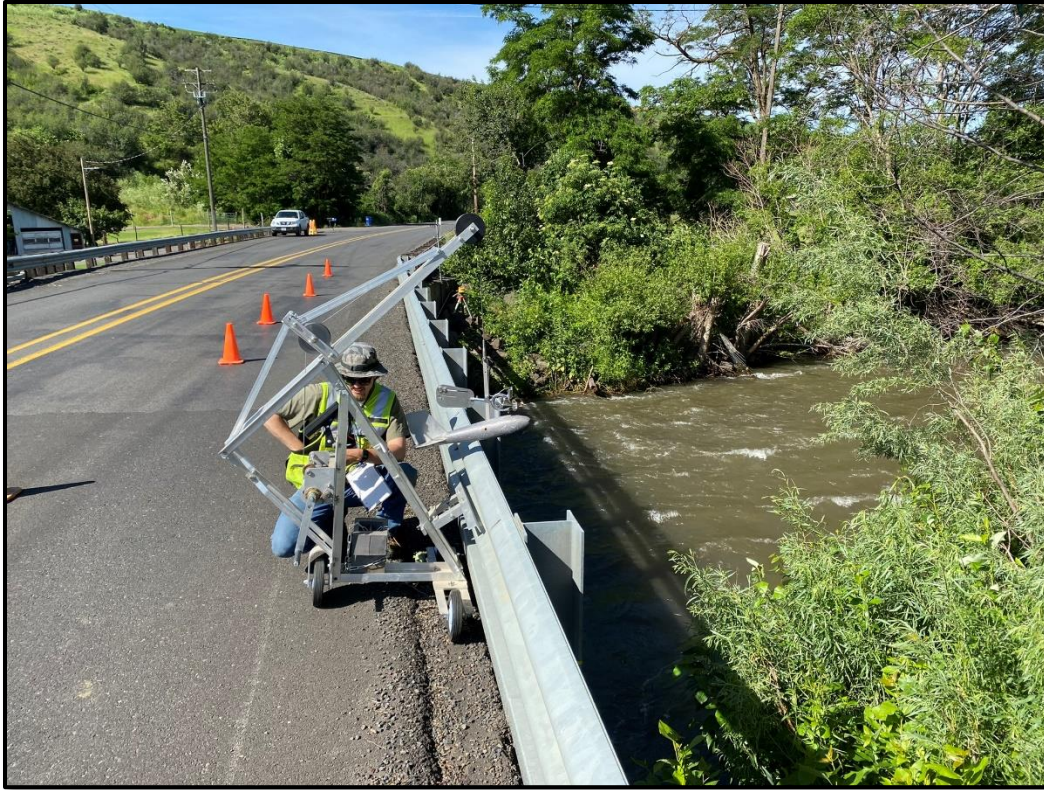
**Figure 5. Staff setting up a bridge board flow measurement on South Fork Walla Walla River (S-103) using a Price AA current meter and AquaCalc Pro Plus.**

Monitoring staff visited the near real-time sites every two weeks to read the staff gauges and visually inspect equipment. Manual discharge measurements were taken approximately every six weeks using a SonTek FlowTracker Handheld Acoustic Doppler Velocimeter, Marsh-McBirney Flo-Mate 2000 flow meter, or Price AA current meter (Figure 5). Water temperature was measured using a calibrated NIST-traceable YSI 30 handheld meter ([www.ysi.com](http://www.ysi.com)).

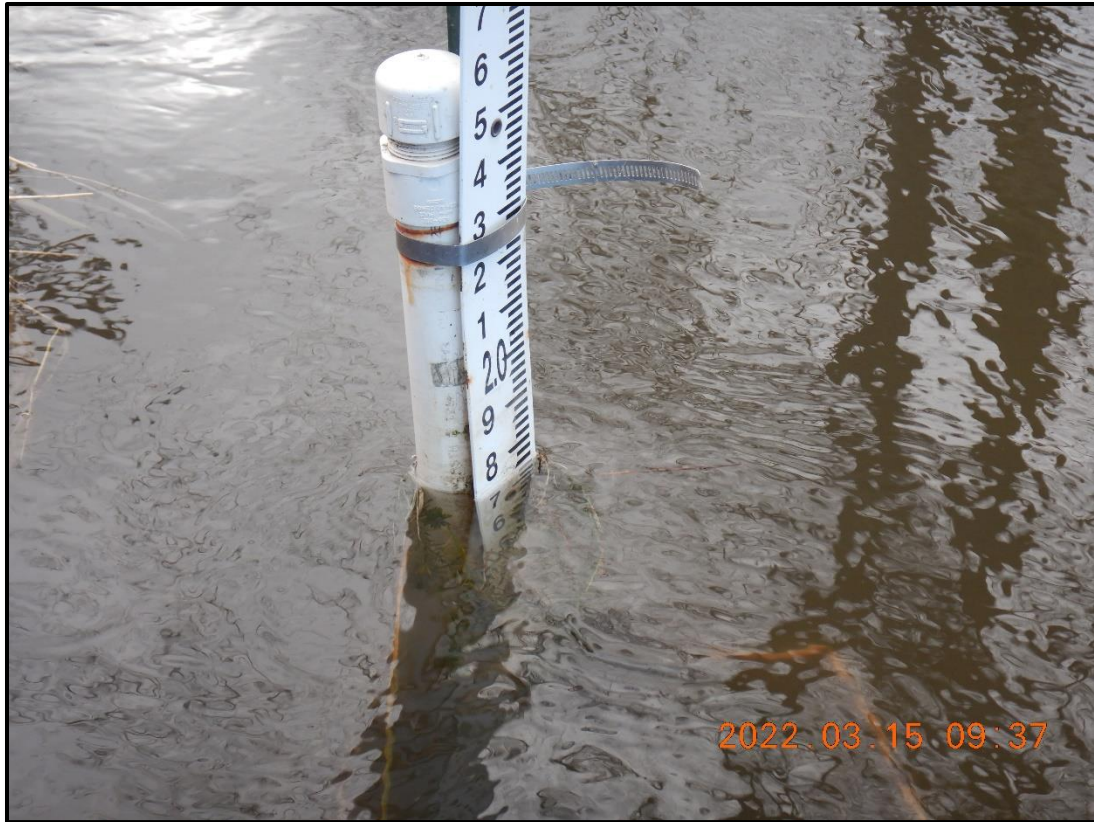
**Figure 6. At this stand-alone monitoring site on the West Little Walla Walla River (S-222), a staff gauge and perforated PVC stilling well enclose a suspended pressure transducer. These are the typical components installed at stand-alone monitoring sites that were visited quarterly for manual data download**

Many of WWBWC's streamflow monitoring sites are stand-alone stations not equipped with telemetry capability. We visit these sites quarterly to take stage and discharge measurements and to download data. For the 2021-2022 monitoring period, these sites were equipped with Solinst pressure transducers programmed to log water level and temperature measurements at a set interval (typically every 15). Figure 6 shows an example of data logger deployment in a perforated PVC stilling well anchored to a t-post in the off-center of the channel.
