# WALLA WALLA BASIN WATERSHED COUNCIL

## Water Temperature Monitoring in the Walla Walla Basin

*2023 Water Year*

### FINAL REPORT

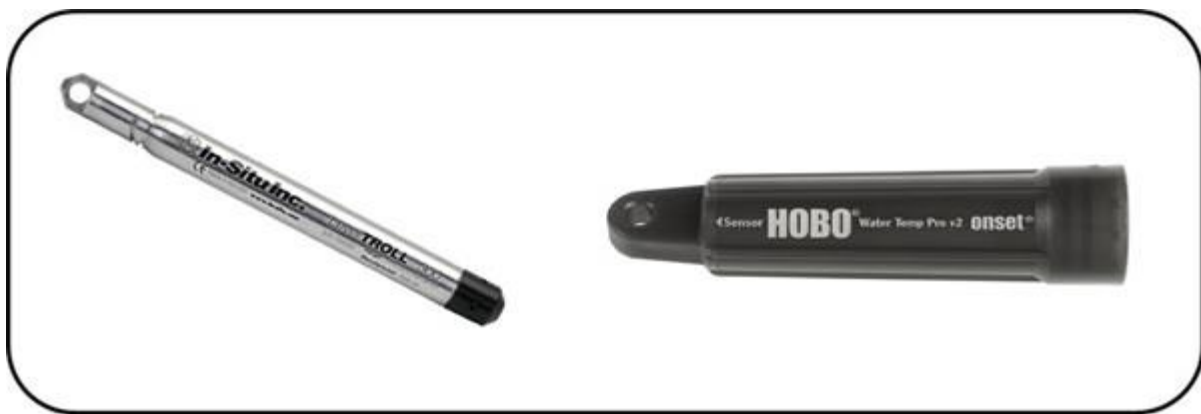
Figure 3. The equipment used to collect the water temperature data

Since the early 2000s, the WWBWC has monitored water temperature along the Oregon portion of the Walla Walla River (Figure 2). For a complete explanation of methods, please see the WWBWC's Standard Operating Procedures – Version 1.3, available at [www.wwbwc.org](http://www.wwbwc.org). Each site has deployed an Onset Hobo data logger or In-Situ Leveltroll 300 pressure transducer (Figure 3). Data are recorded every 15 minutes. Pre and Post-deployment quality checks are completed for all water temperature loggers. Field checks are conducted with either a NIST-traceable VWR thermometer or a NIST-calibrated YSI-30 water temperature meter.
