Results of the First Season of Shallow Aquifer Recharge Testing at the Hall-Wentland Site, Umatilla County, Oregon and Walla Walla County, Washington

23 June 2006

Prepared for
HDR, Inc.
2805 St. Andrews Loop, Suite A
Pasco, Washington 99356

K/J Project No. 0492001*00

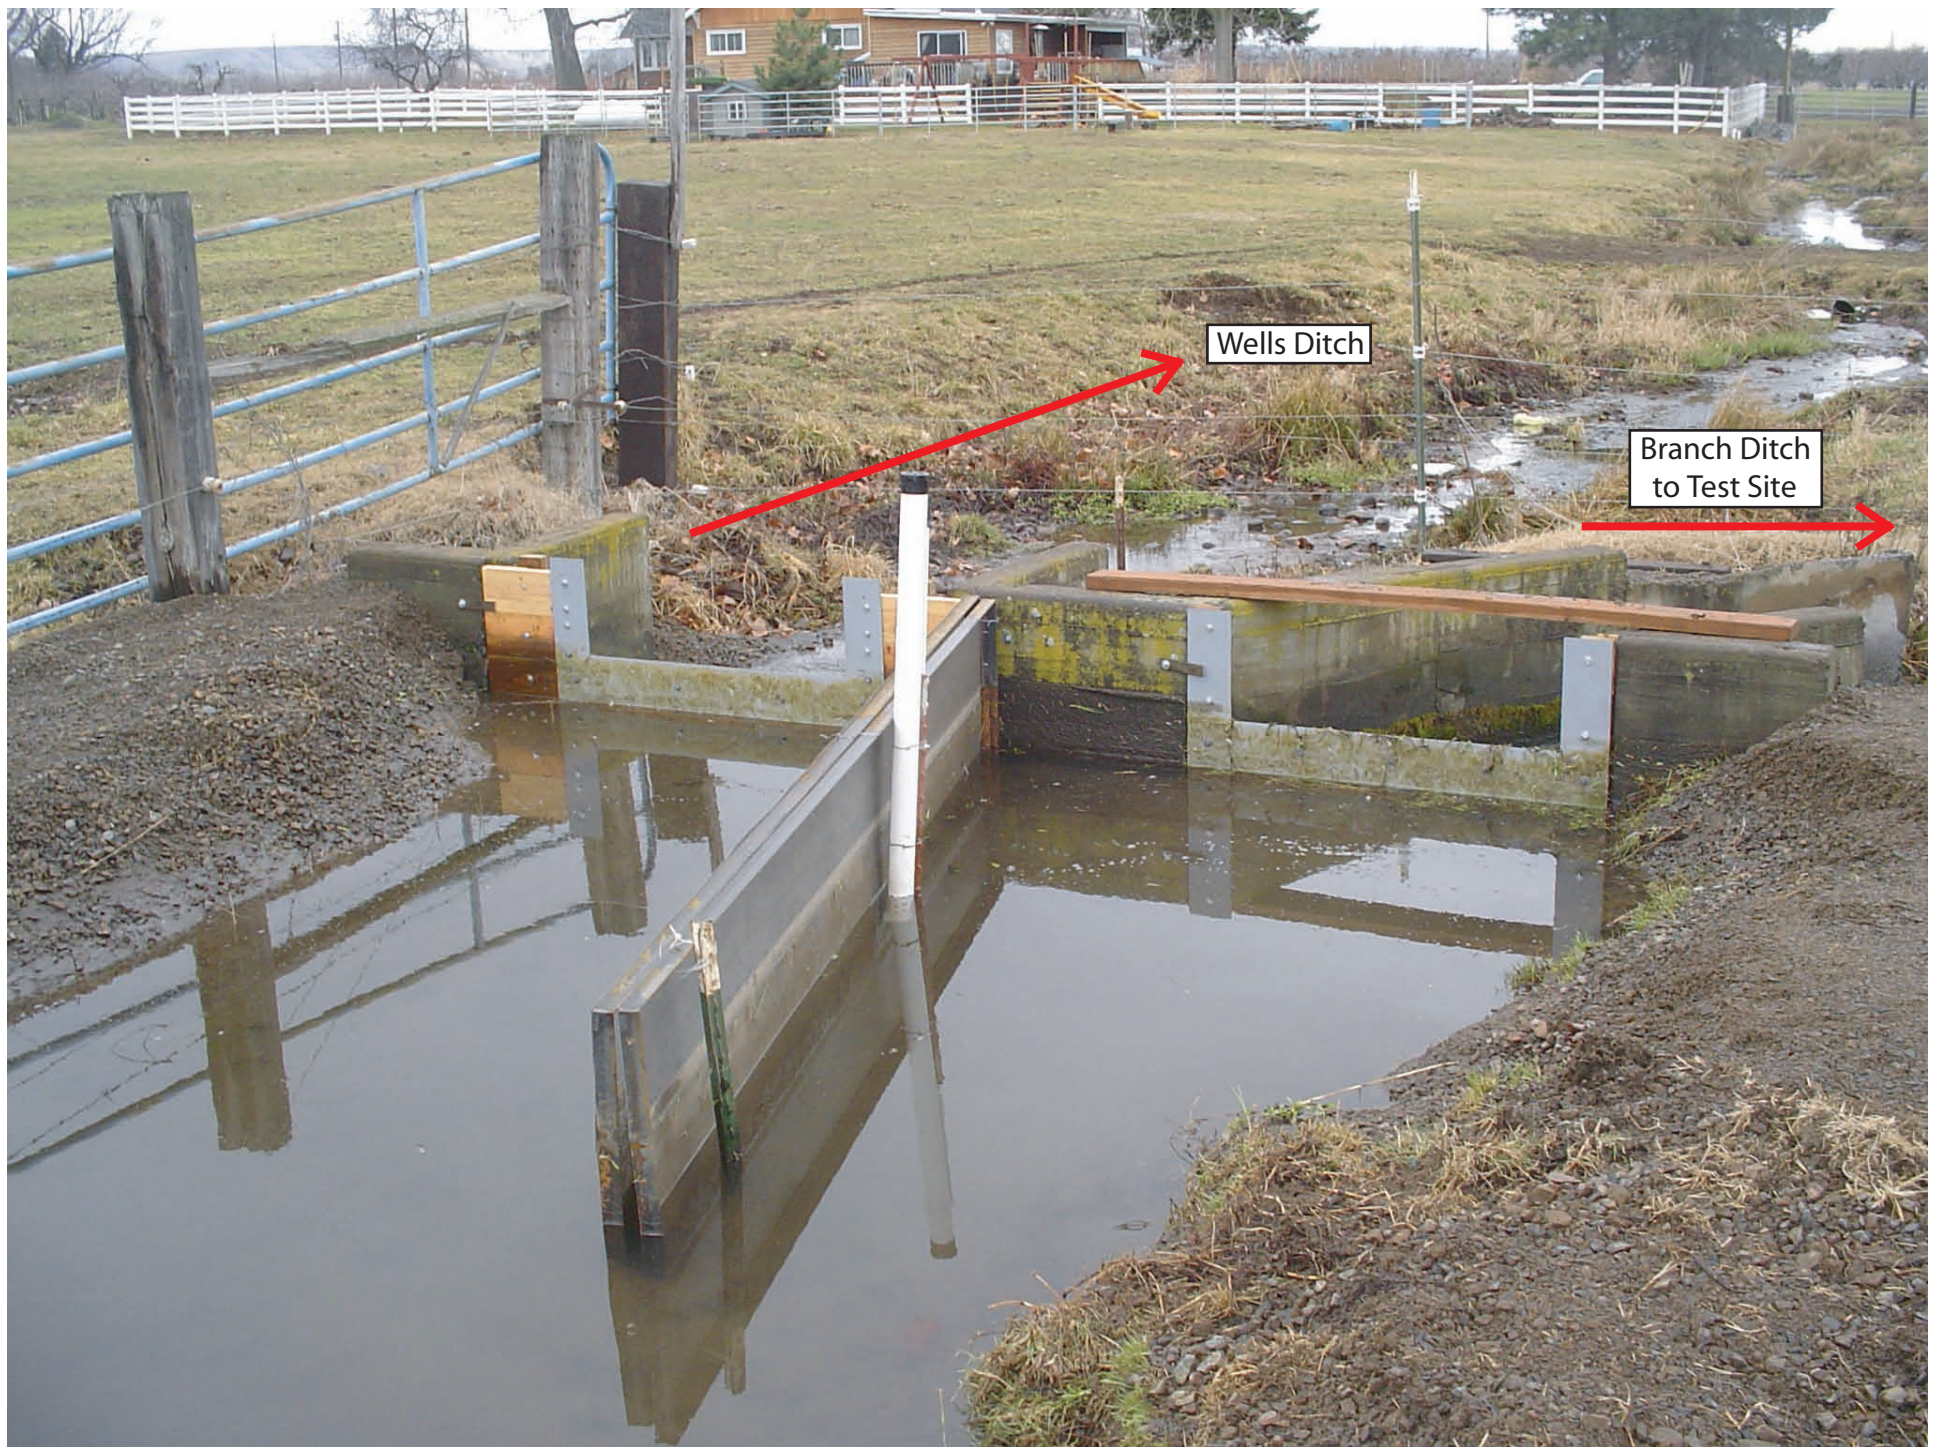
Figure 4. Photograph of the diversion head gate for the branch ditch on Wells Ditch.

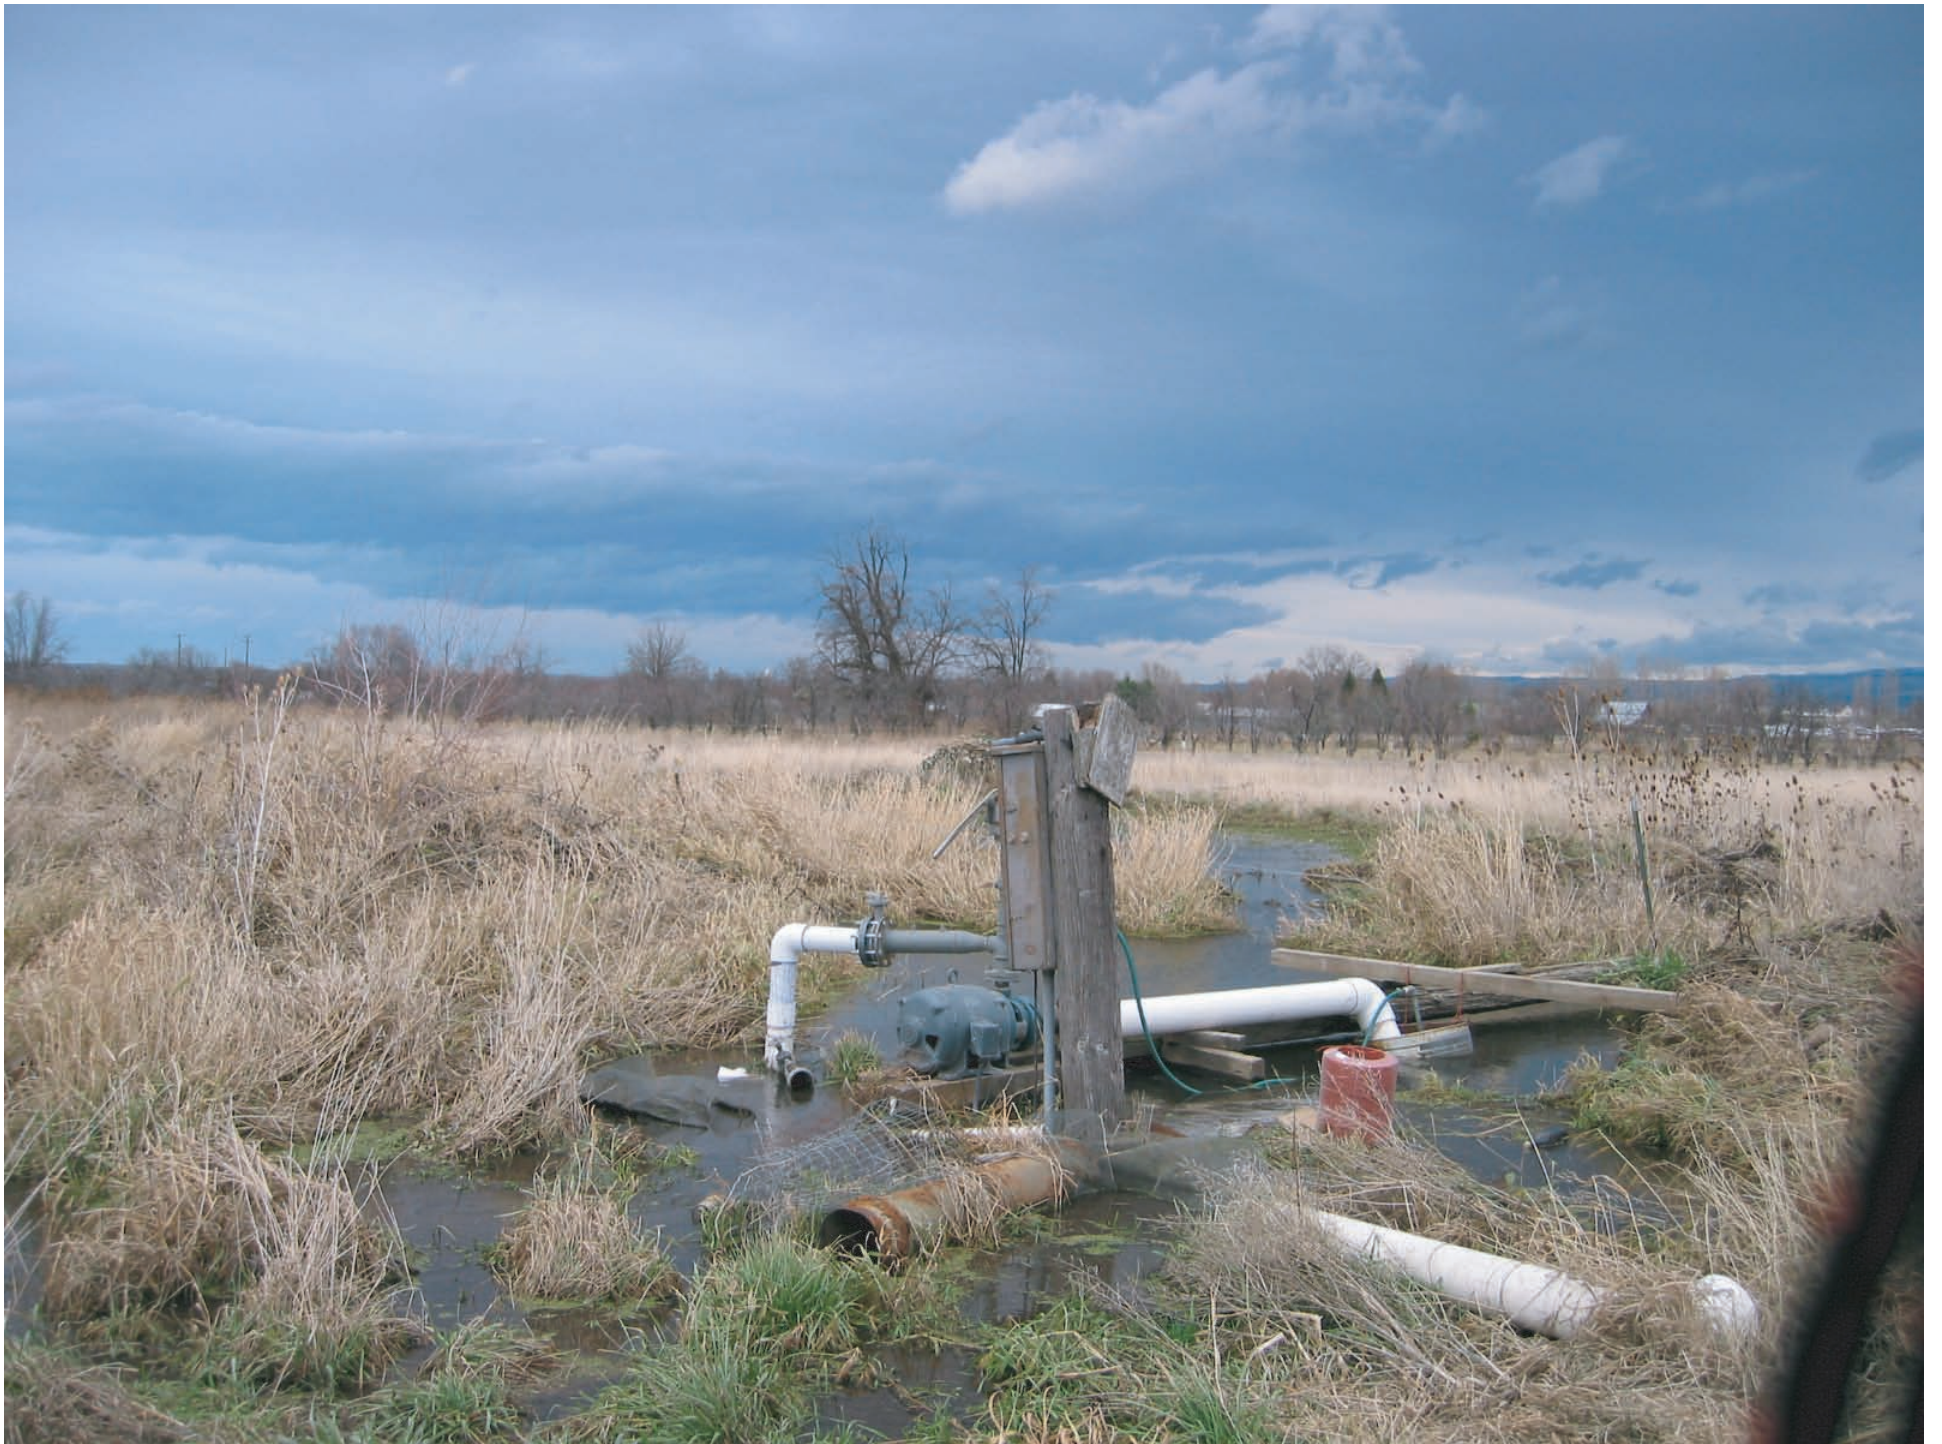
Figure 5. Irrigation pump sump pit at the Test Site

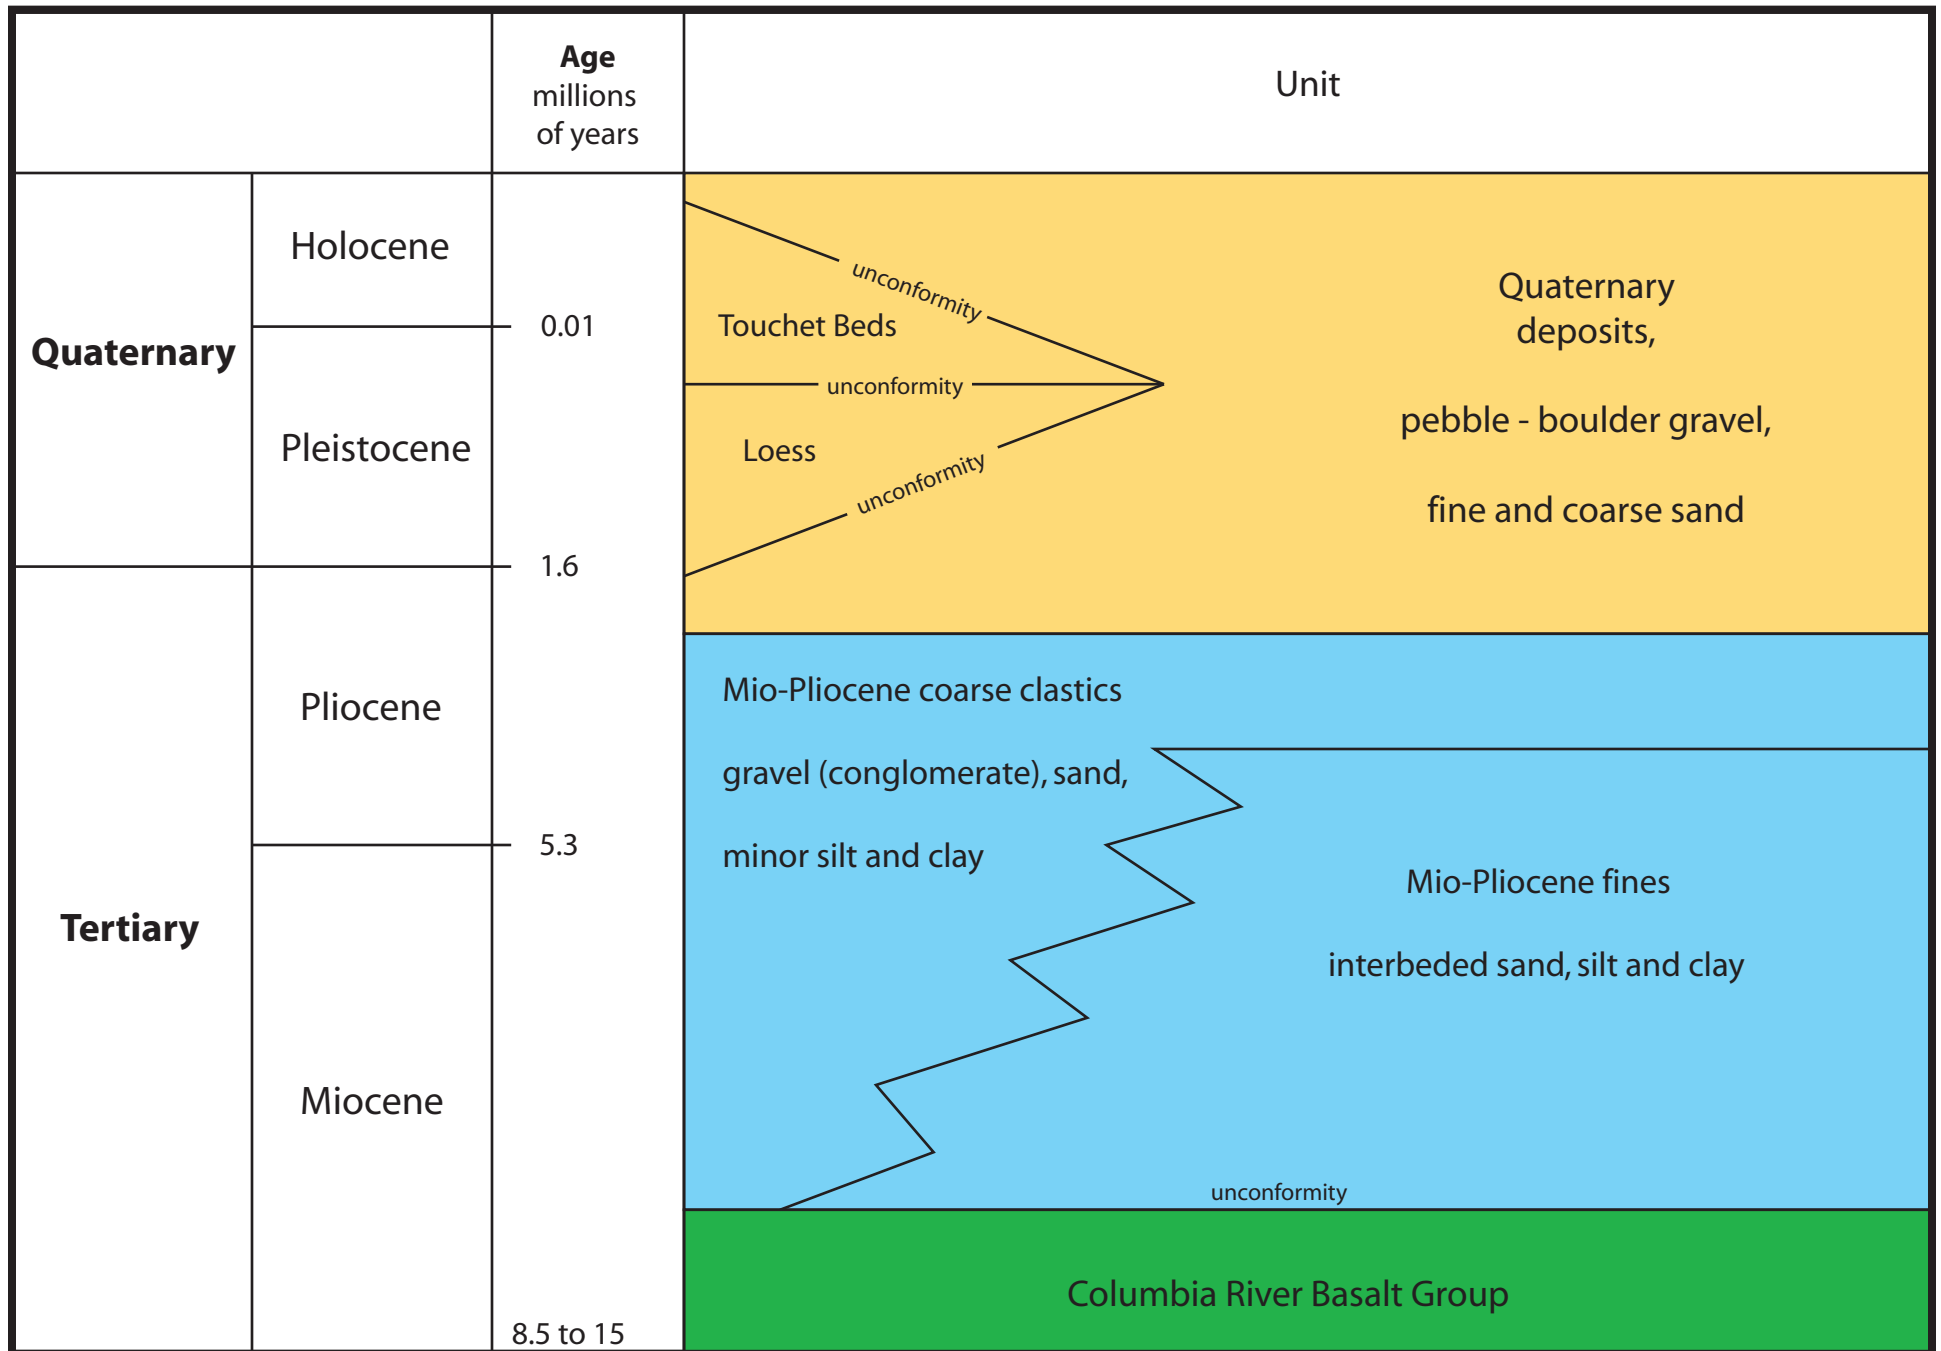
Suprabasalt Sediment Stratigraphic Chart, Walla Walla Basin

Figure 7. Generalized suprabasalt sediment stratigraphic chart for the Walla Walla Basin.

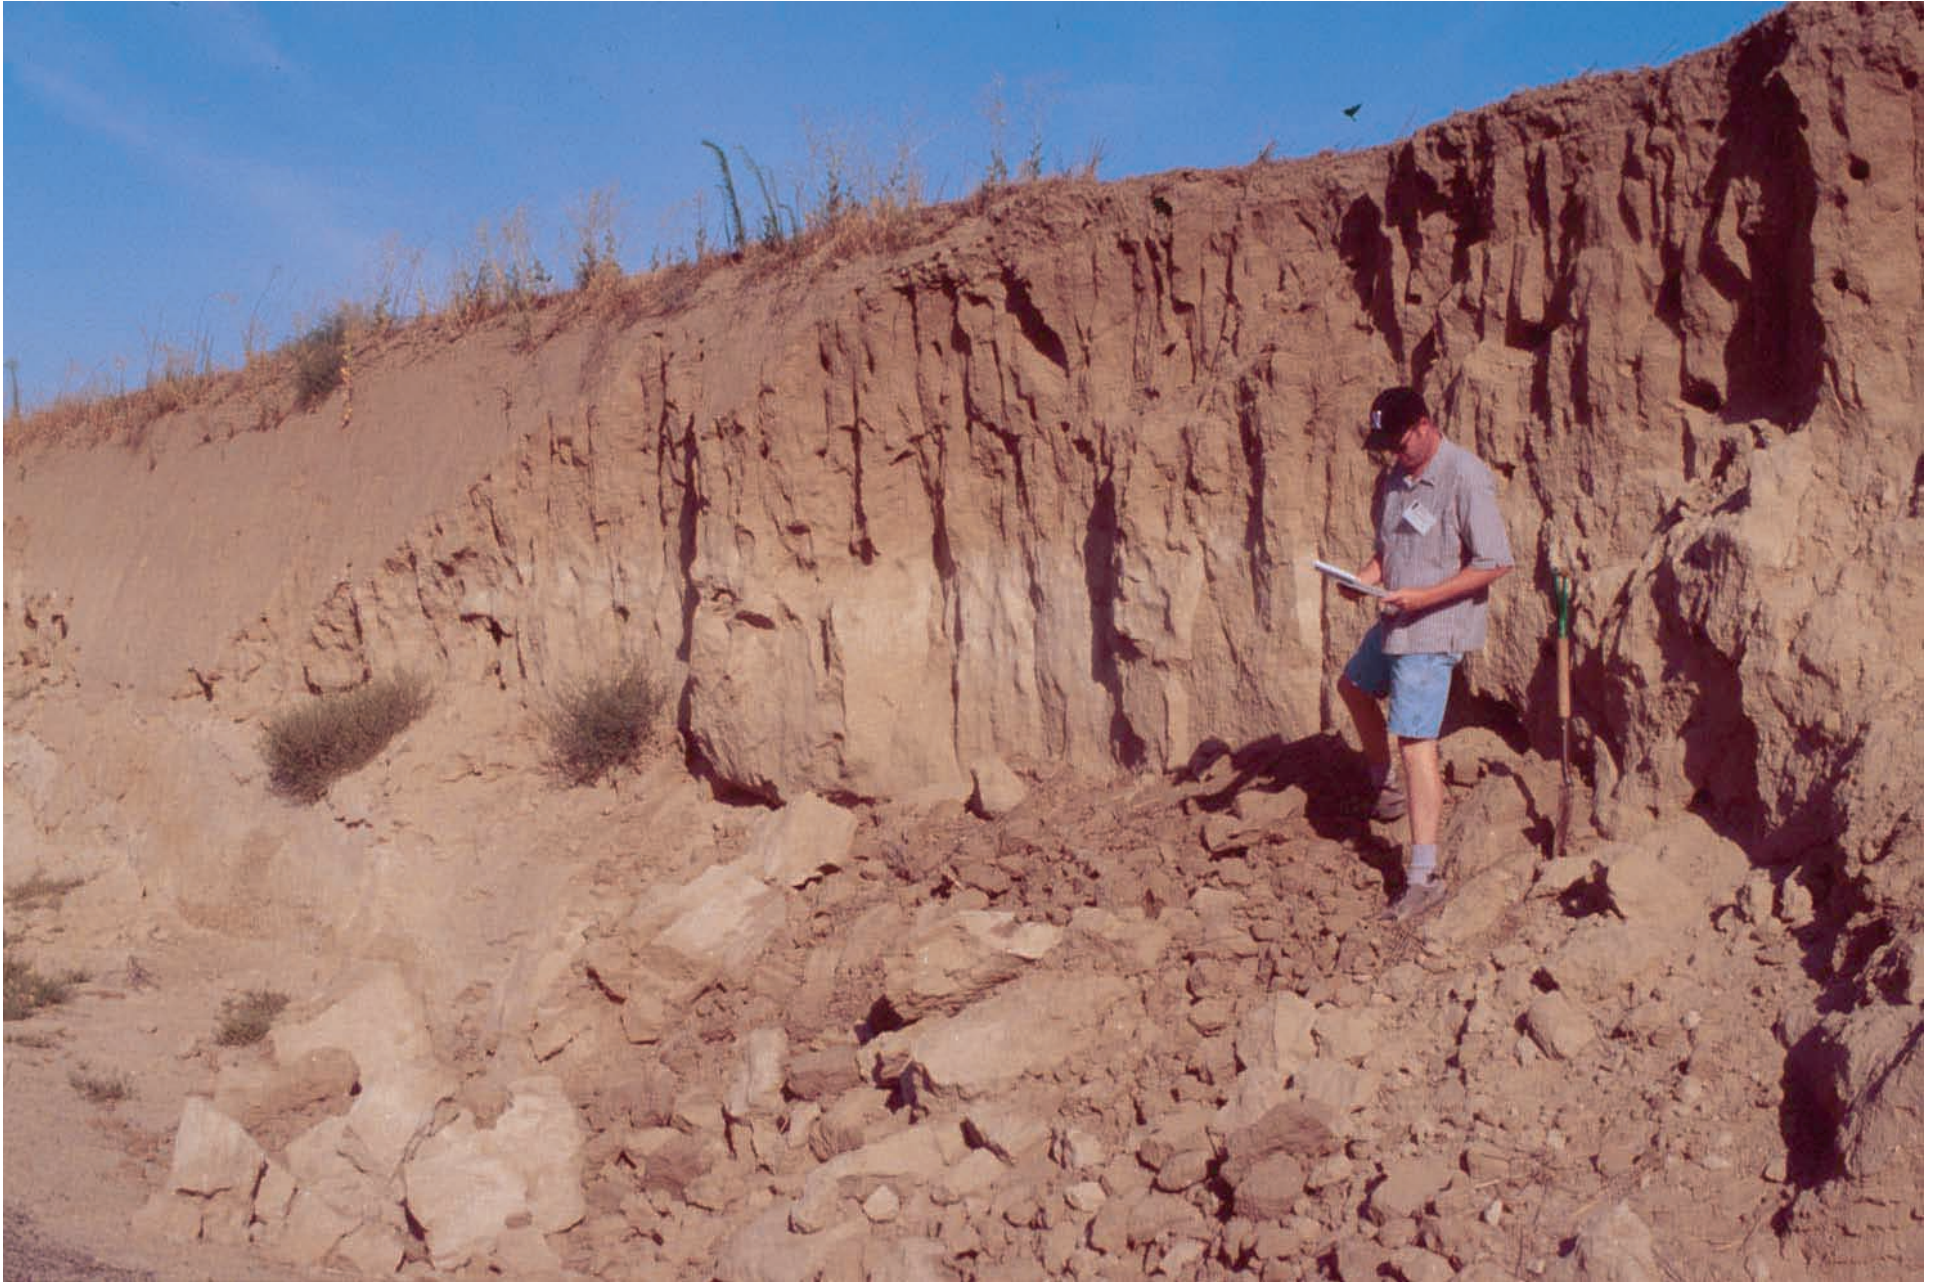
Figure 8. Outcrop photograph of loess.

Loess - Pleistocene loess (also called the Palouse Formation) consists of eolian (wind-deposited), massive to poorly stratified silt and very fine sand deposits that display evidence of pedogenic (soil forming) modification (Figure 8) (Busacca and MacDonald, 1994). Pedogenic calcium carbonate may also be found in these loess deposits. Loess can range from less than 1 foot to several tens of feet-thick in the area (Newcomb, 1965). These loess deposits are thought to range from greater than 50,000 years old to less than 10,000 year old, making loess older than, age-equivalent to, and younger than the Touchet Beds.

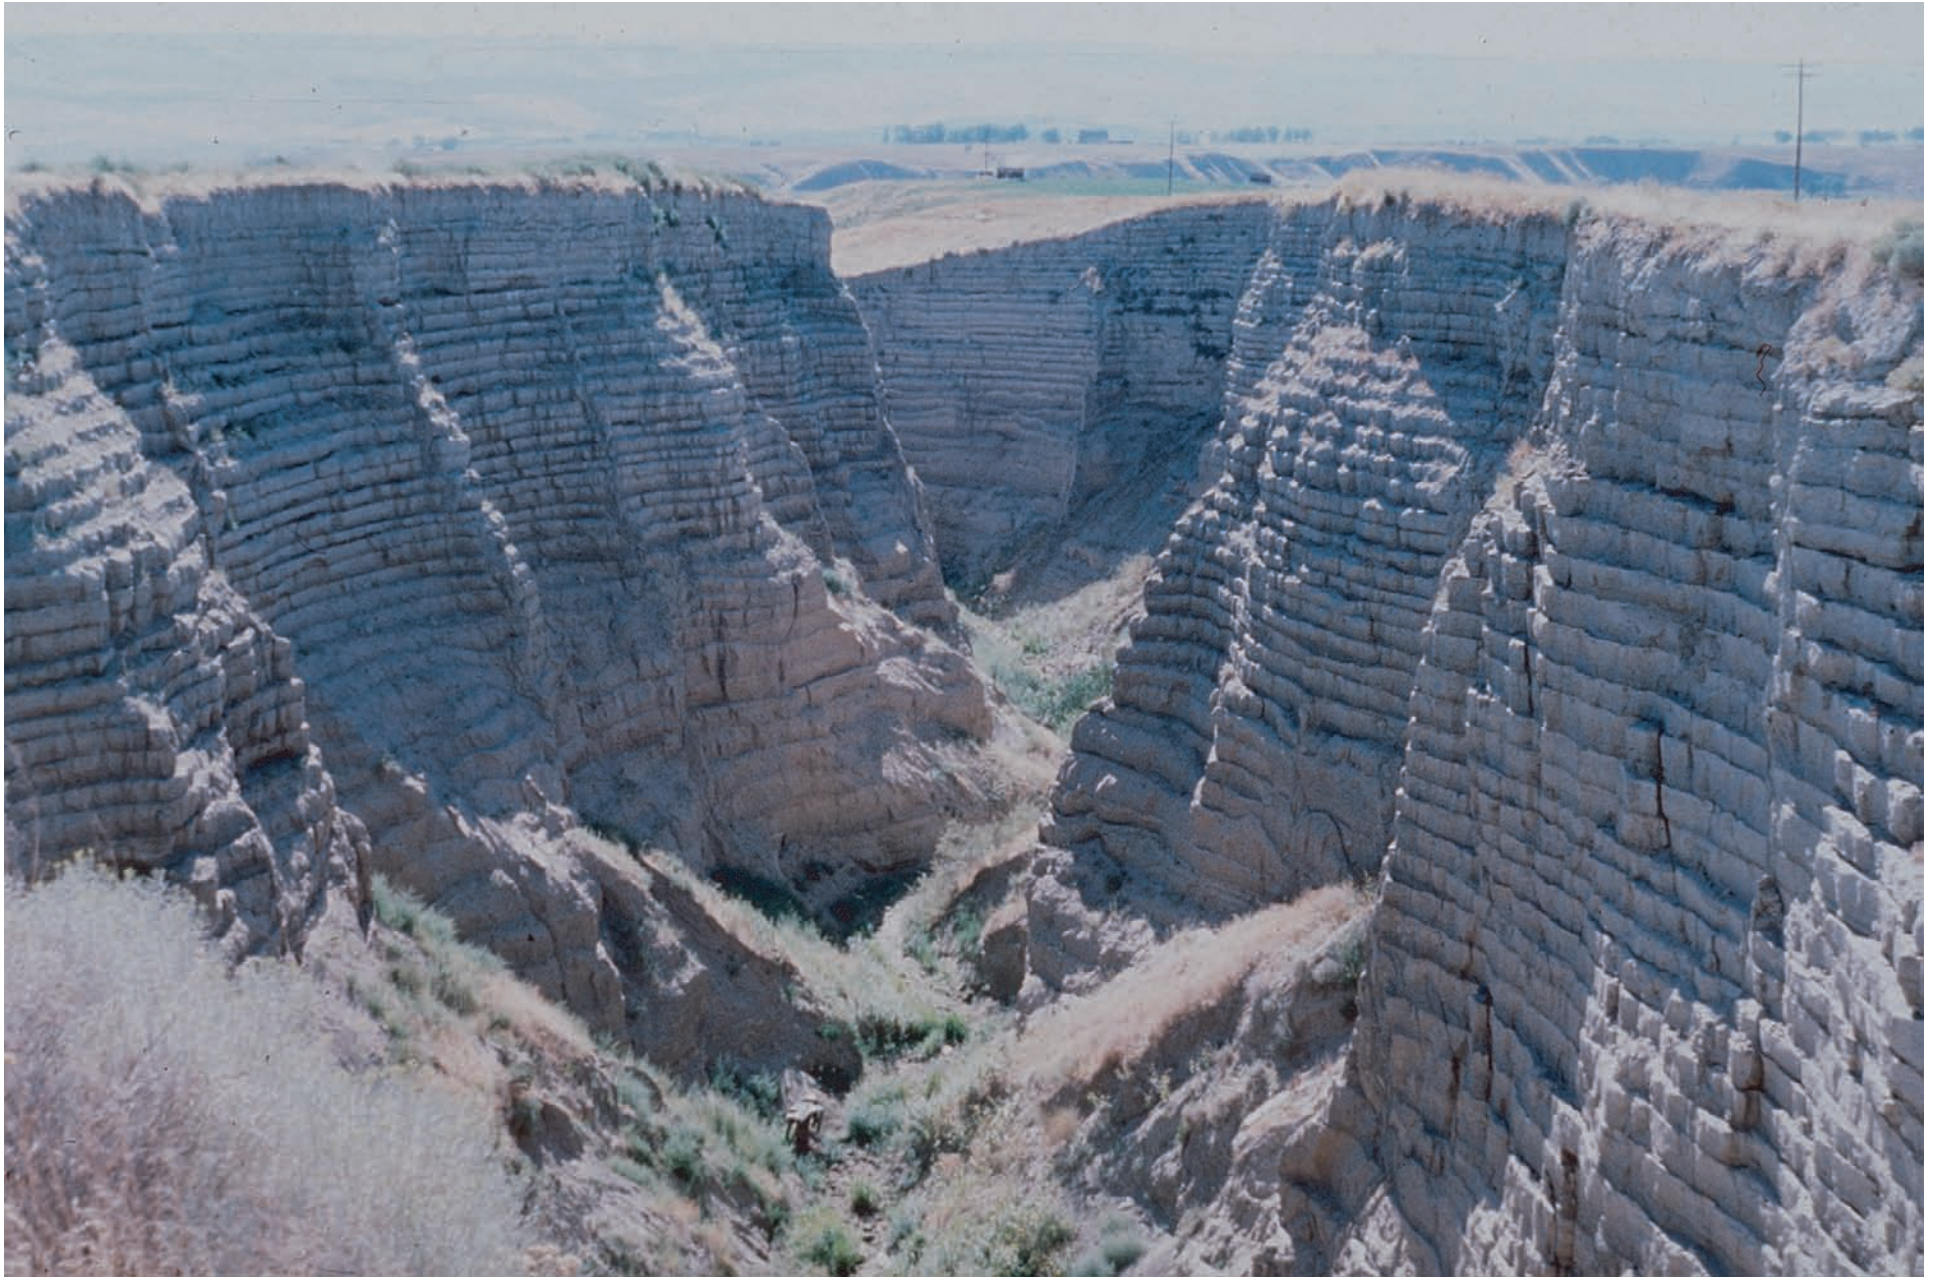
Figure 9. Photograph of Touchet Beds (Pleistocene Cataclysmic Flood deposits).

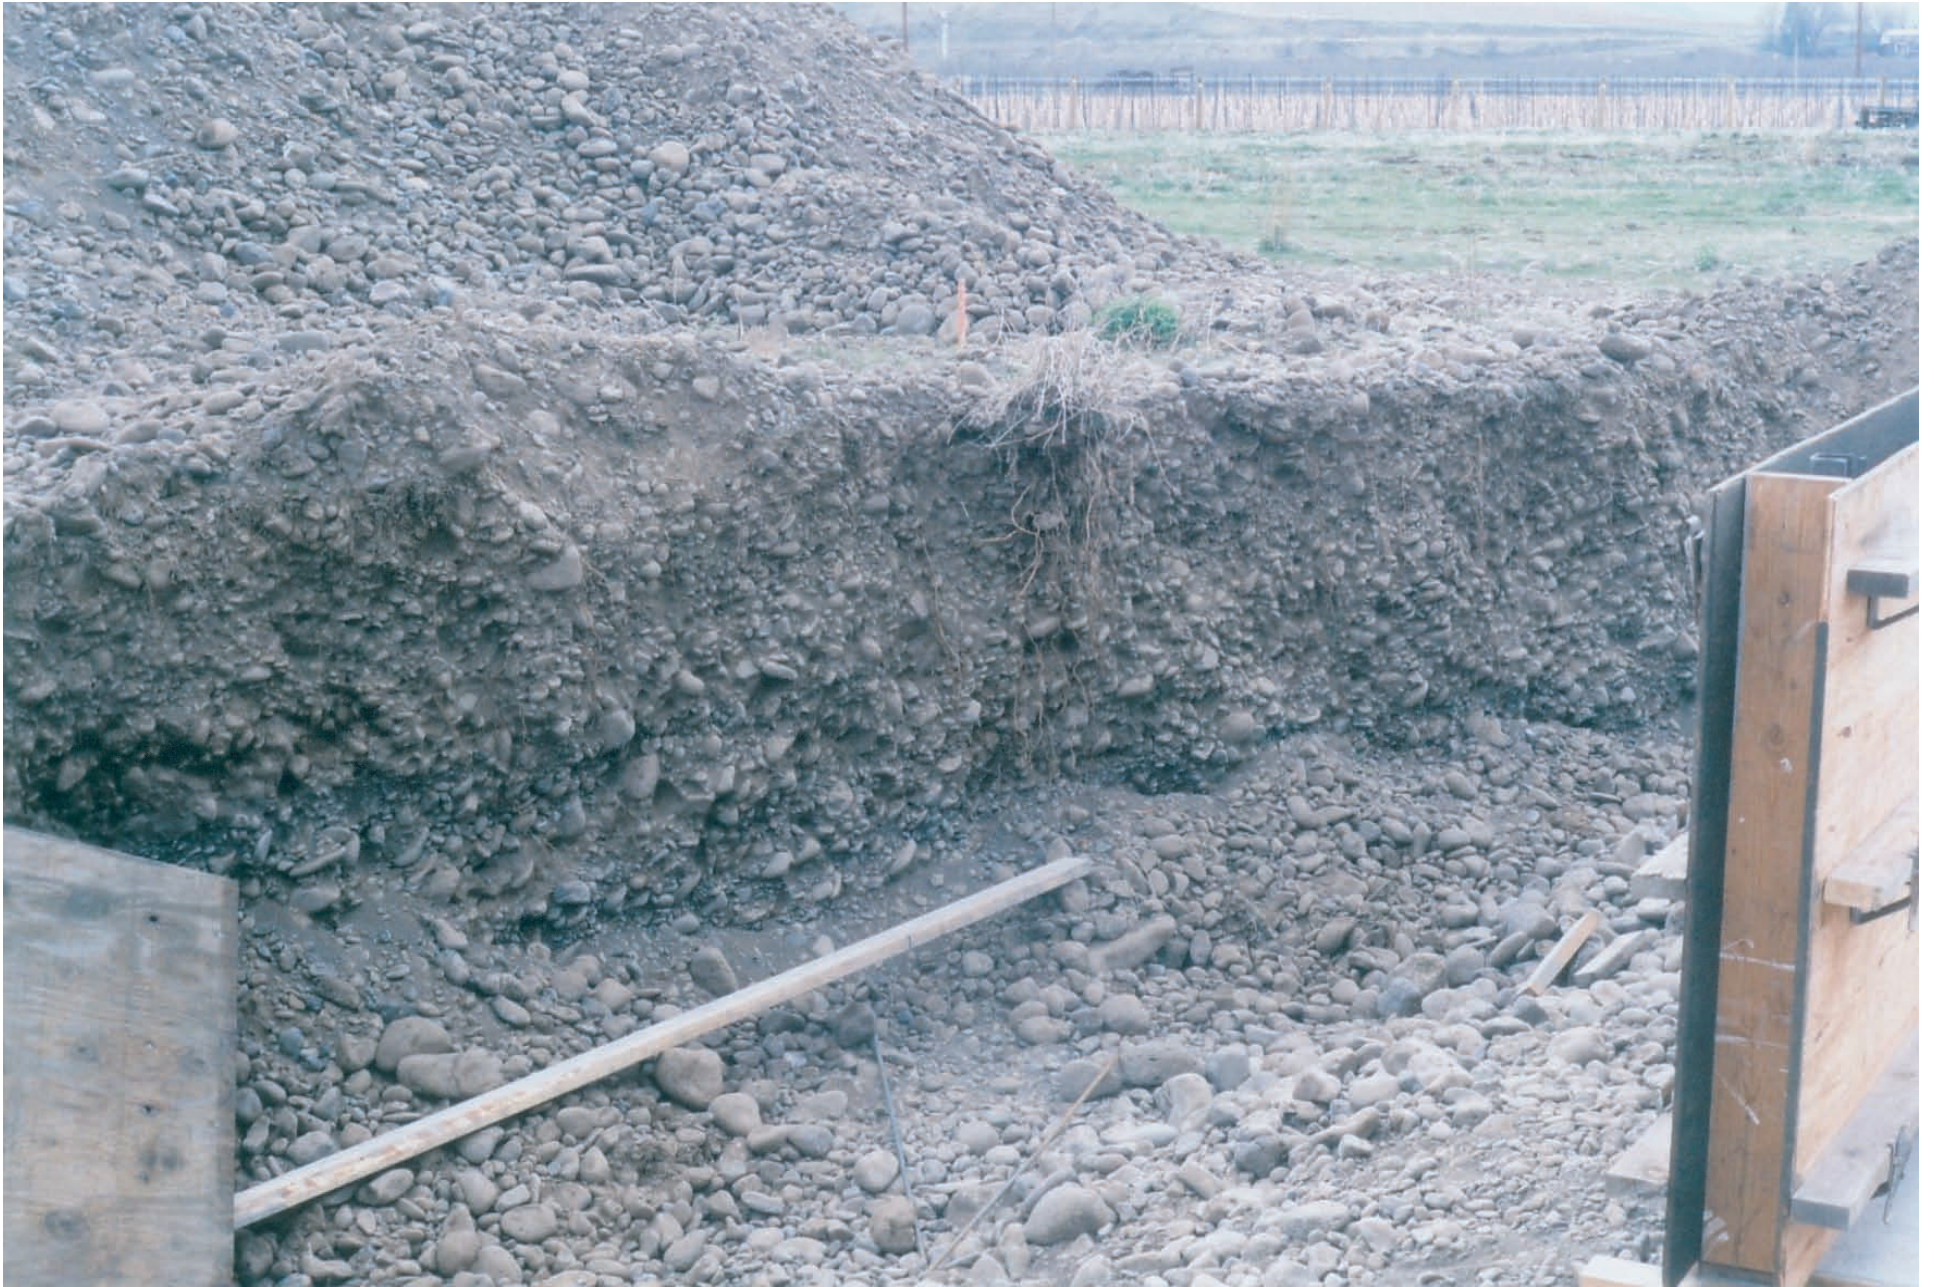
Figure 10. Photograph of Quaternary gravel deposit.

strata found elsewhere in the Basin (Newcomb, 1965) these gravely deposits probably are basaltic, moderately to well bedded, have a silty to sandy matrix, are generally uncemented, and contain thin silty interbeds (Figure 10). These uncemented and nonindurated gravels are generally equivalent to Newcomb's (1965) younger alluvial sand and gravel and are interpreted to record stream deposition in the Walla Walla Basin by streams draining off the adjacent Blue Mountains.

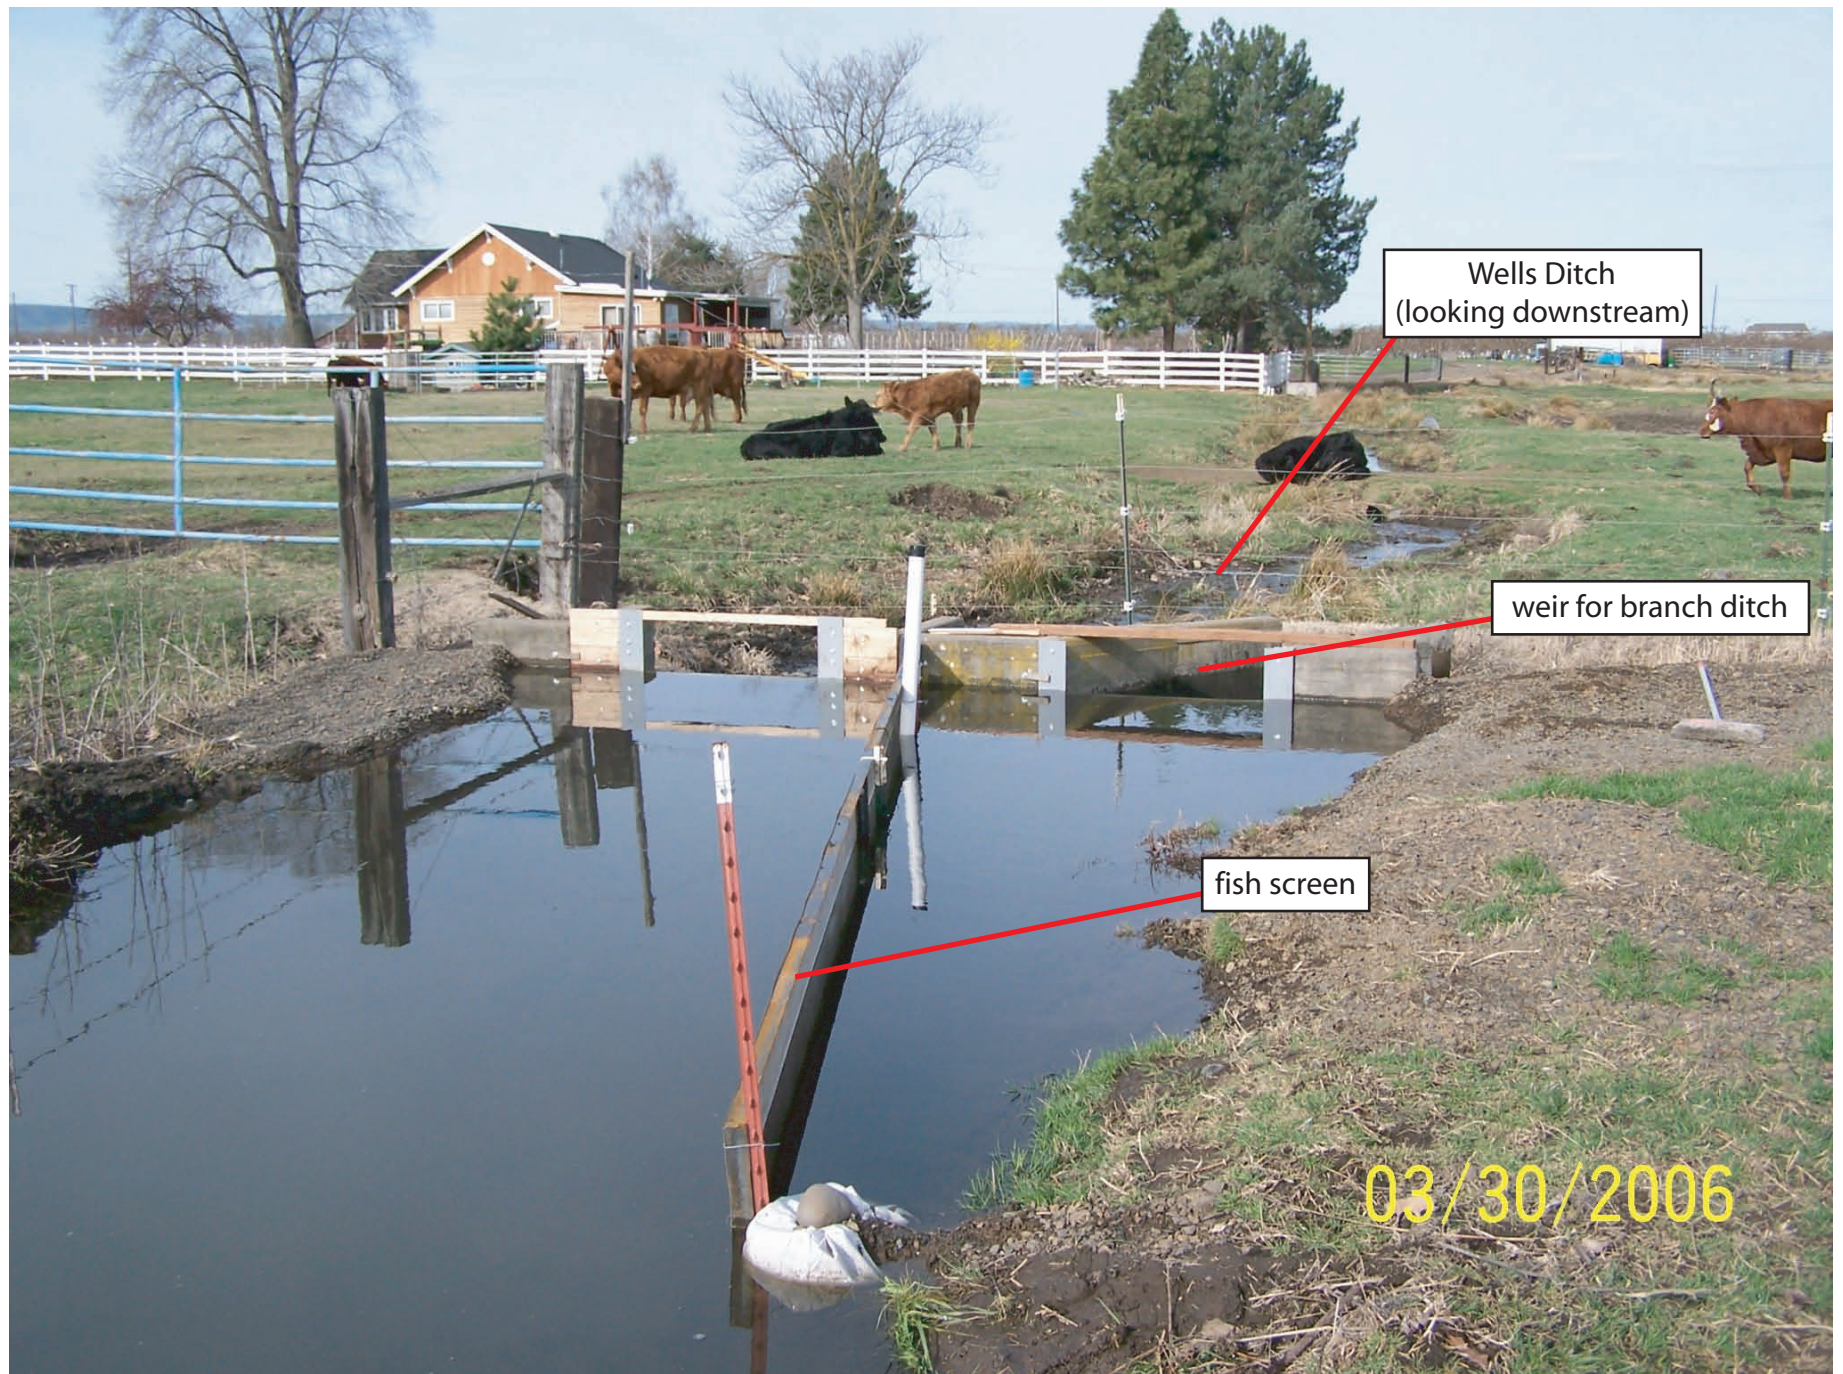
Figure 14. Photograph of the fish screen and weir at the branch ditch diversion off Wells Ditch.

- A fish screen and flow measurement weir (Figure 14), as required by the License conditions, were installed at the turnout for the branch ditch leading to the Test Site off of Wells Ditch. The turn out structure was modified to accommodate the weir and screen. These structures are both temporary and only in place during testing.

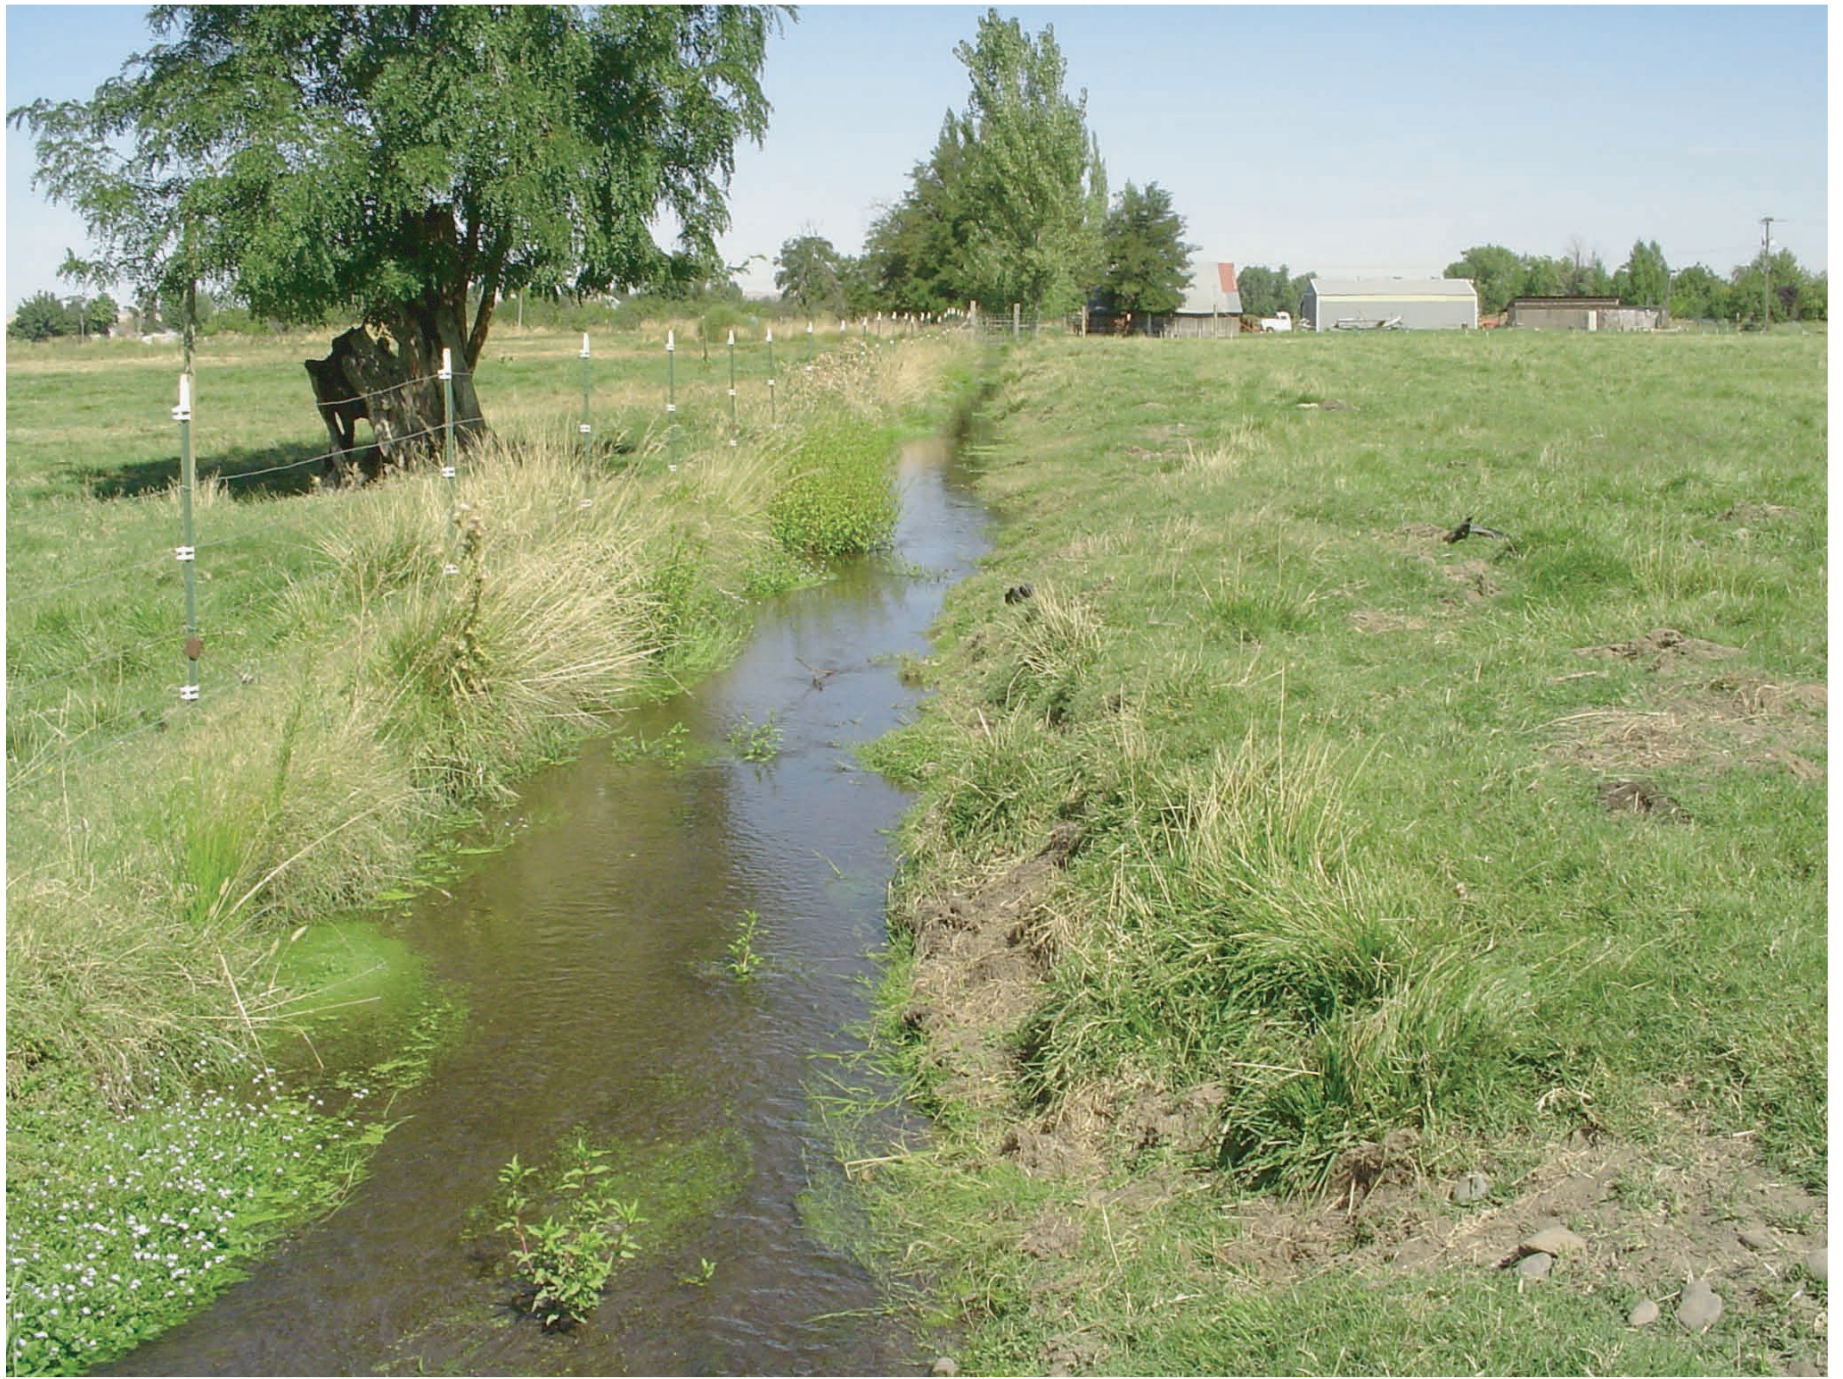
Figure 15. Branch ditch leading north to the Test Site.
