Results of the First Season of Shallow Aquifer Recharge Testing at the Hall-Wentland Site, Umatilla County, Oregon and Walla Walla County, Washington

23 June 2006

Prepared for
HDR, Inc.
2805 St. Andrews Loop, Suite A
Pasco, Washington 99356

K/J Project No. 0492001*00

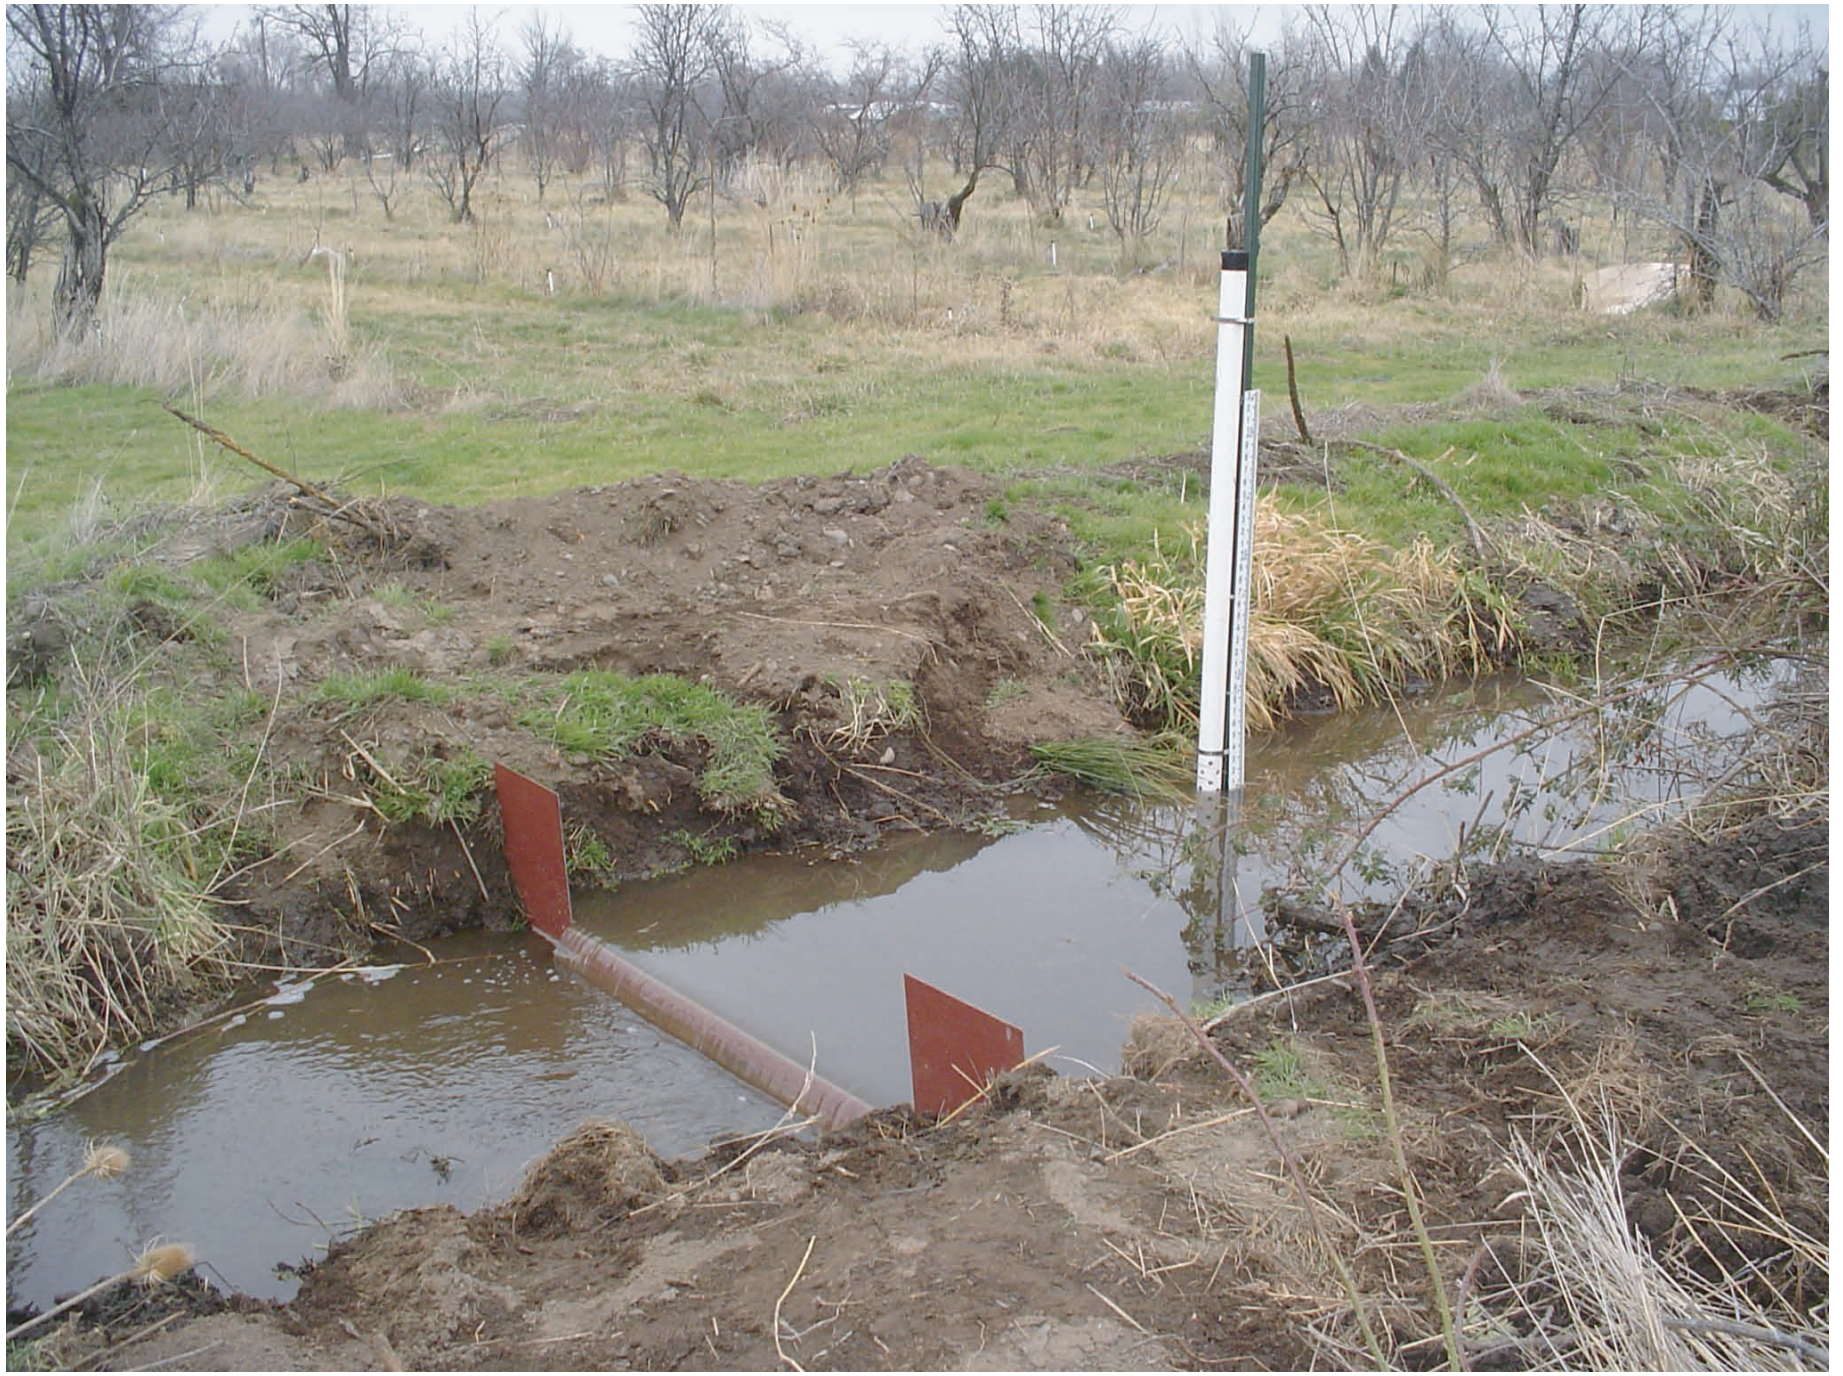
Figure 16. Photograph of the measurement weir on the branch ditch leading onto the Test Site.

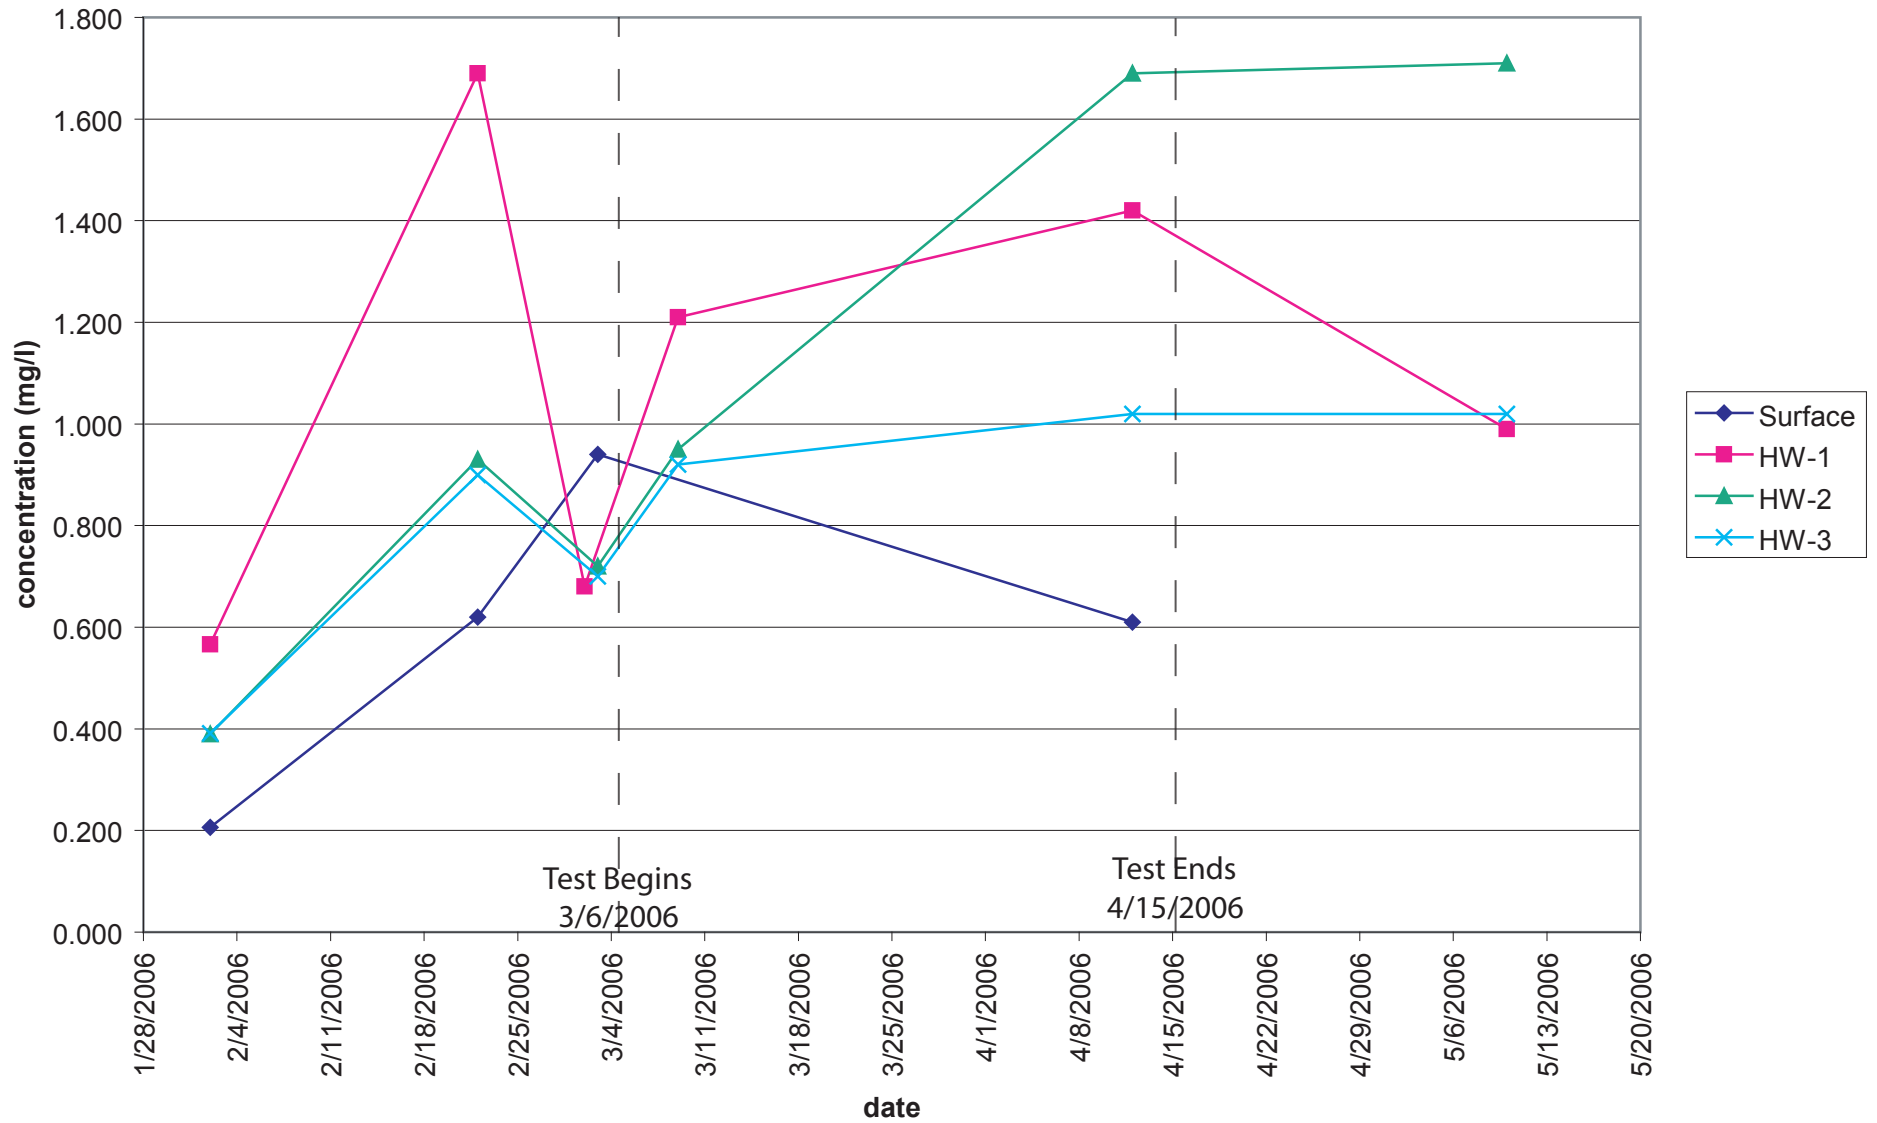
Figure 21. Graph showing nitrate-N concentrations in monitoring wells and surface water

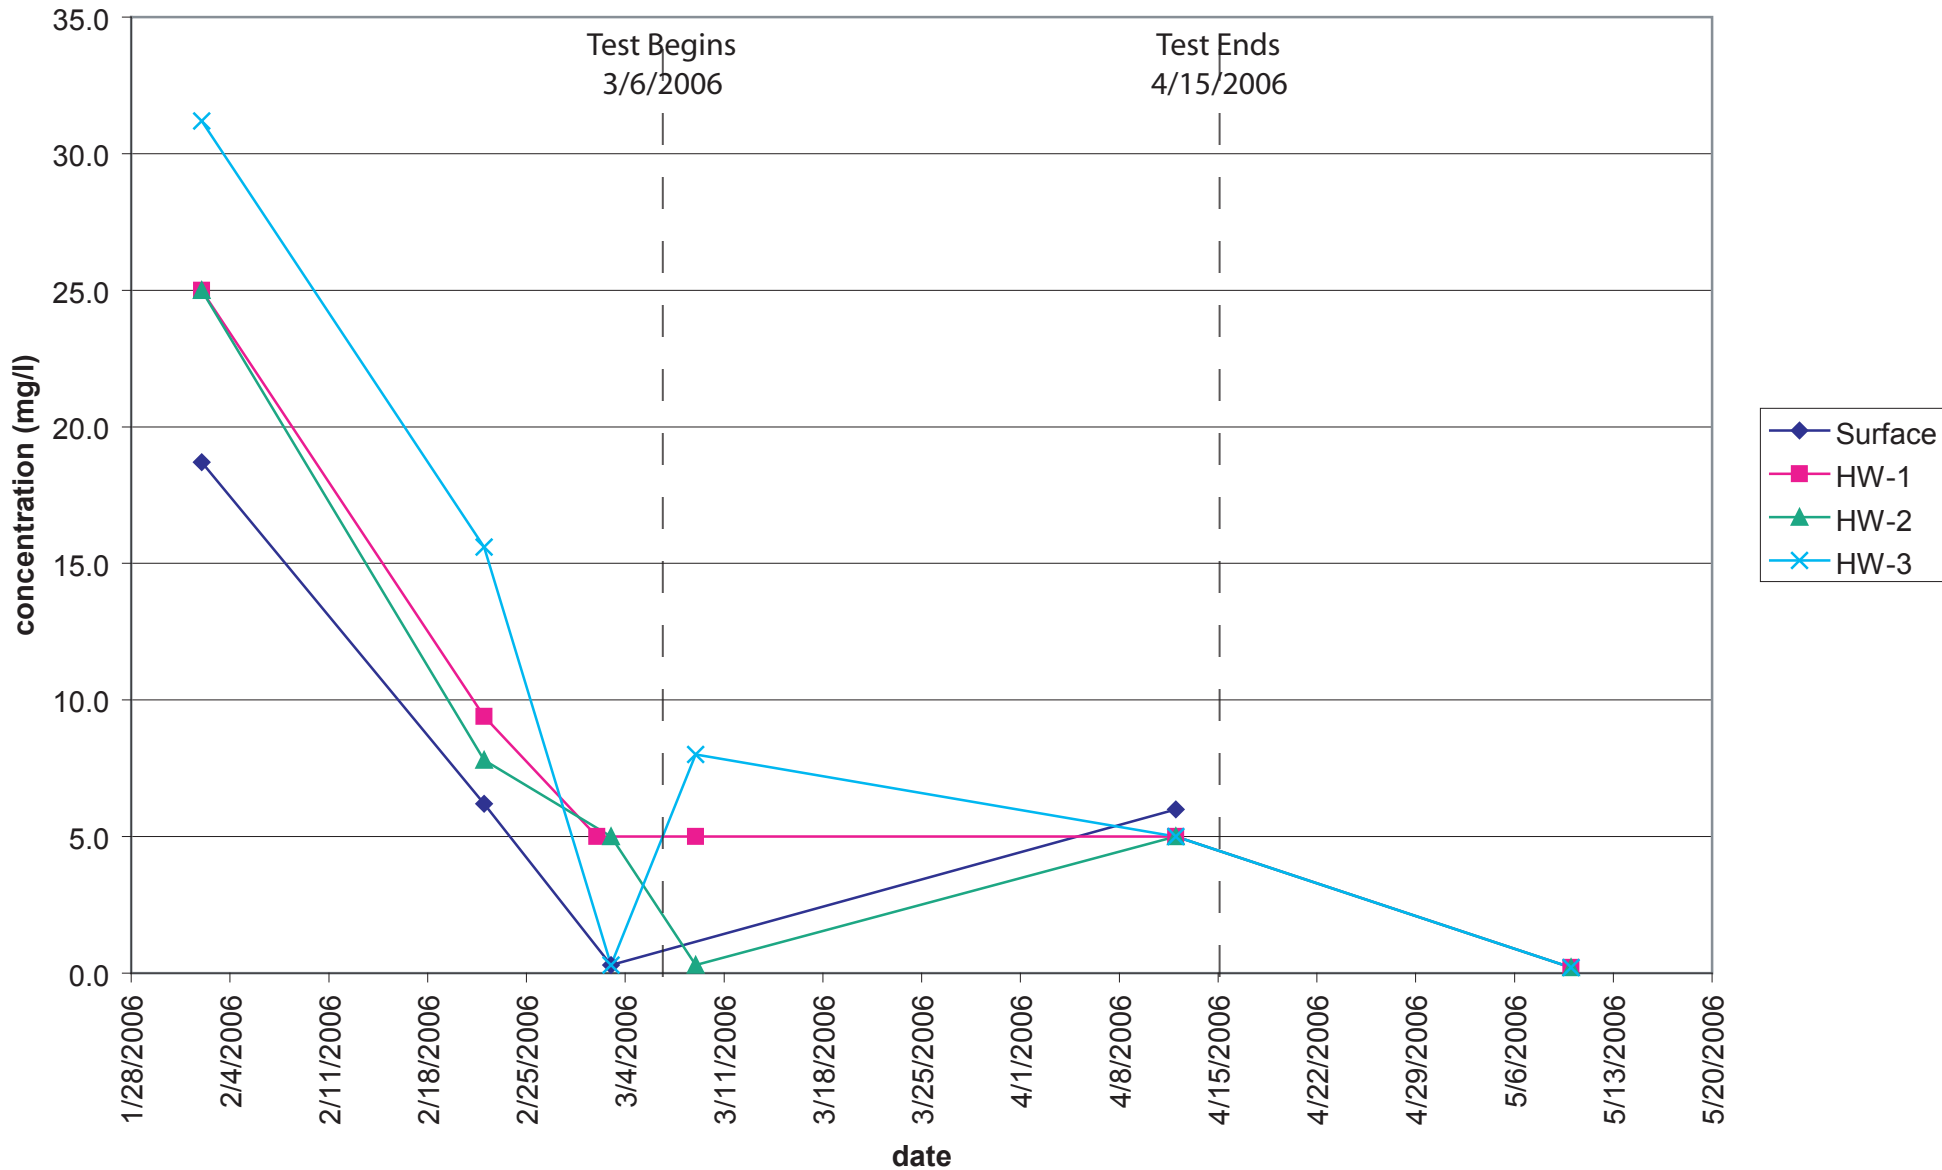
Chloride

Figure 24. Graph showing chloride concentrations in monitoring wells and surface water

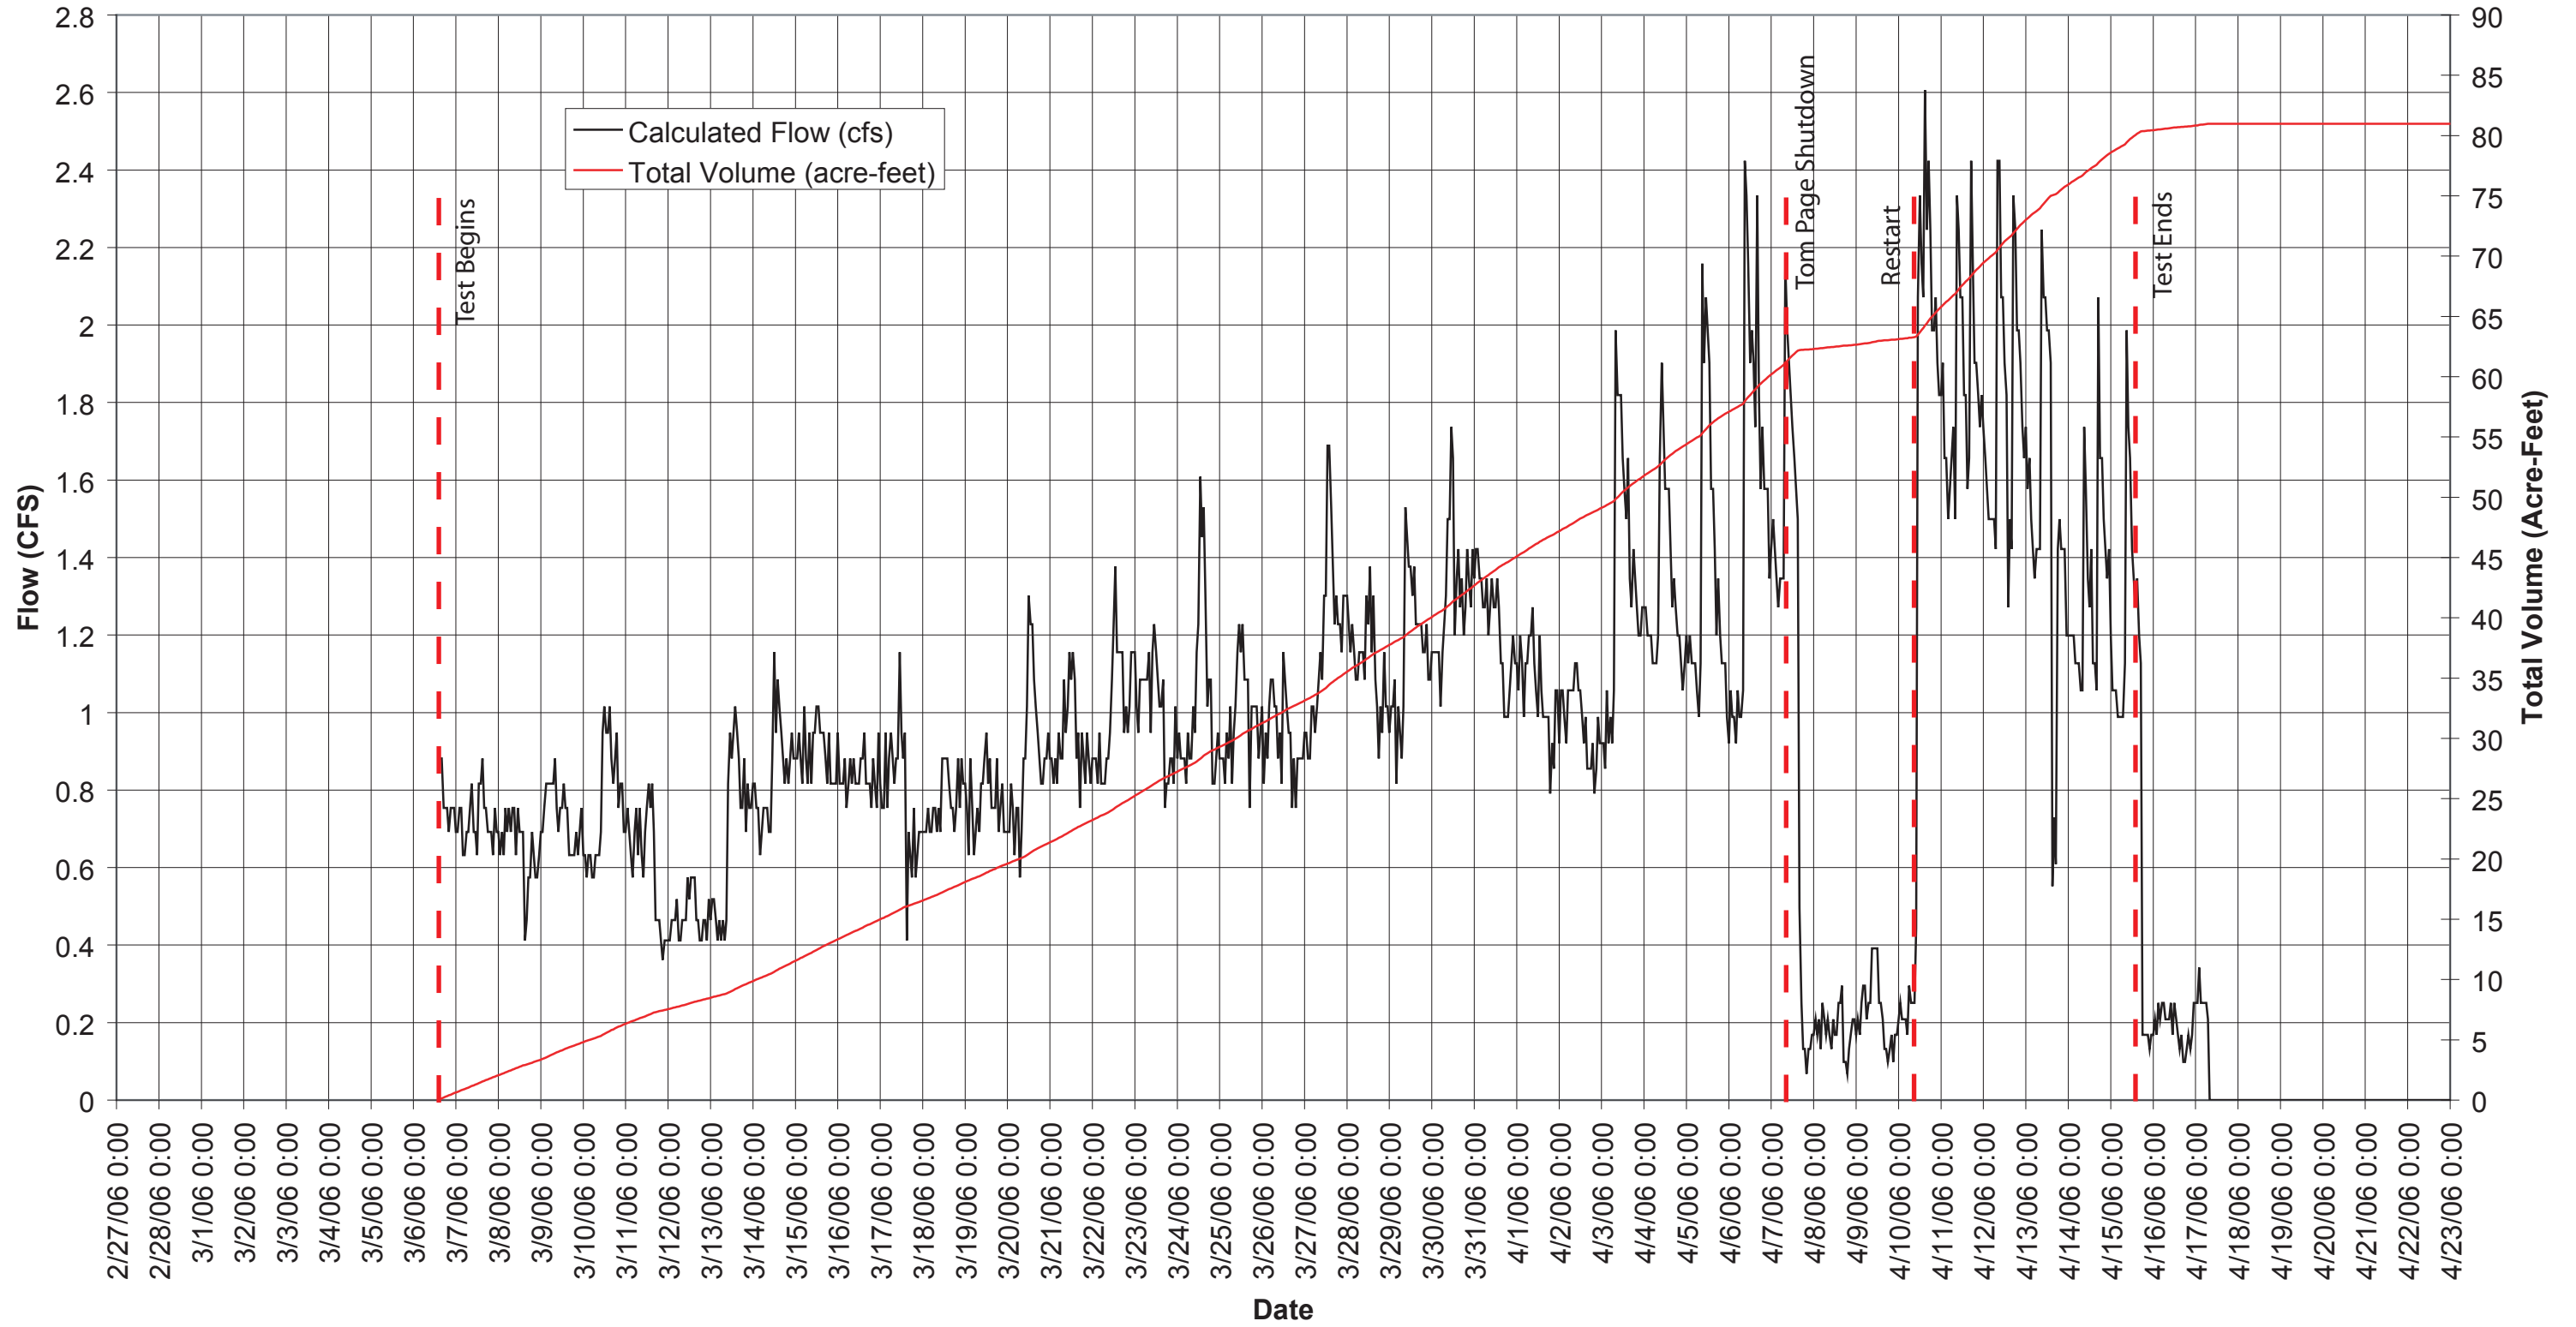
Diversion Weir

Figure 28. Hydrograph for branch ditch diversion gauge.

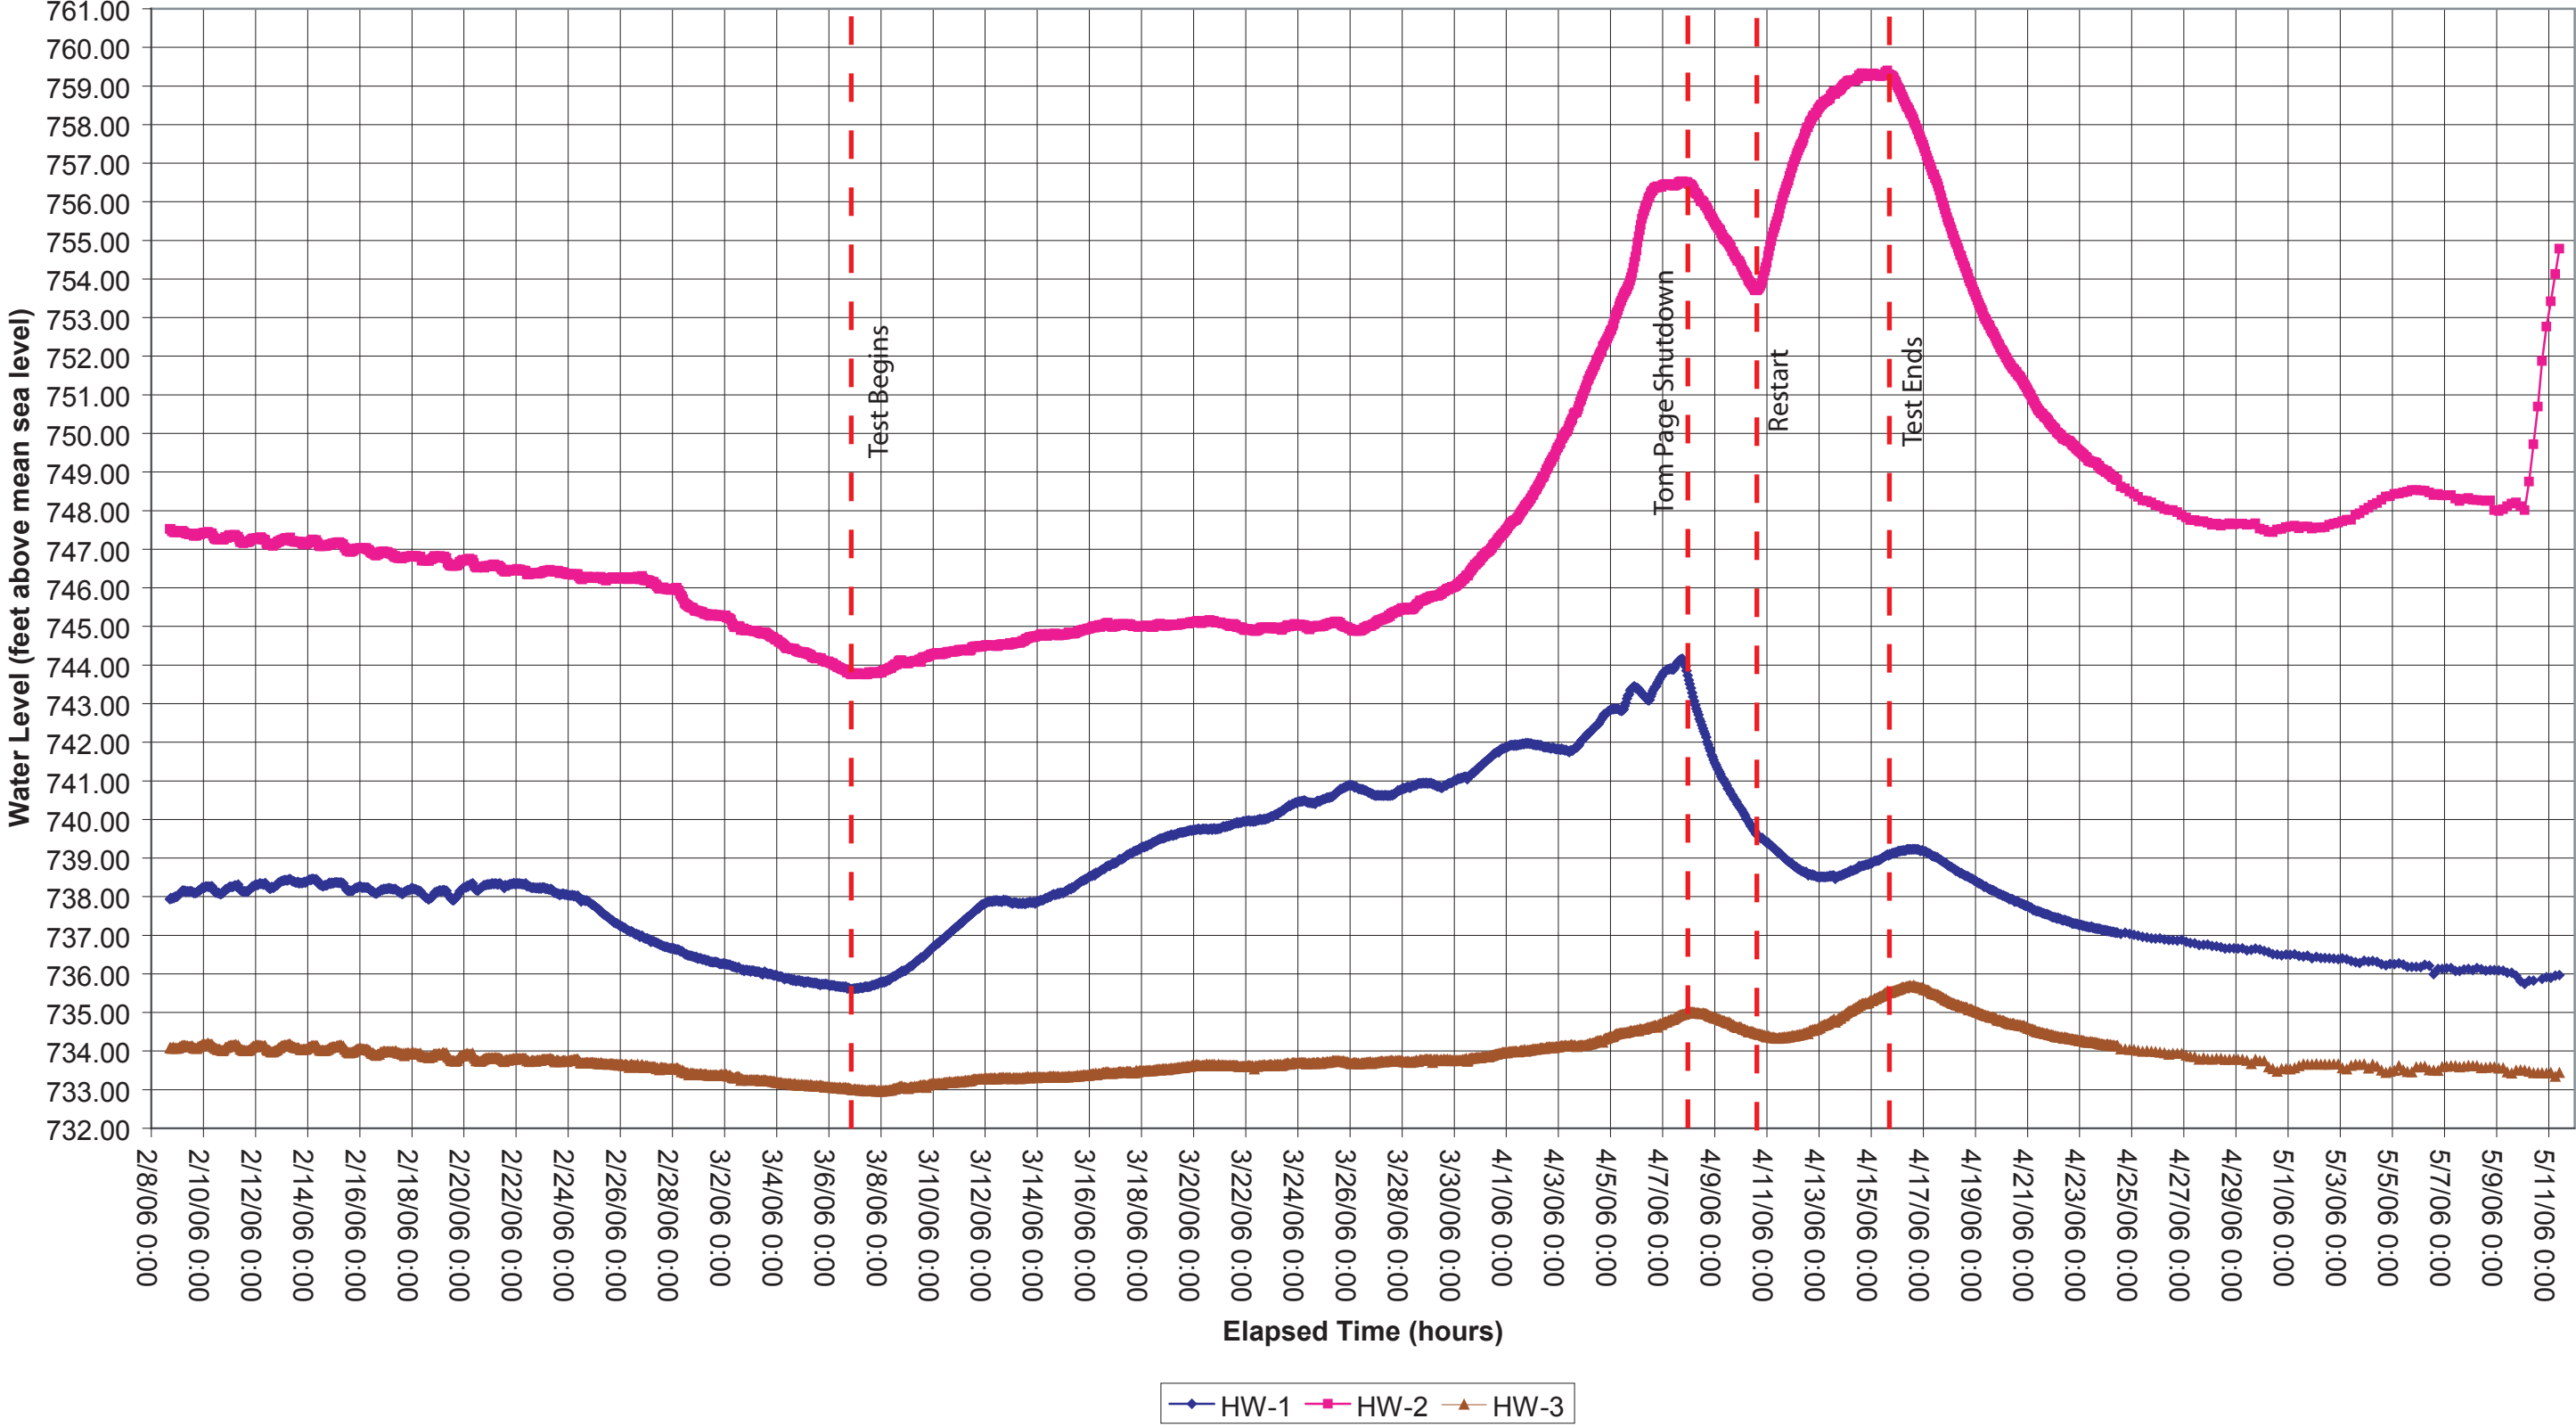
Hall Wentland Water Level Monitoring

Figure 30. Hydrographs for the three monitoring wells.

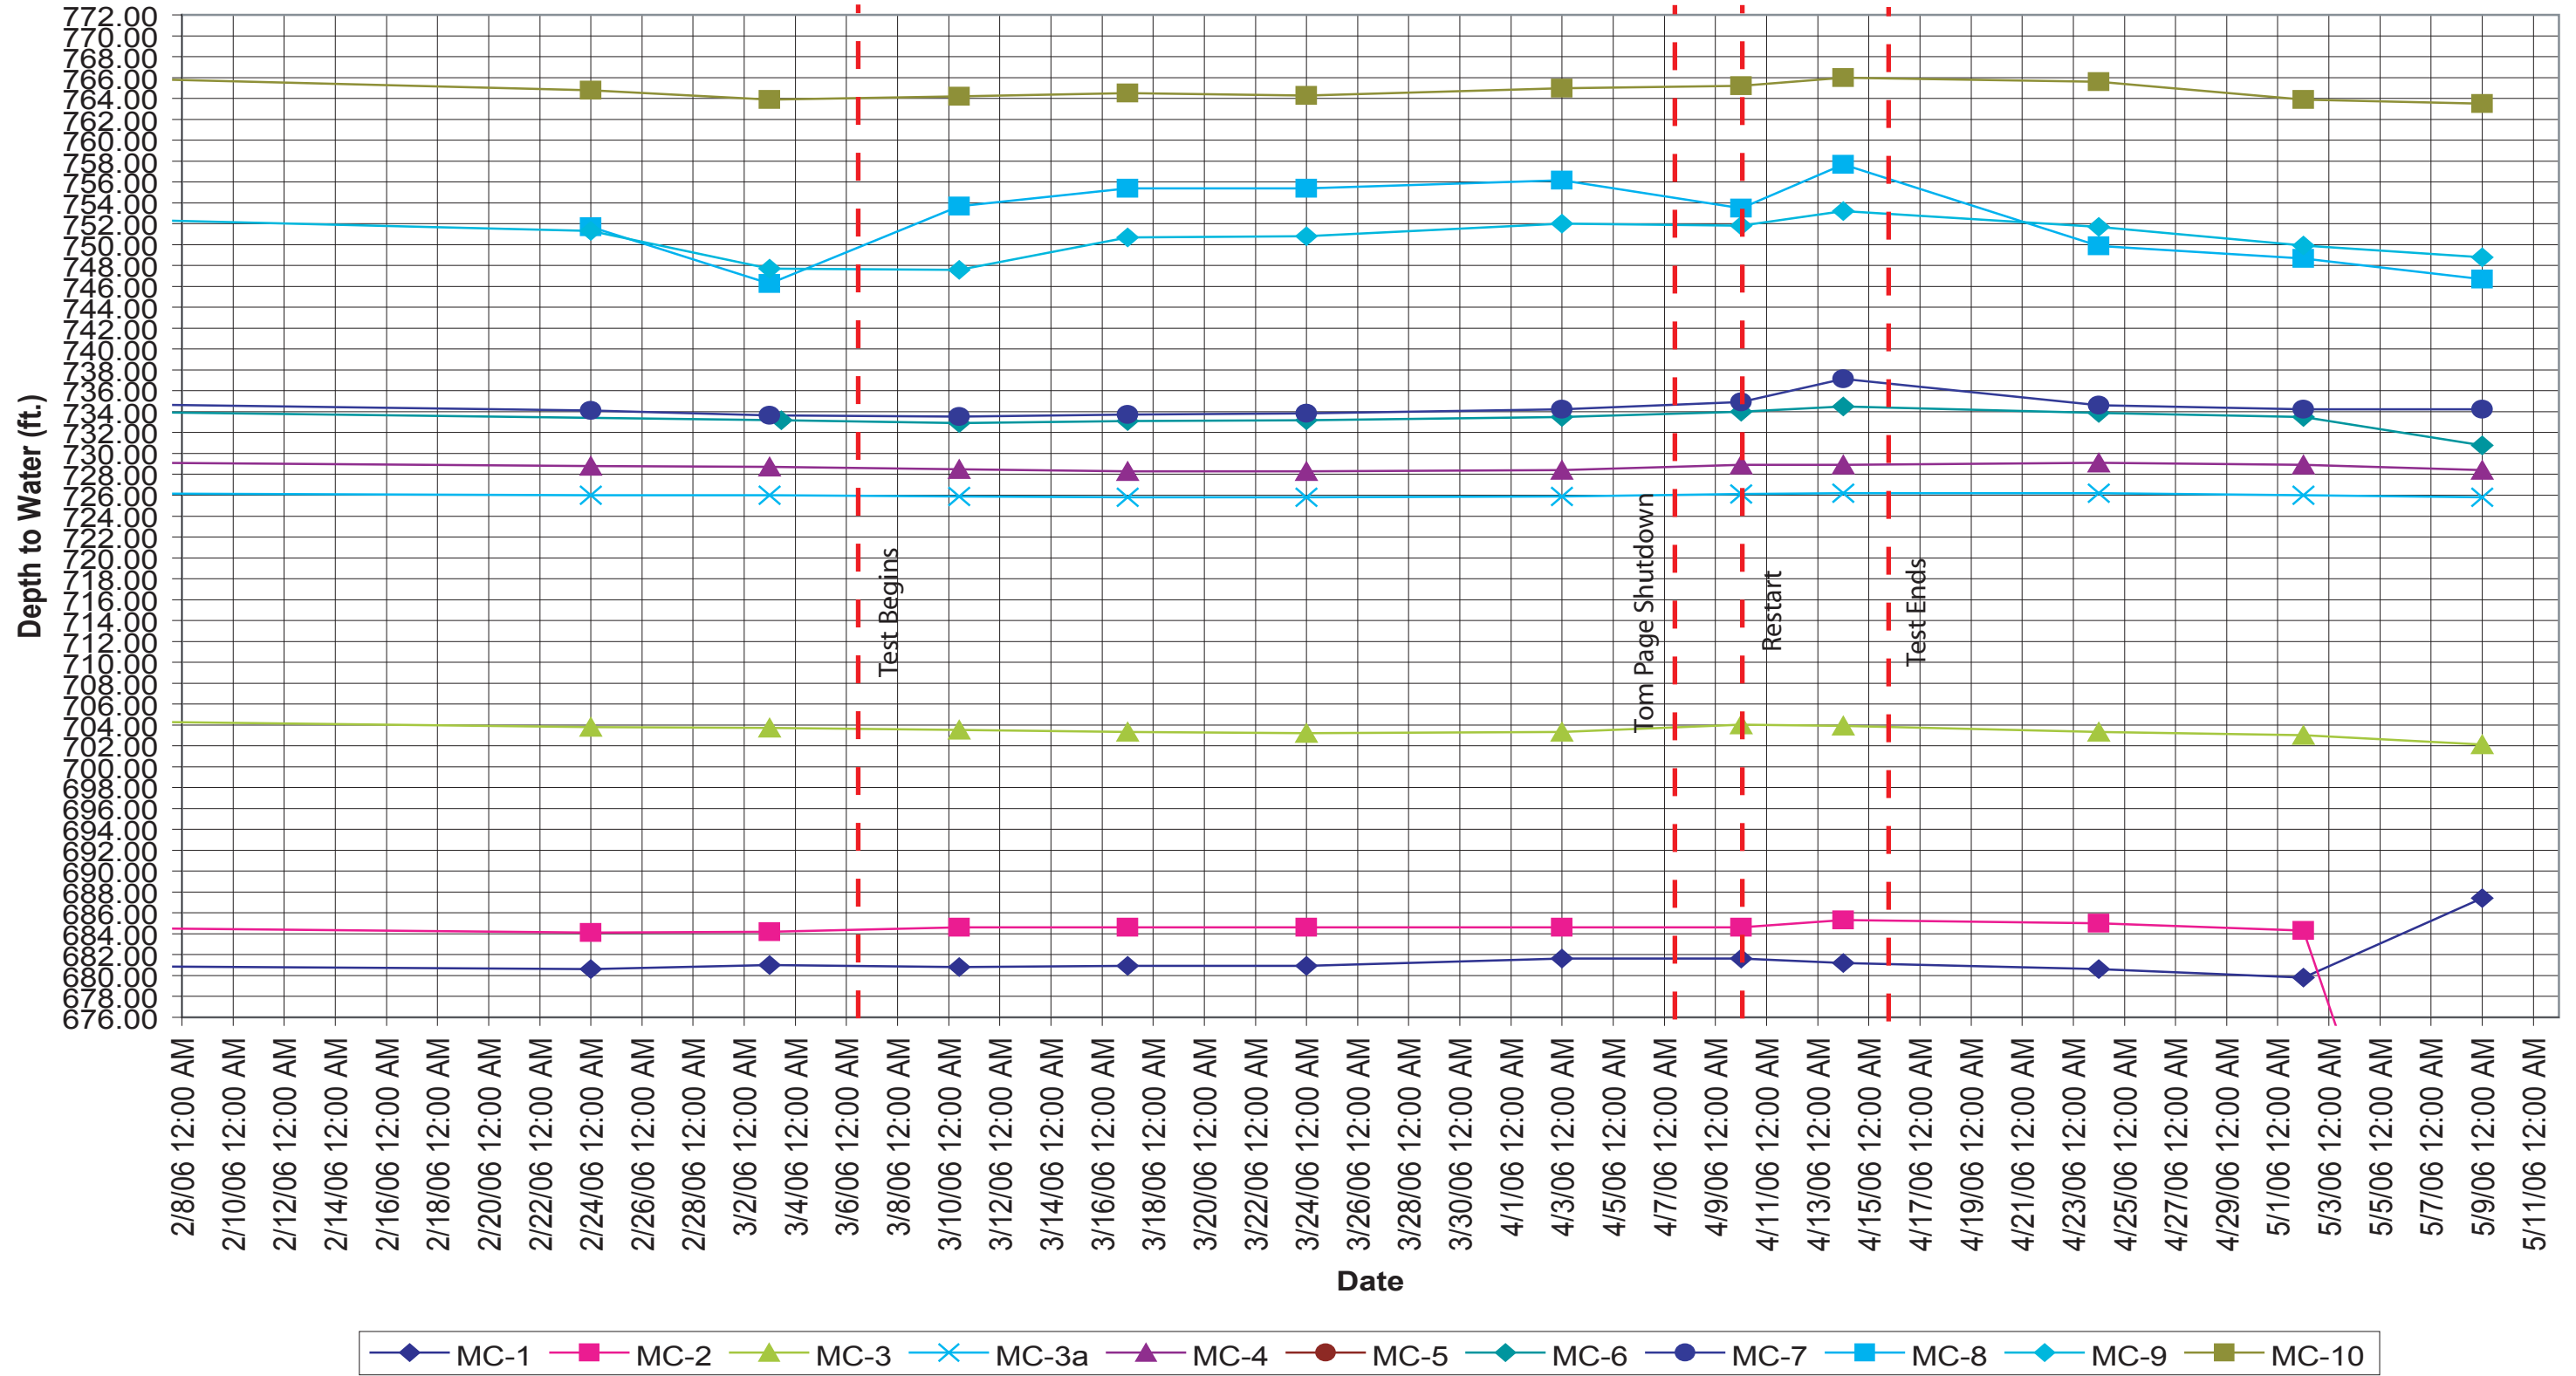
Page Monitoring Well Levels

Figure 31. Hydrographs for the manually measured water wells.
