Results of the First Season of Shallow Aquifer Recharge Testing at the Locher Road Site, Walla Walla County, Washington

Prepared for:
Gardena Farms Irrigation District #13
And
Washington Department of Ecology

by:
GSI Water Solutions, Inc.
1020 North Center Parkway, Suite F
Kennewick, WA 99336

July 2007

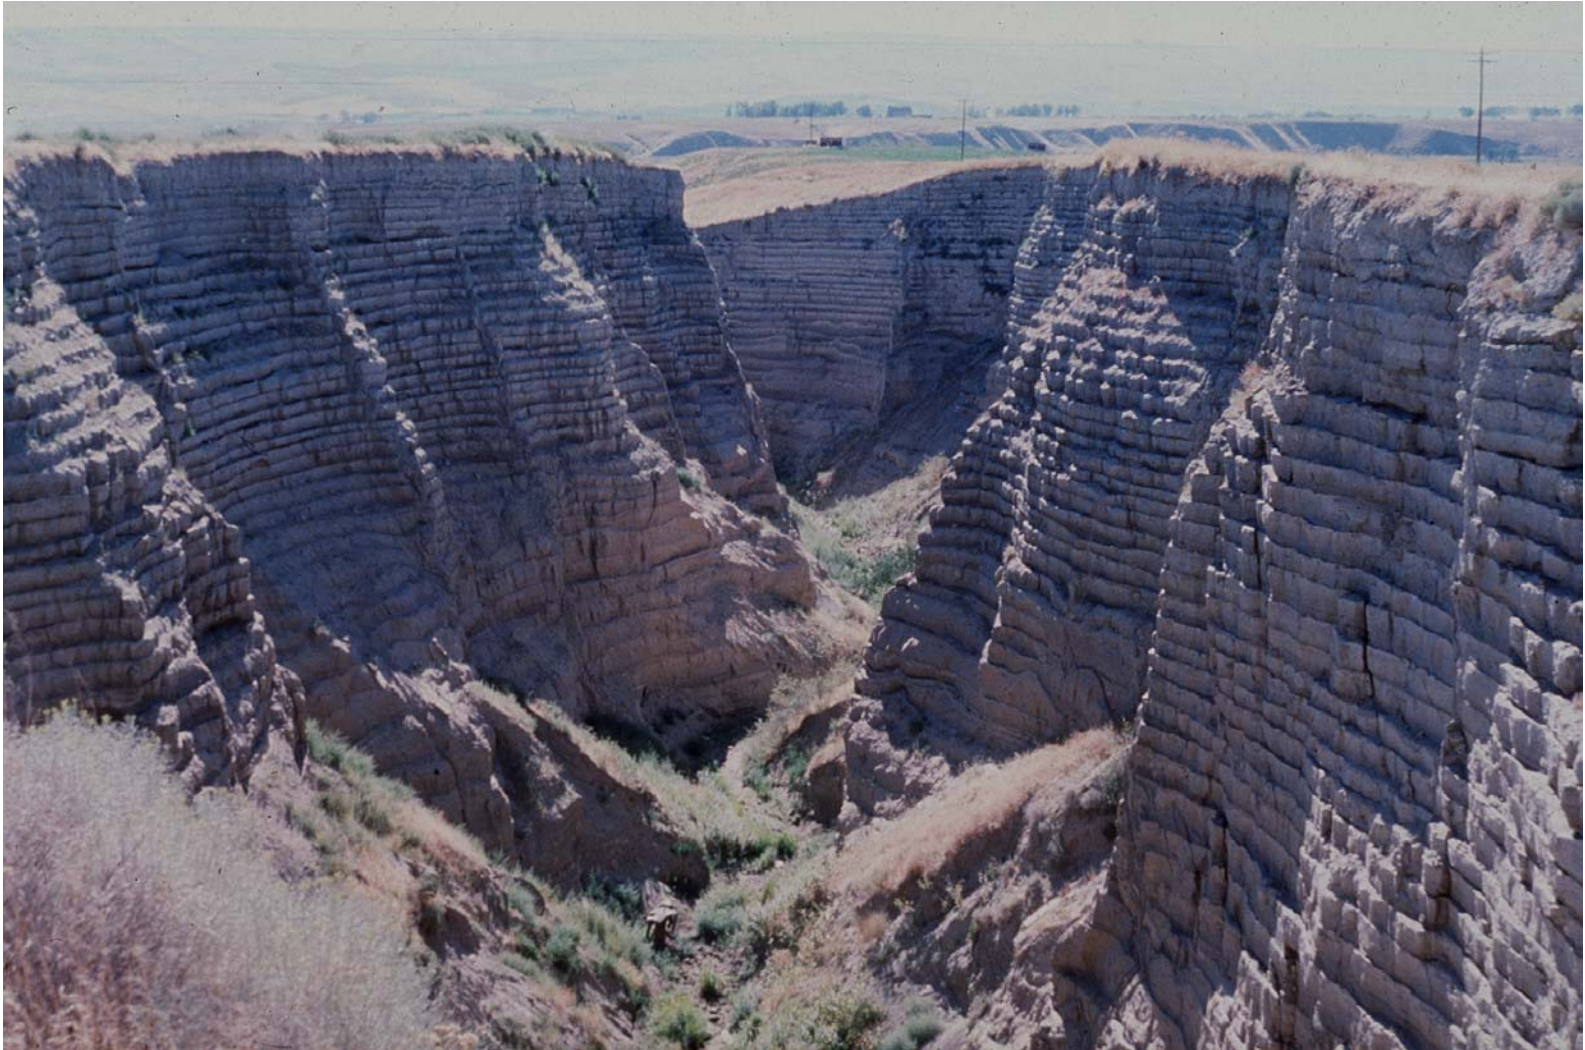
Figure 5. Outcrop of Touchet Beds (Quaternary fine unit) showing the well bedded nature of these strata. Outcrop is located a few miles west of the Locher Road SAR Site.

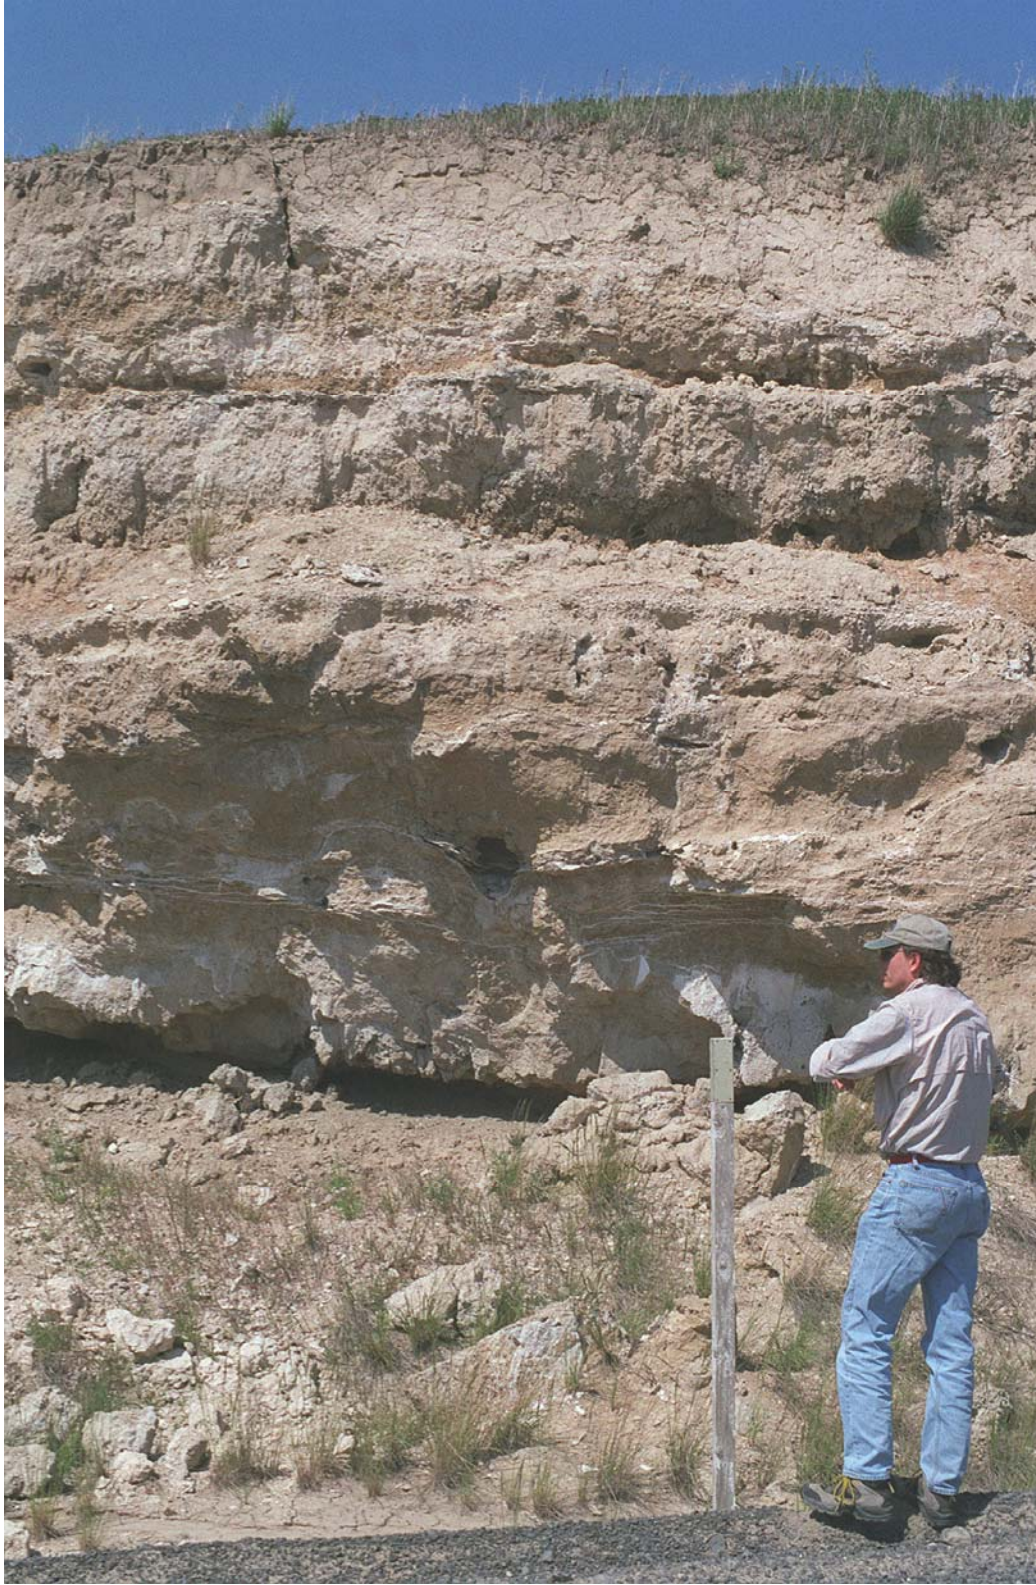
Figure 6. Photograph of loess (Palouse Formation, Quaternary fine unit) with overprint of pedogenic calcium carbonate.

The Palouse Formation consists of eolian (wind-deposited), massive to poorly stratified silt and very fine sand deposits that display evidence of pedogenic (soil forming) modification (Figure 6) (Busacca and MacDonald, 1994). Newcomb (1965) generally described this unit as massive, well compacted clayey silt (or loess) containing irregular, thin caliche layers. Pedogenic calcium carbonate may also be found in these loess deposits. Palouse Formation loess can range from less than 1 foot to several tens of feet-thick in the area (Newcomb, 1965). These loess deposits are thought to range from greater than 50,000 years old to less than 10,000 year old, making loess older than,

age-equivalent to, and younger than the Touchet Beds. In outcrops found along a number of the county roads, loess appears to consist of up multiple, superimposed paleosols, and includes poorly to well developed calcrete (Figure 6). Schuster (1994) maps these strata simply as Quaternary loess.

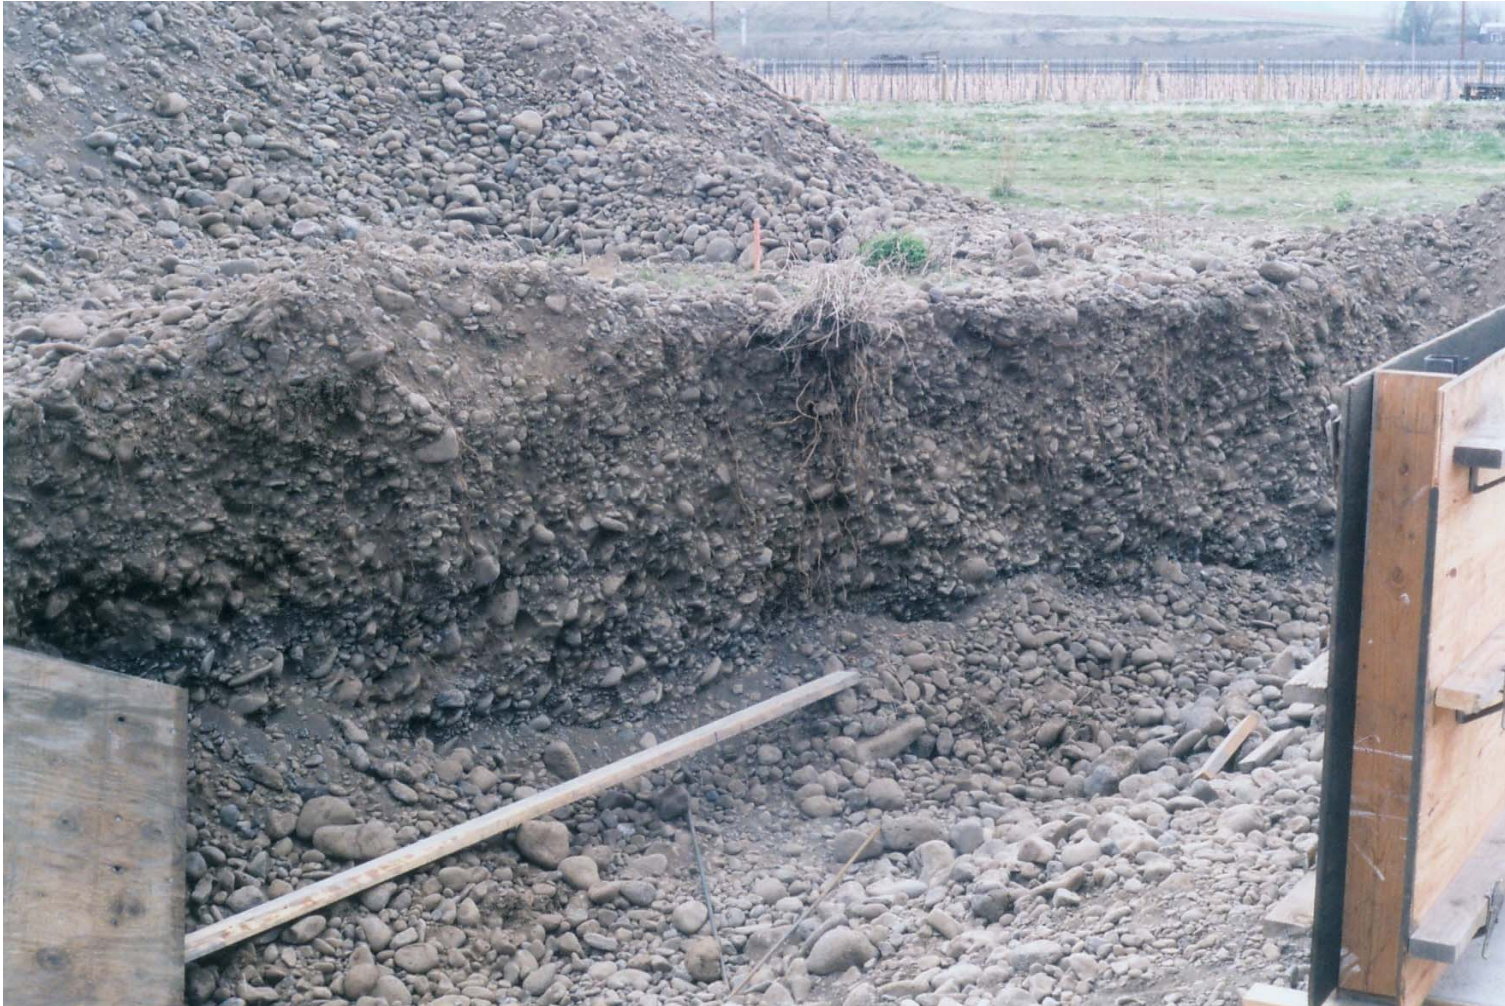
Figure 7. Photograph of uncemented, non-indurated gravel of the Quaternary coarse unit. Trench excavated during the construction of the WWBWC-Hudson Bay SAR Site.

Uncemented and nonindurated sandy to gravelly strata is found in the shallow subsurface beneath much of the Basin (Figure 7). Based on previously described outcrops of such uncemented strata found elsewhere in the Basin (Newcomb, 1965) drill cuttings geologic logging (GSI, in prep), and field reconnaissance these gravelly deposits are basaltic, moderately to well bedded, have a silty to sandy matrix, are generally uncemented, and contain thin, local silt interbeds. These uncemented and nonindurated gravels are generally equivalent to Newcomb's (1965) younger alluvial sand and gravel and for this report referred to as the Quaternary coarse unit. This sequence of uncemented gravel is interpreted to record stream deposition in the Walla Walla Basin by streams draining off the adjacent Blue Mountains. These streams are inferred to include the ancestral courses of the modern stream drainage.

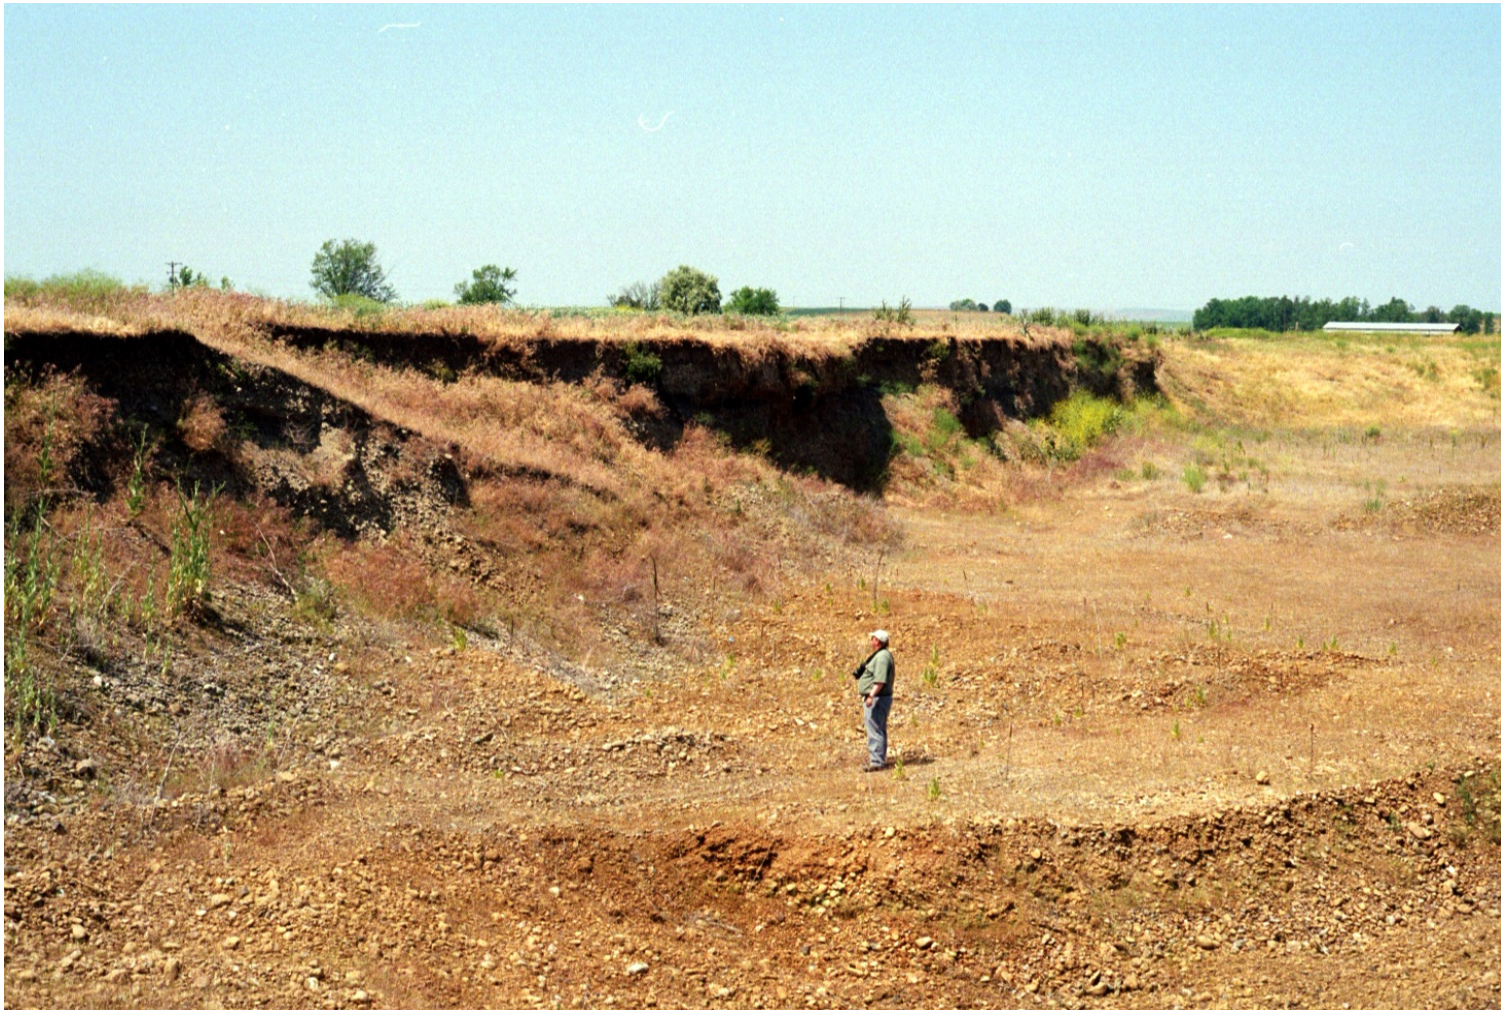
Figure 8. Outcrop of the Mio-Pliocene upper coarse unit showing the red-brown colors typically associated with this unit. Outcrop is in the Locher Road SAR Site gravel pit.

The uppermost unit found at the Site, including the strata exposed in the gravel pit, is interpreted to be the Mio-Pliocene upper coarse unit. The strata exposed in the gravel pit at the Site consist of weakly to moderately indurated, weakly cemented, pebble to cobble conglomerate with a sand to silty sand matrix. The sand and gravel fraction consist almost entirely of weakly to strongly weathered, rounded to subrounded basalt lithic detritus. Weathering rinds on gravel clasts are very common. The degree of weathering typically seen in the strata cropping out in the gravel pit generally is accompanied by strongly developed brown to red brown colors. While no interbedded muddy strata are exposed in this unit in the gravel pit, regional work (GSI, in prep) suggests local, intercalated siltstone and mudstone could occur. Based on the geologic log for the WWGRVL well, this unit extends to a depth of approximately 250 to 260 feet at the Site (Bush and others, 1973).

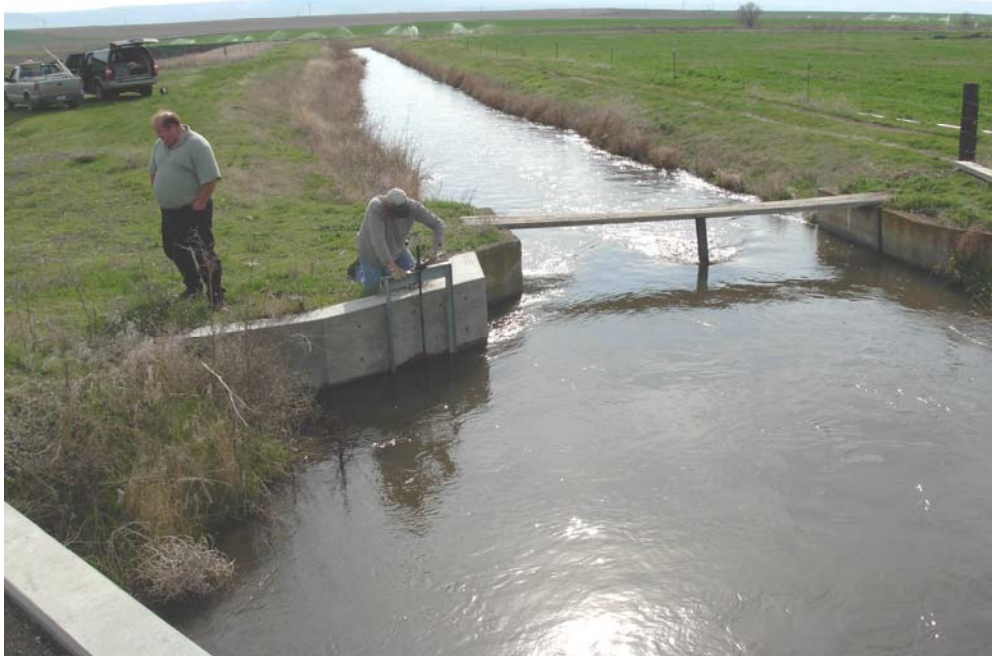
Figure 9. Head gate on the Gardena Farm Canal for the Locher Road SAR Site. View is looking to west-southwest, down stream on the Ditch. Site is just out of picture to the left.

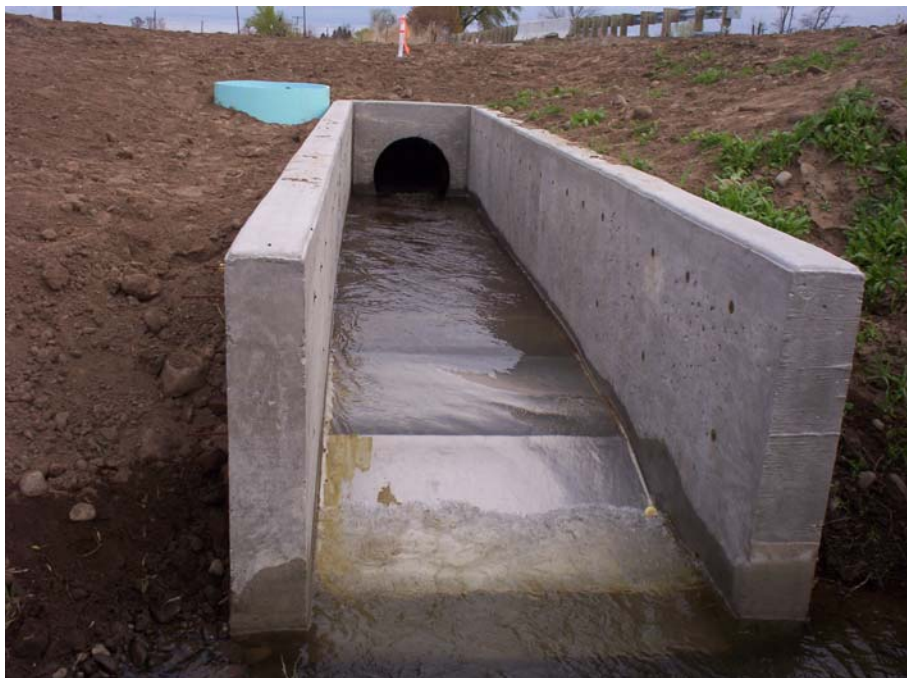
Figure 10. View looking to north up the ramp flume Gardena Farm Canal and the head gate (Figure 9) are located just beyond the flume, near the guard rail in top of photo. Transducer installed in a tube located in the blue pipe to left of flume.

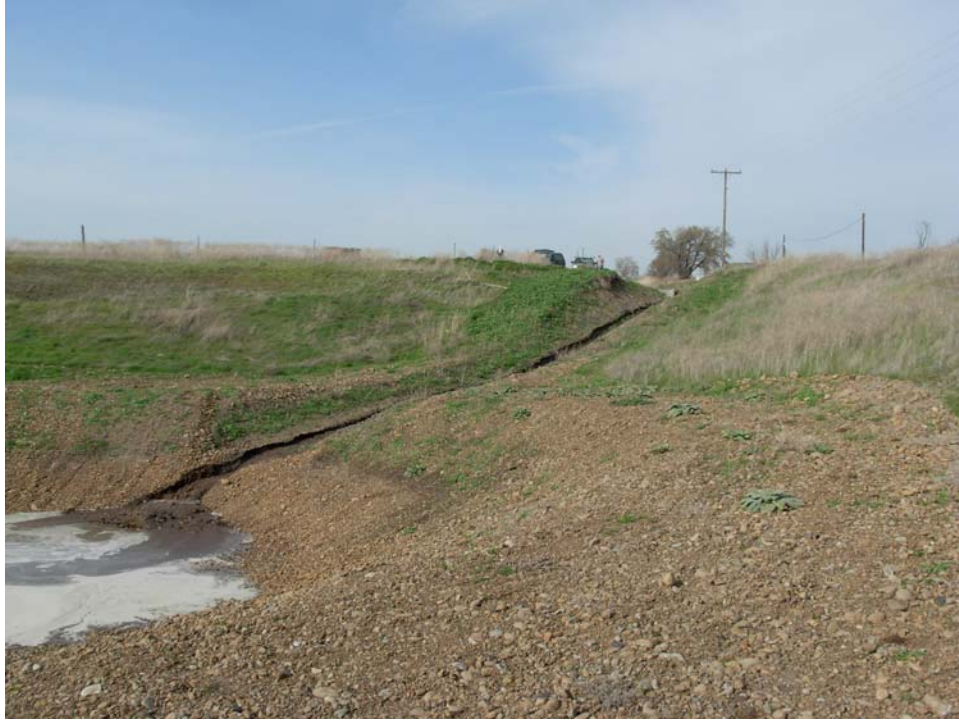
Figure 11. Ditch leading into upper basin. Ramp flume is visible just above head of ditch in background.

The flume empties into an unlined ditch that carries water to the edge of, and into, the gravel pit (Figure 11). Water is conveyed into the gravel pit and the first of two infiltration basins (upper basin) via an unlined ditch excavated into the sloping wall of the gravel pit (Figure 11). The upper basin was generally configured as follows:

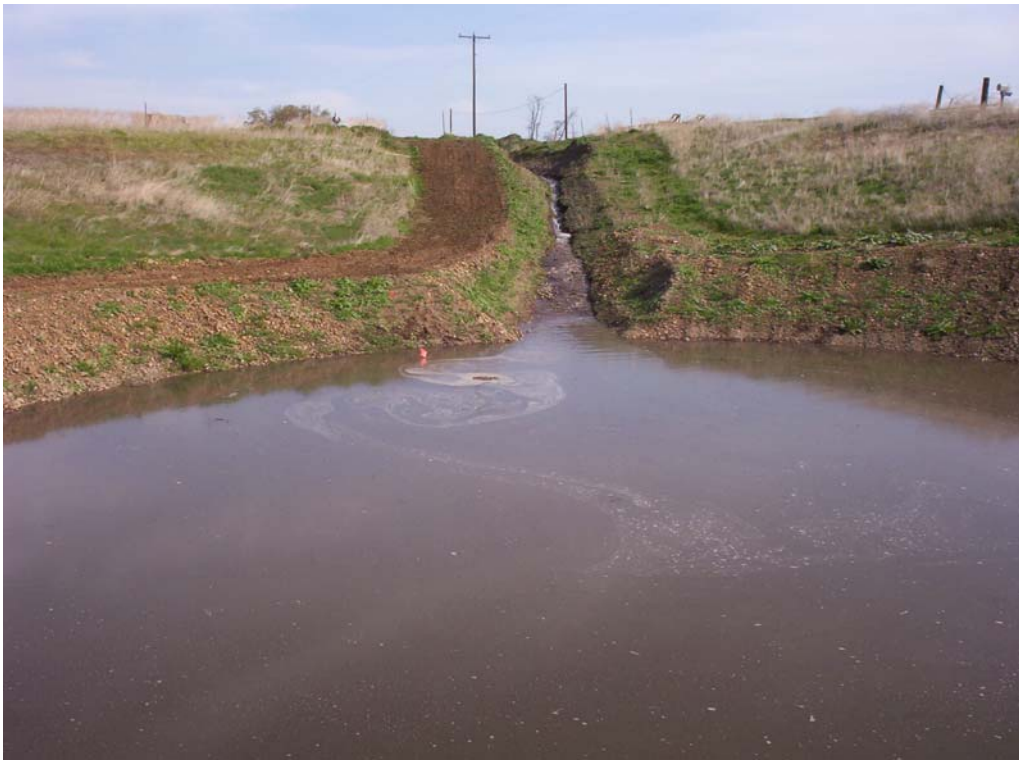
Figure 12. Upper basin as it was filling approximately mid-test.

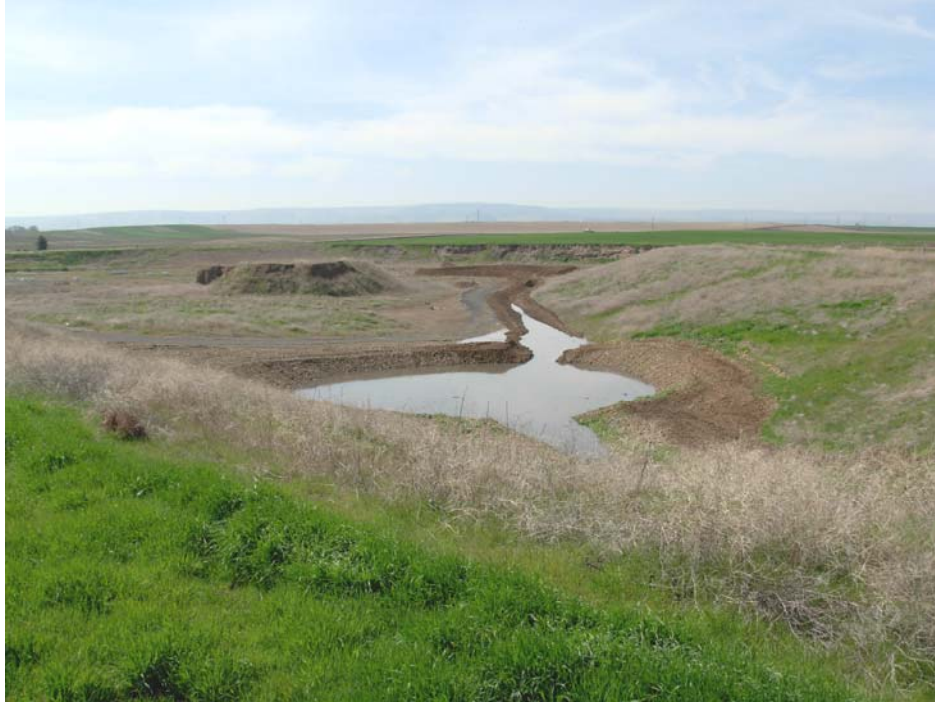
Figure 13. View to southwest looking across the upper basin and down the connector ditch leading to the lower basin, seen in the distance. Photograph was taken the first day the lower basin was used, 03 April 2007.

From the upper basin, water was directed via a shallow unlined ditch (Figure 13) to the second, or lower, infiltration basin (Figure 14) located several hundred feet from the upper basin. For this ditch, referred to as the connector ditch:

- The upper end was excavated using a blade equipped bulldozer, and excavation was reported as difficult due to hard and/or compacted conditions.
- The lower end of the ditch was dug using a toothed bucket excavator and digging was reported to be easier than in the upper end.
- The connecting trench ranges from 1 to 3 feet wide and 1 to 4 feet deep.

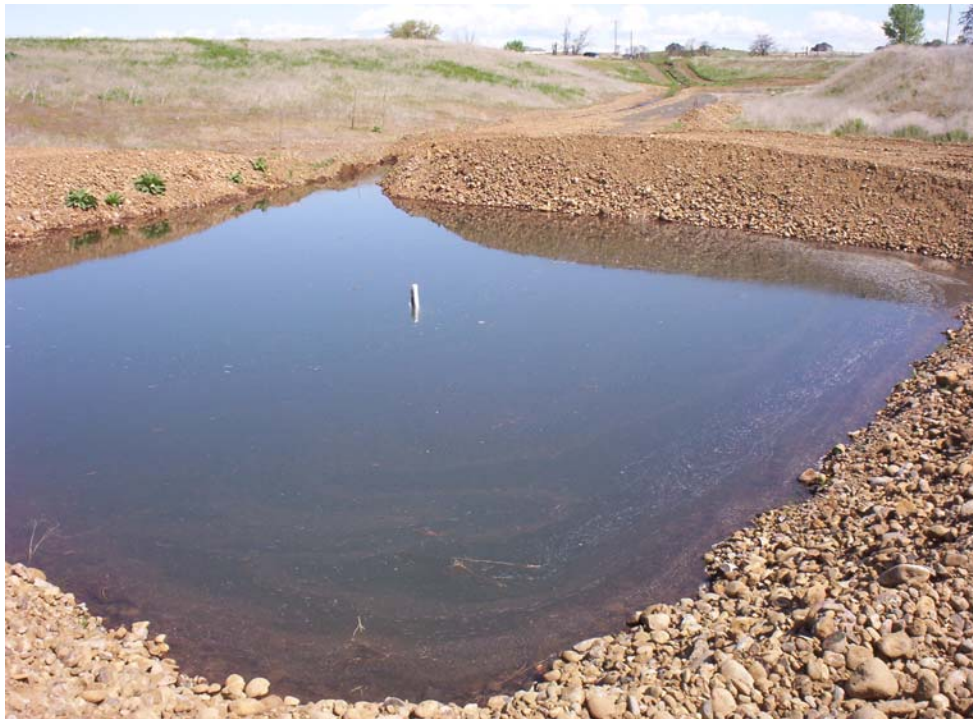
Figure 14. The lower basin late in the test. Tube in middle of basin contains digital transducer and an attached staff gauge. Upper basin is at base of slope in upper part of photo.

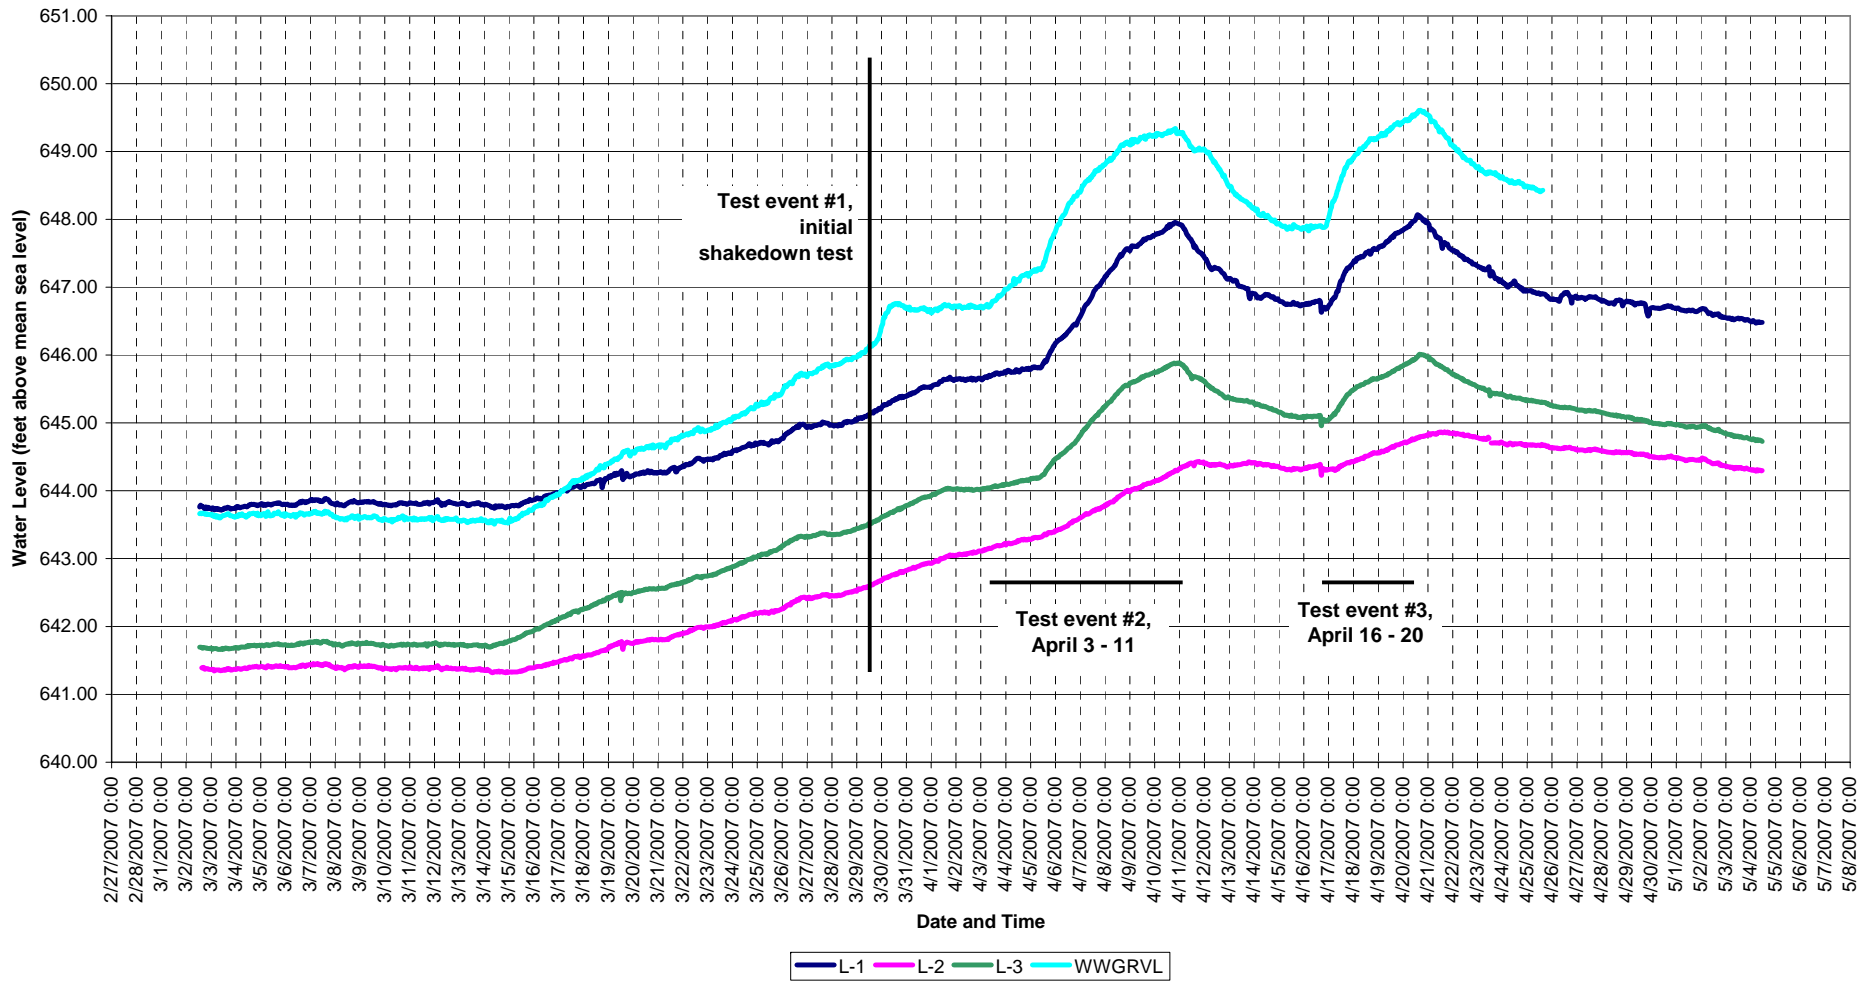
Figure 15. Hydrographs for monitoring wells L-1, L-2, and L-3 and the WWGRVL well.

Water level changes observed in the shallow alluvial aquifer in all 4 wells during and after the 04-10 April and 16-20 April 2007 test events are interpreted to be the direct result of SAR testing. In addition, while wells L-1, L-2, and L-3 do not show an apparent response to the 29 March shakedown event, the WWGRVL well located less than 200 feet from, and down gradient of, the upper basin did. The lack of response in the three monitoring wells is interpreted to reflect their distance from the upper basin and delivery ditch and the small volume of water used in the shakedown test.

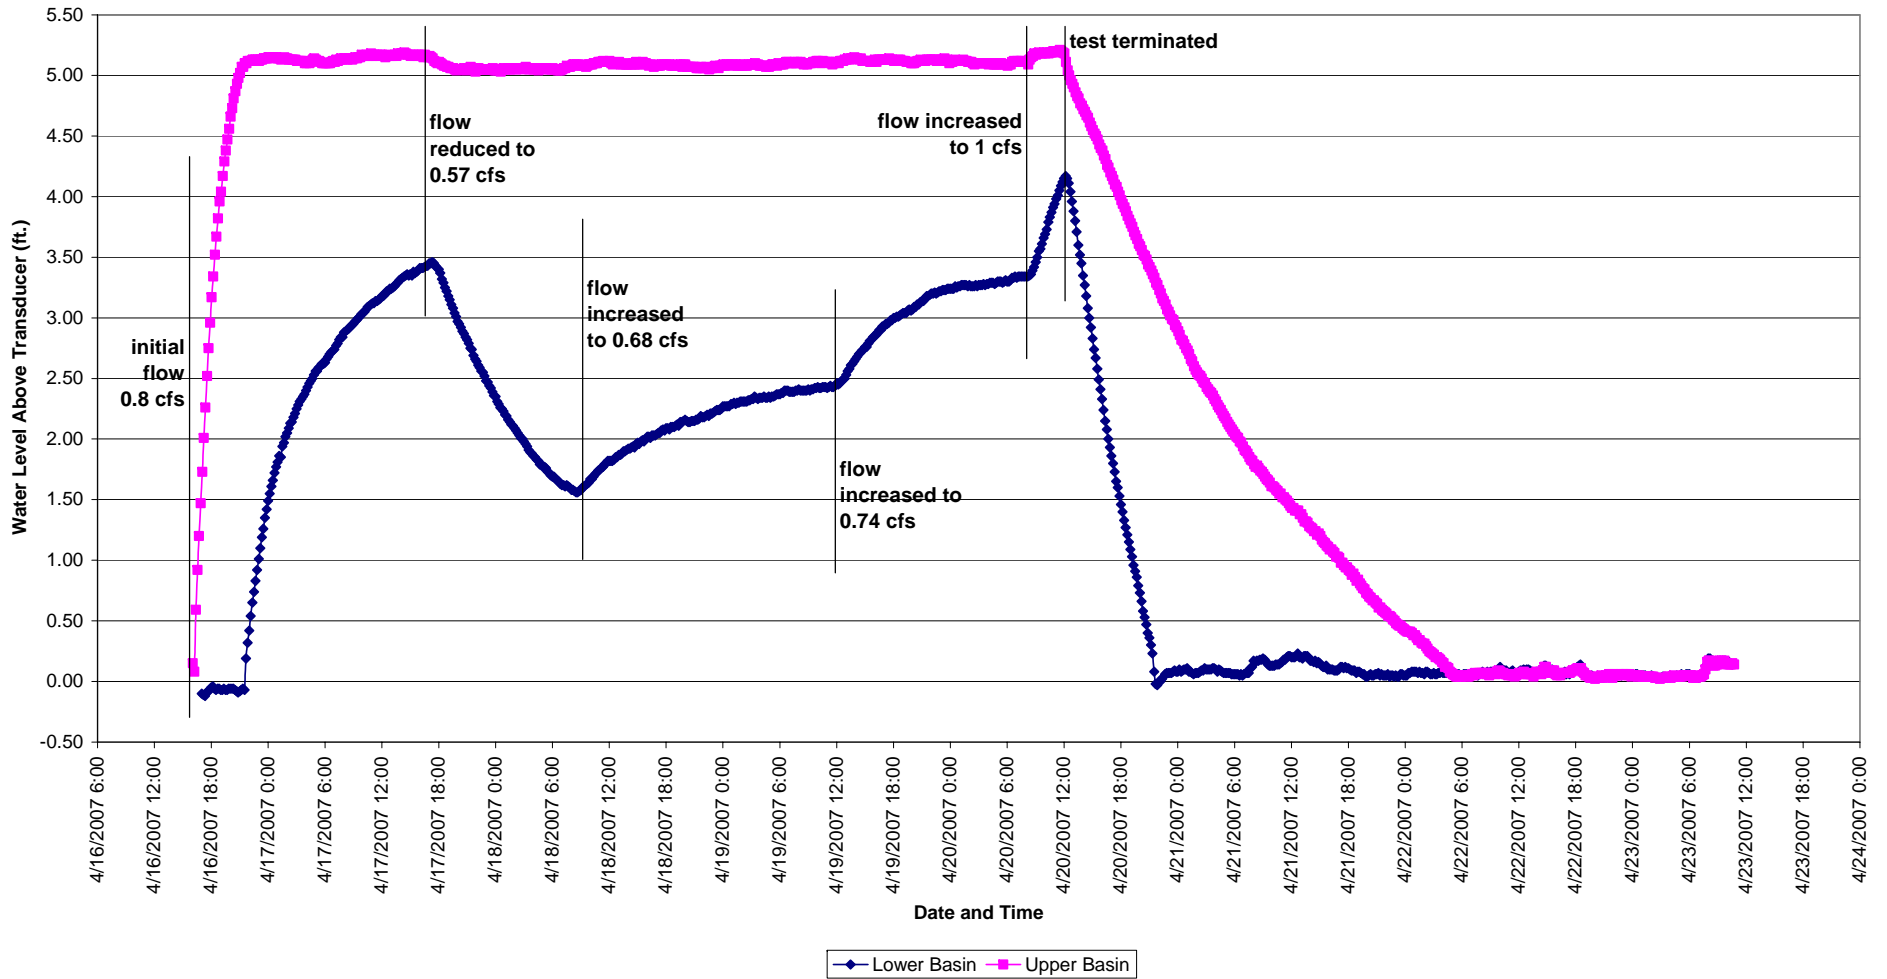
Figure 16. Hydrographs for the to recharge basins showing water level changes as they were filled and drained between 16 April and 20 April.

third SAR event done between 16 and 20 April 2007. For this test both basins were filled to a measured depth, then the time it took to drain each after water delivery was turned off was measured. The hydrographs for both basins showing this final fill and drain event are reproduced on Figure 16. The results of these tests for both basins are listed on Table 2, and generally found to be (1) 0.058 gpm/ft² or 5.63 cfs/acre in the lower basin and (2) 0.008 gpm/ft² or 0.81 cfs/acre in the upper basin. This data also provides insight into the speed of water movement through the vadose zone at the Site.

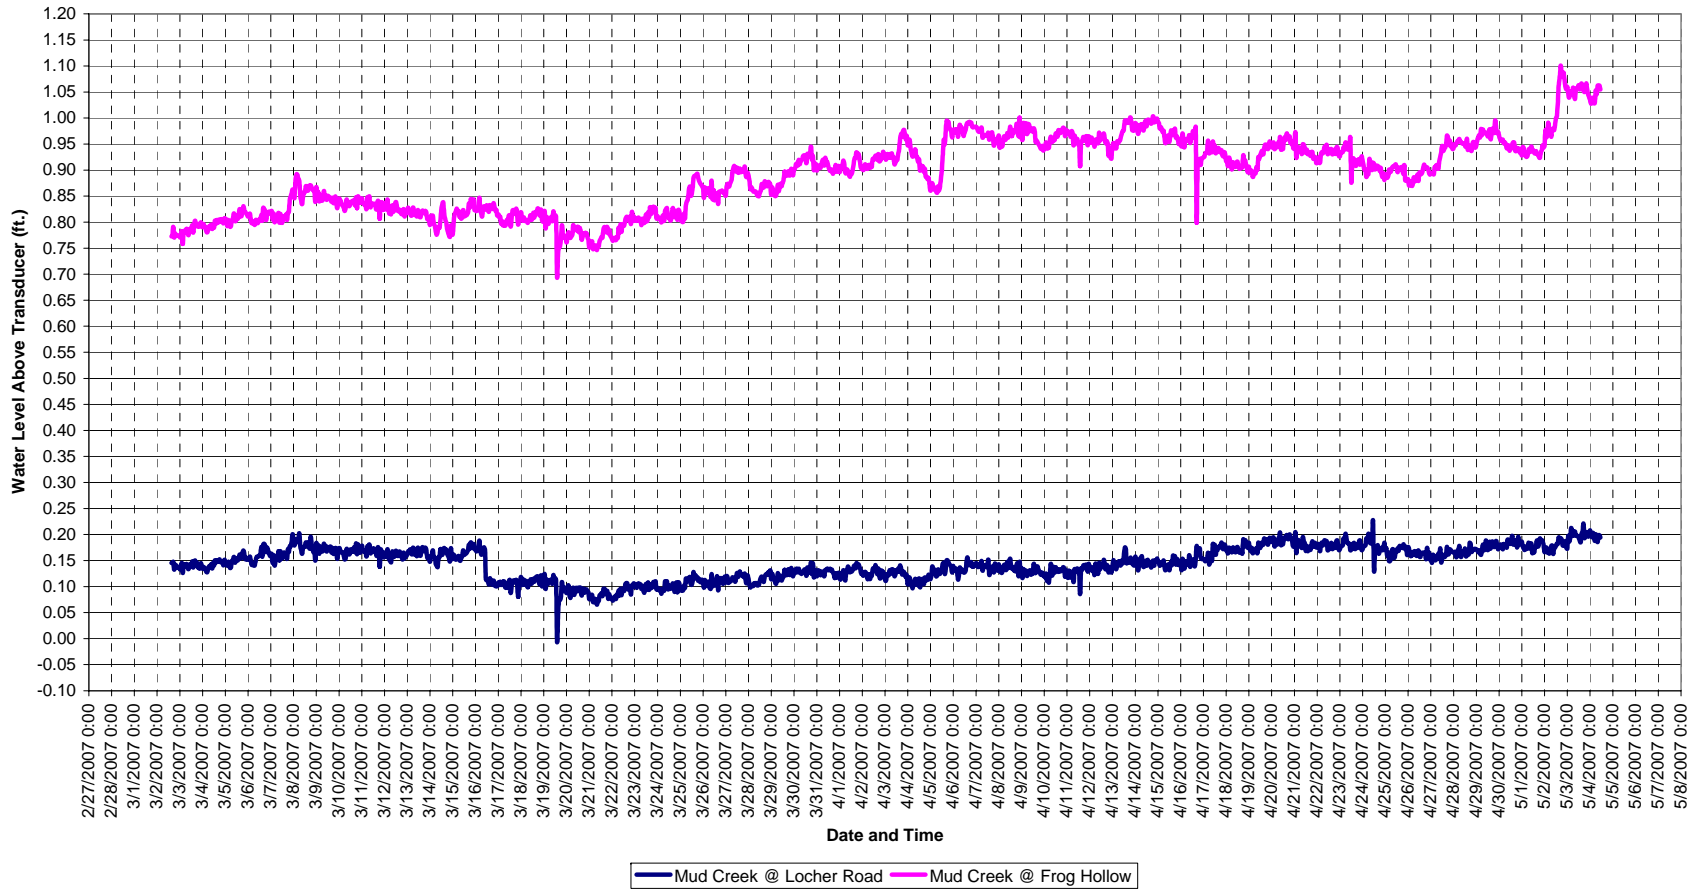
Figure 17. Hydrographs showing changes in stream stage for Mud Creek at Locher Road and at Frog Hollow Road.

Mud Creek stage at Frog Hollow shows more fluctuation than was observed at Locher Road. In late March 2007, preceding the start of testing, stream stage at Frog Hollow rose approximately 0.15 feet (Figure 17). This rise continued until approximately 05 April, at which time total rise was approximately 0.25 feet. Following this, stage generally stabilized for a period of about 10 days. From 15 April through the end of the current data record stage began to fluctuate, falling and rising approximately 0.25 feet.

The reasons for these stage fluctuations are not readily apparent. The general rises in stream stage seen throughout the data record we have collected to-date could be related to one or more of several basic causes. These could include, but are not limited to:

- Increased base flow to the stream resulting from rising groundwater levels related to leakage from Gardena Farms Canal, or other irrigation ditches operating in the Basin.
- Growth of aquatic vegetation in the stream displacing water and causing higher stage measurements.
