# HBDIC Recharge Project Site

### HBDIC Infiltration Gallery Testing Site Map

*During the 2008-2009 Recharge Season, infiltration galleries are being tested at the HBDIC Recharge site, near Milton-Freewater Oregon. Preliminary testing results indicate infiltration galleries are viable recharge mechanism for areas where spreading basins are not feasible. A combination of all methods will be assessed during the design and siting phase of this program.*

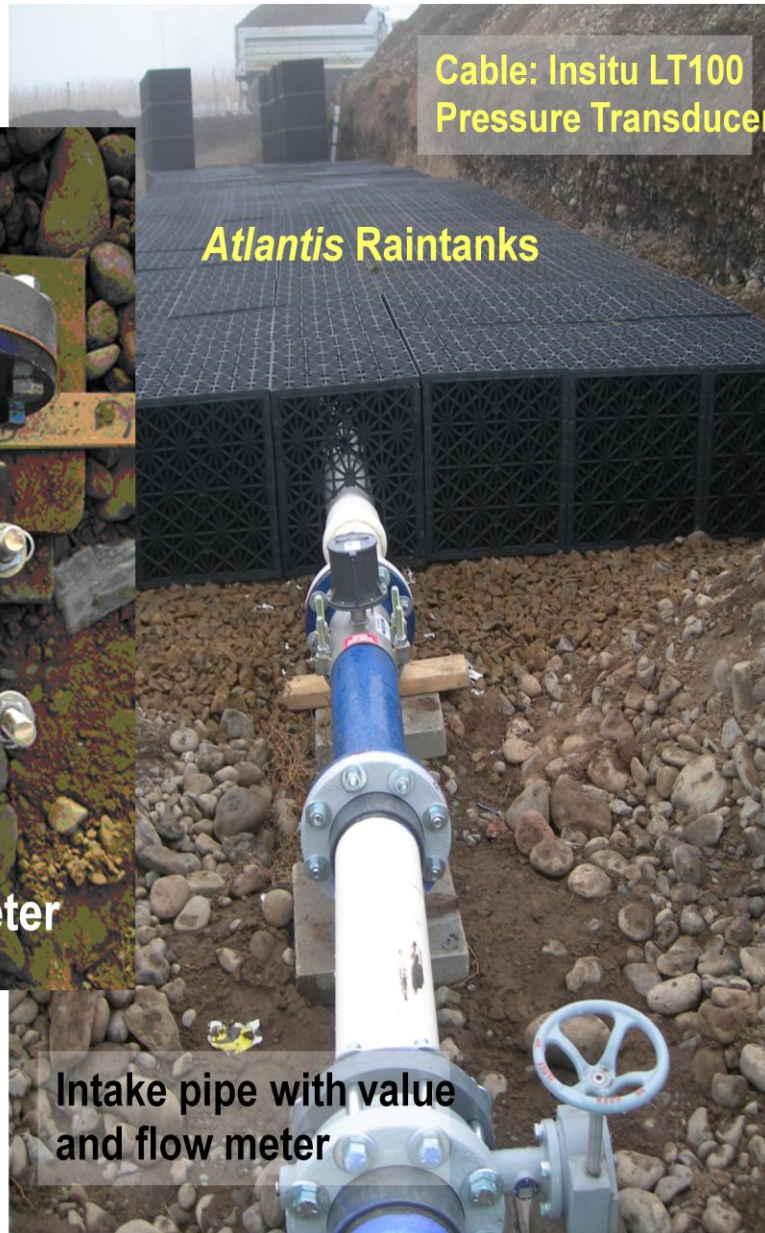
Intake Flow meter

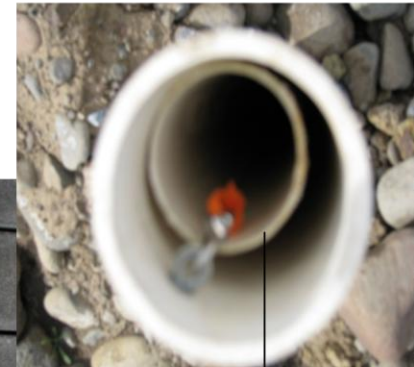
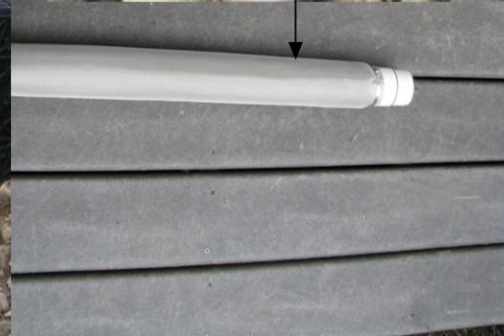
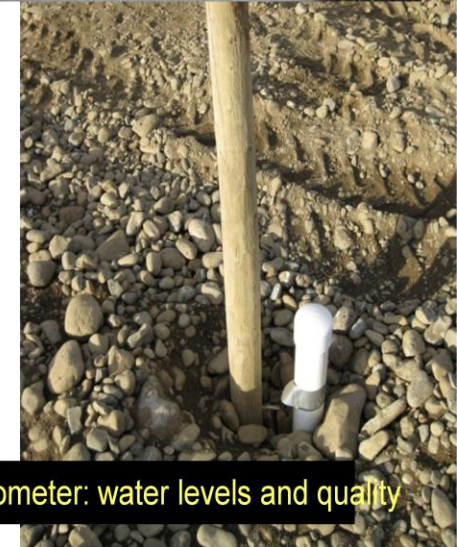
Atlantis Raintanks

Cable: Insitu LT100 Pressure Transducer

Intake pipe with valve and flow meter

Piezometer: water levels and quality

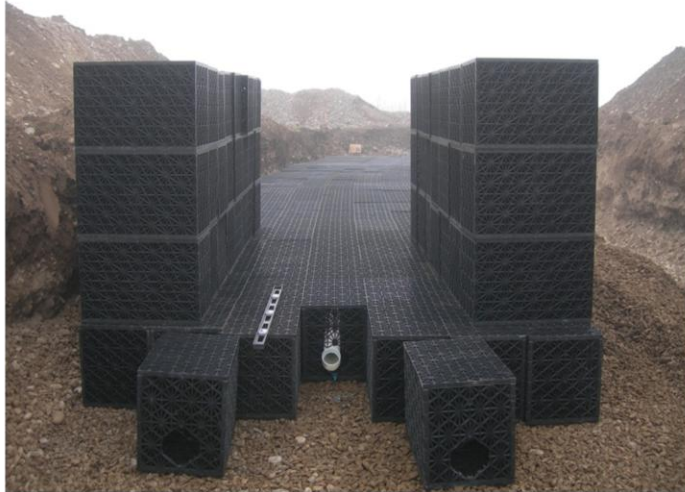
Raintanks being deployed

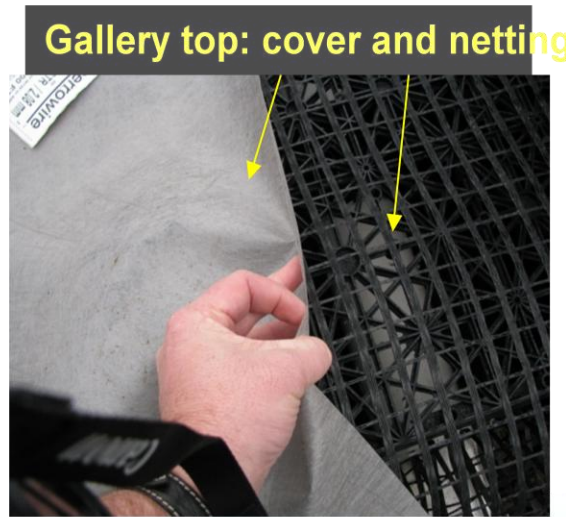
Gallery top: cover and netting

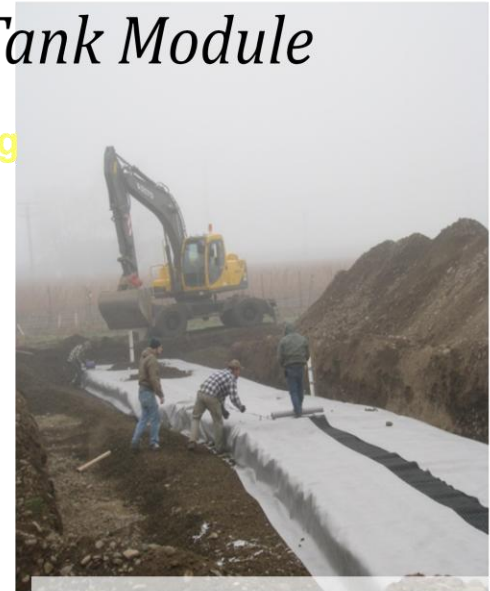
Backfill: native materials

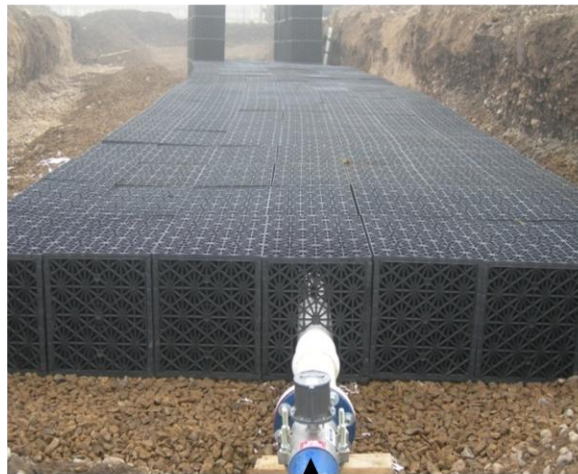
Intake: Valve and metered

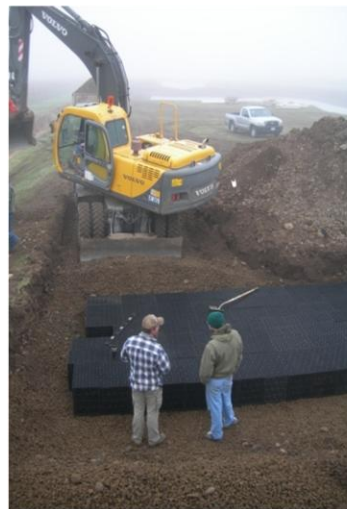
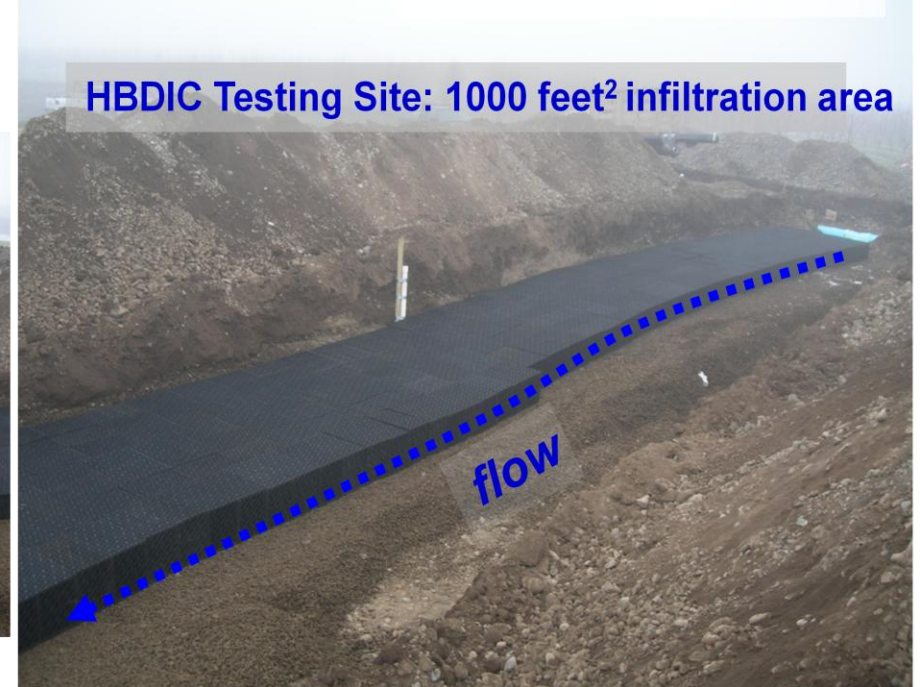
HBDIC Testing Site: 1000 feet<sup>2</sup> infiltration area

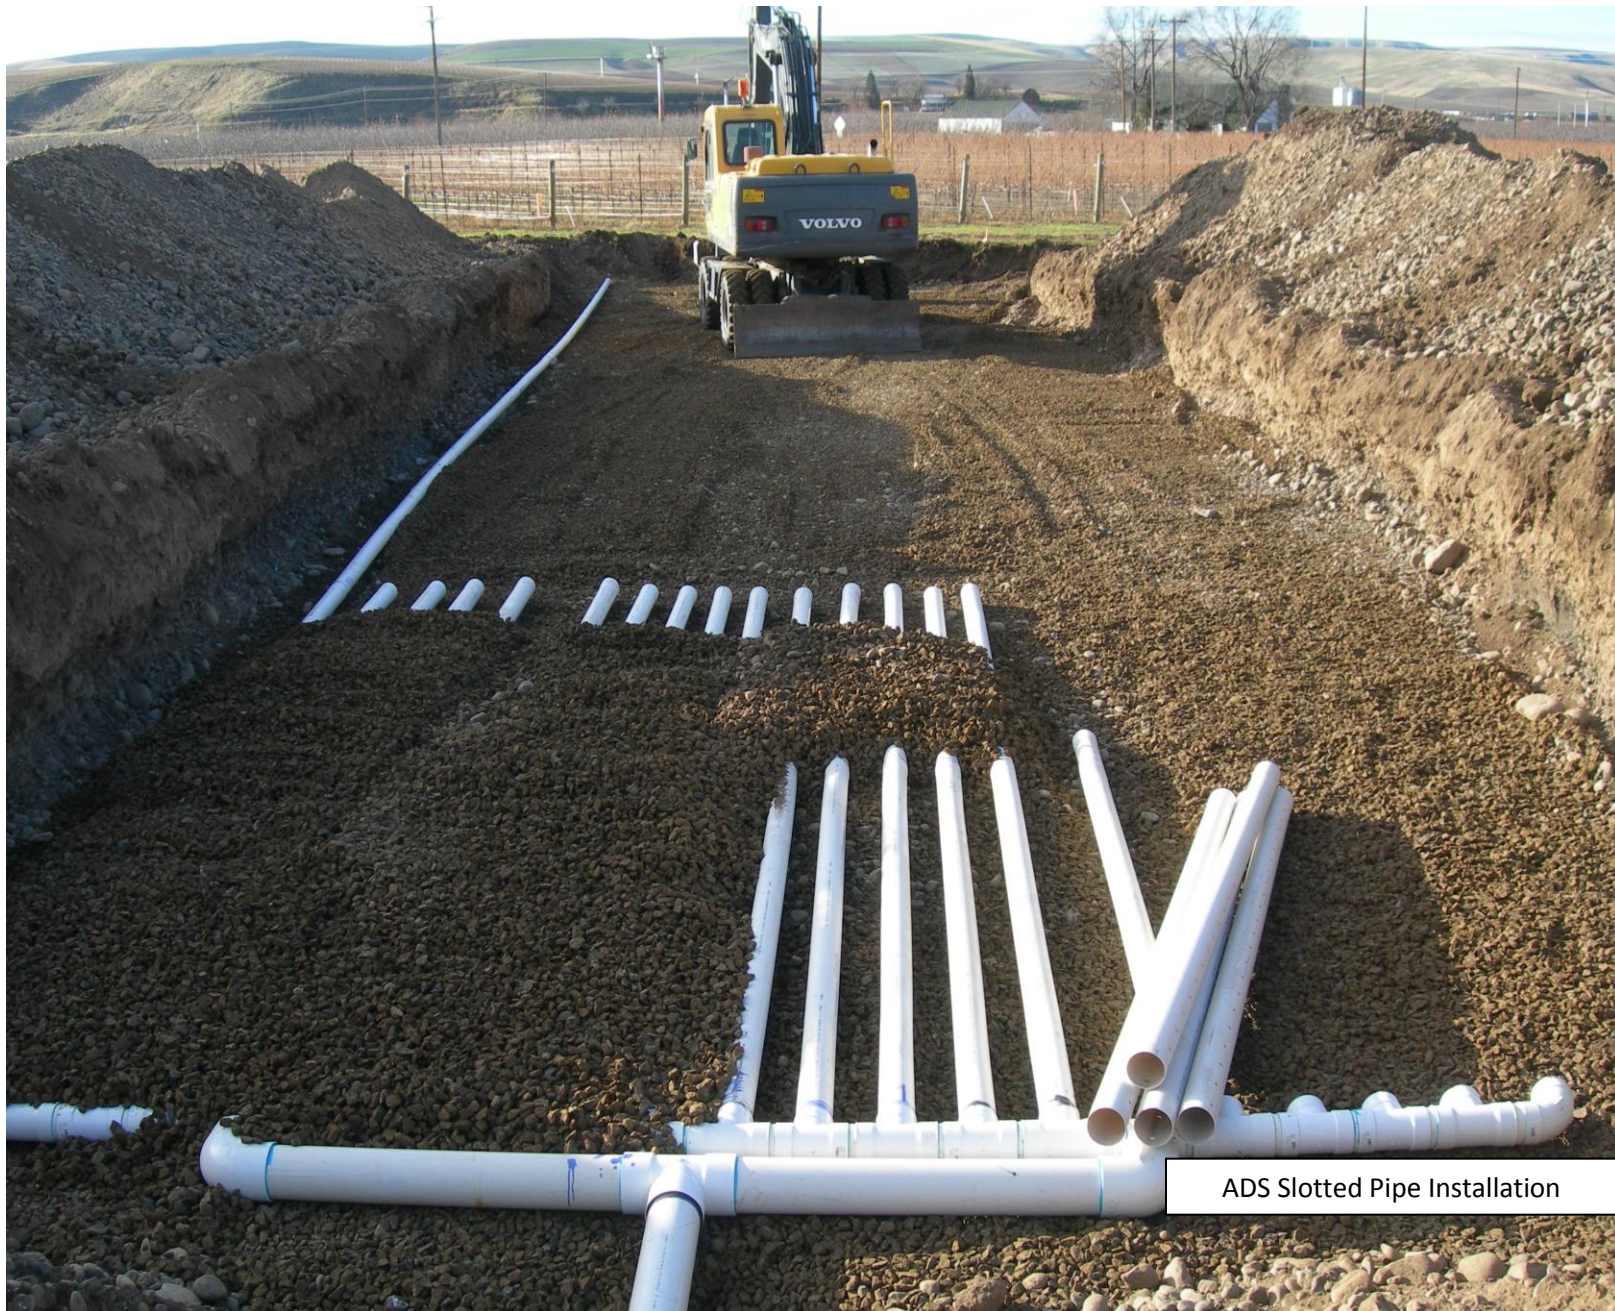
ADS Slotted Pipe Installation

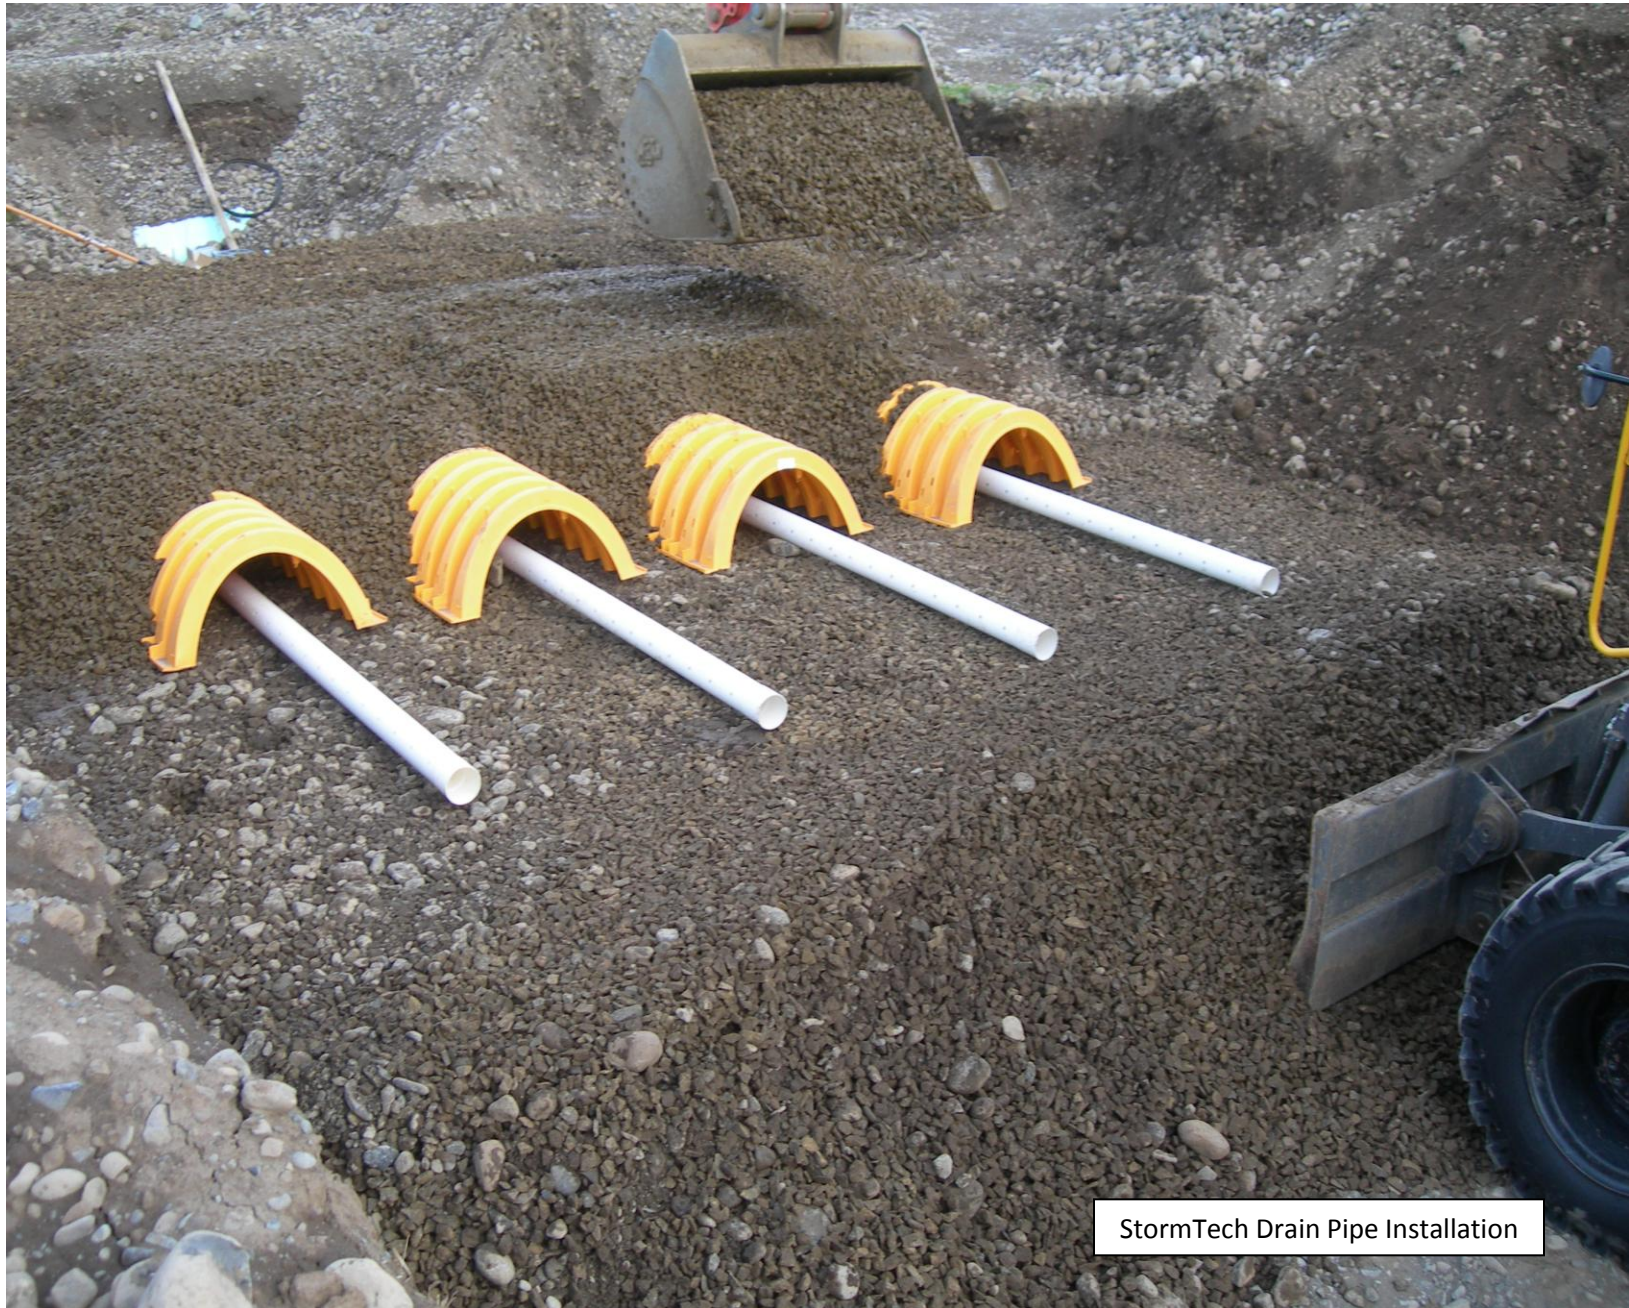
StormTech Drain Pipe Installation

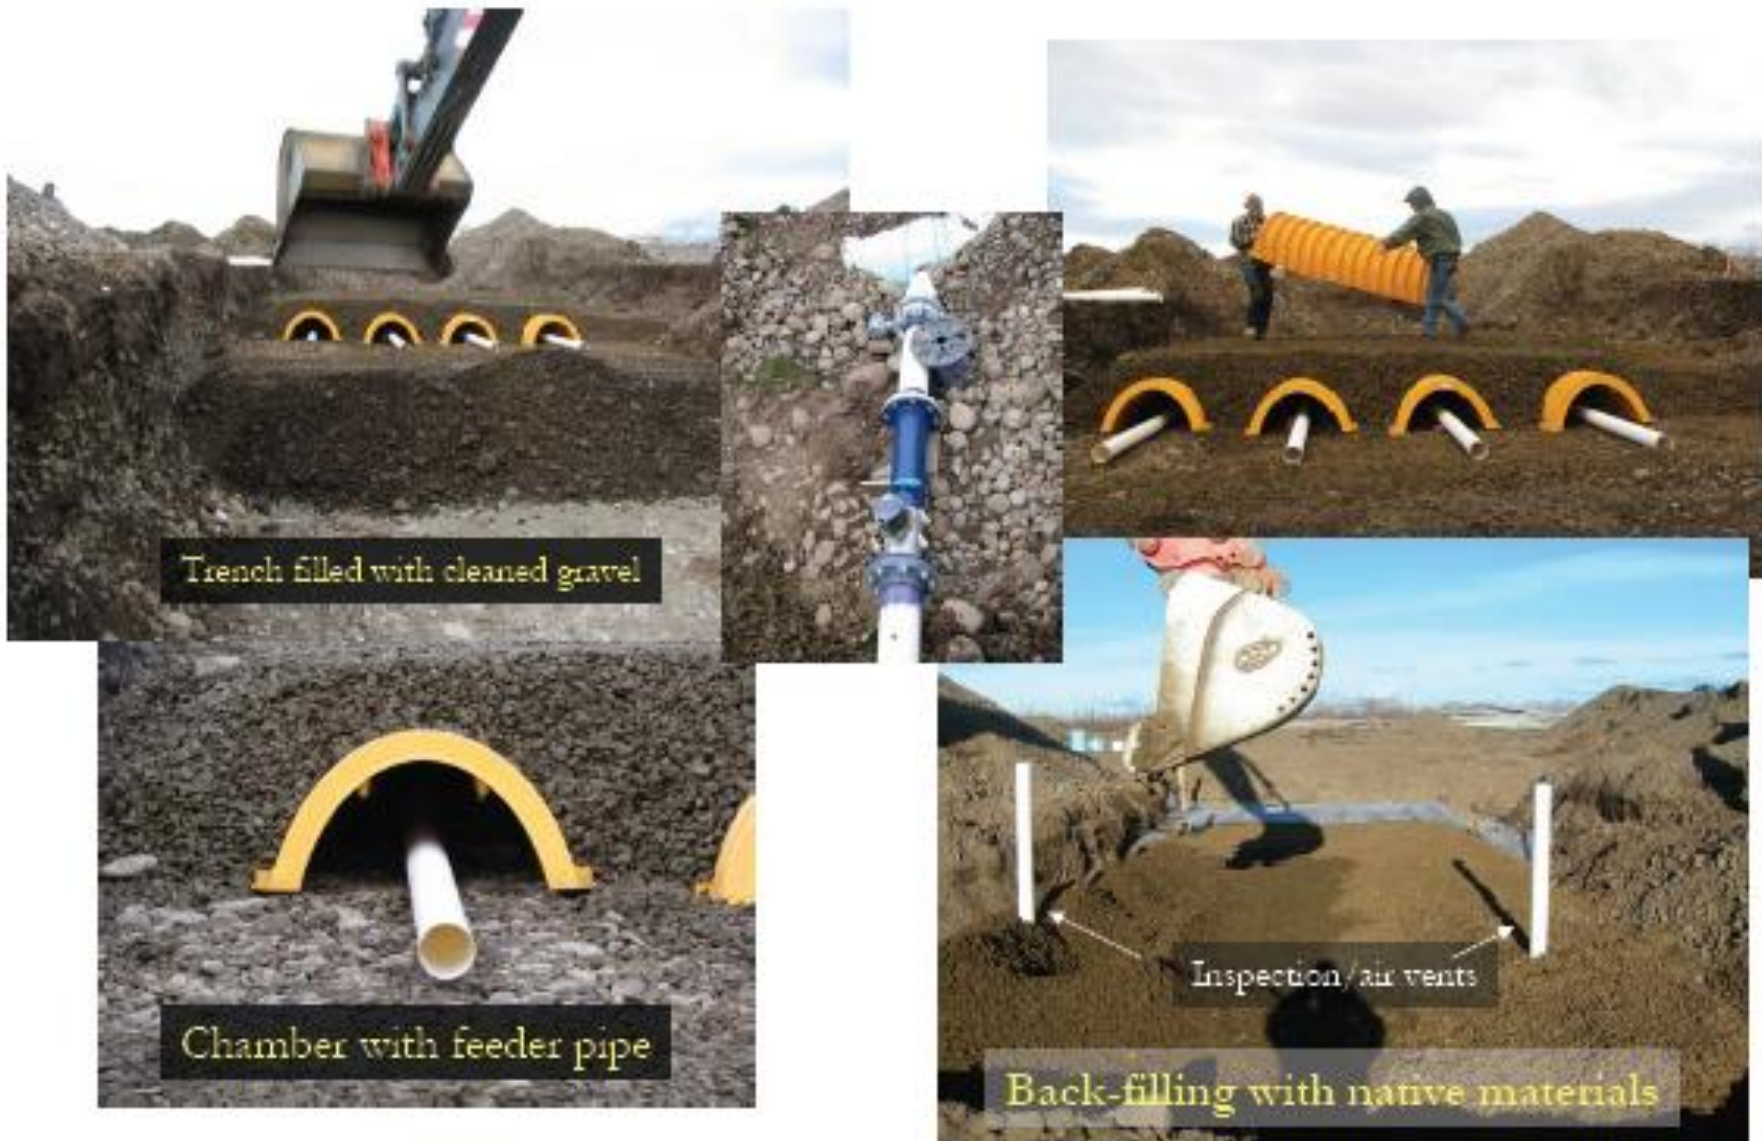
Figure 16

## Infiltration Gallery: *Stormtech* SC-740™ Chamber

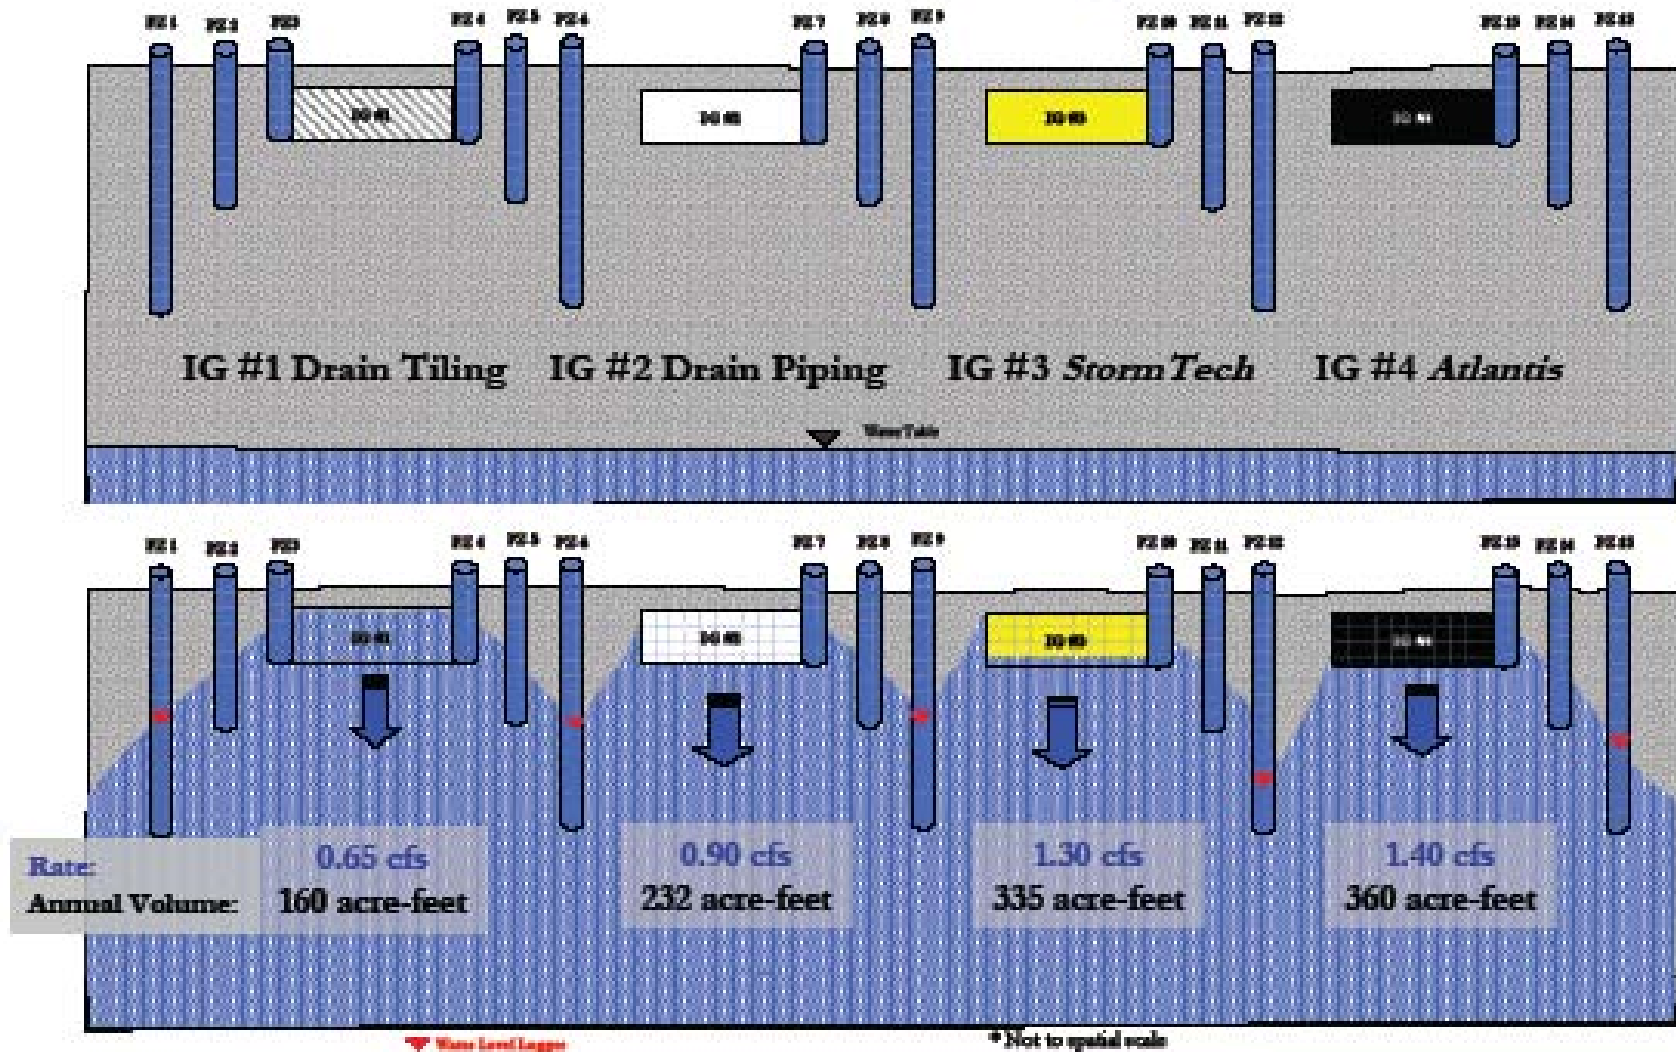
Figure 13

*HBDIC Infiltration Gallery Testing Site: Profile of Galleries and Piezometers*

2008-2009 Preliminary Testing Results

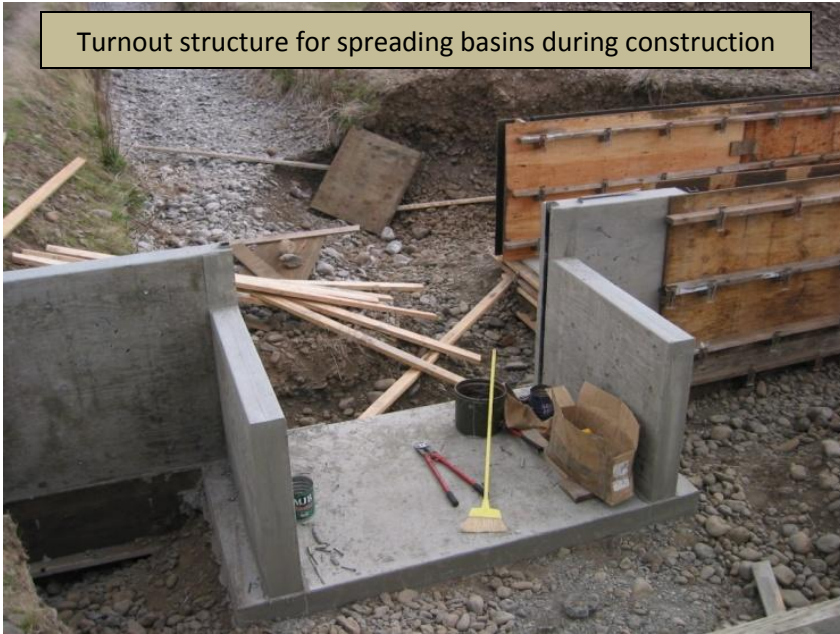
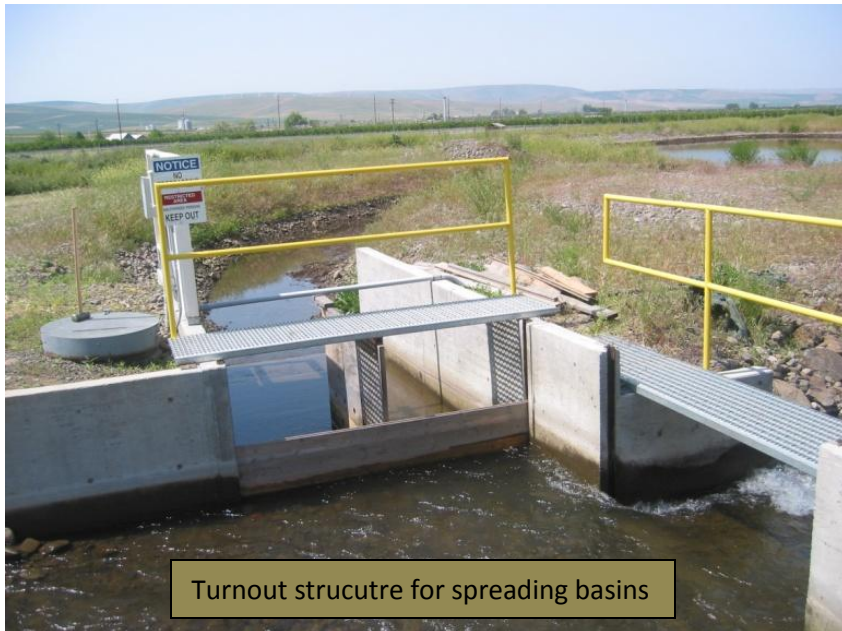
Turnout structure for spreading basins during construction

Turnout structure for spreading basins

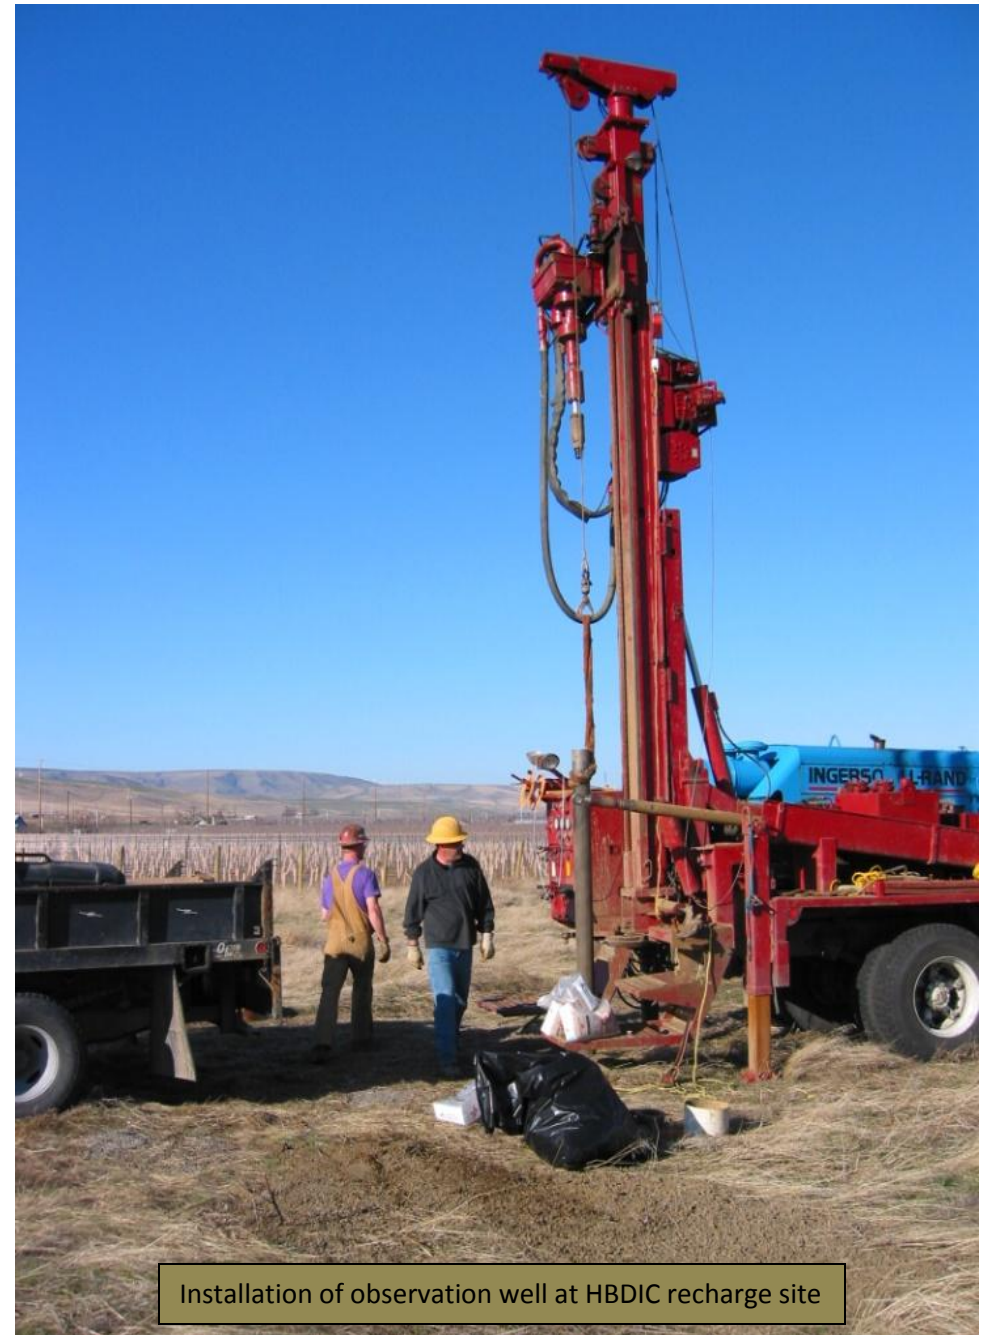
Installation of observation well at HBDIC recharge site

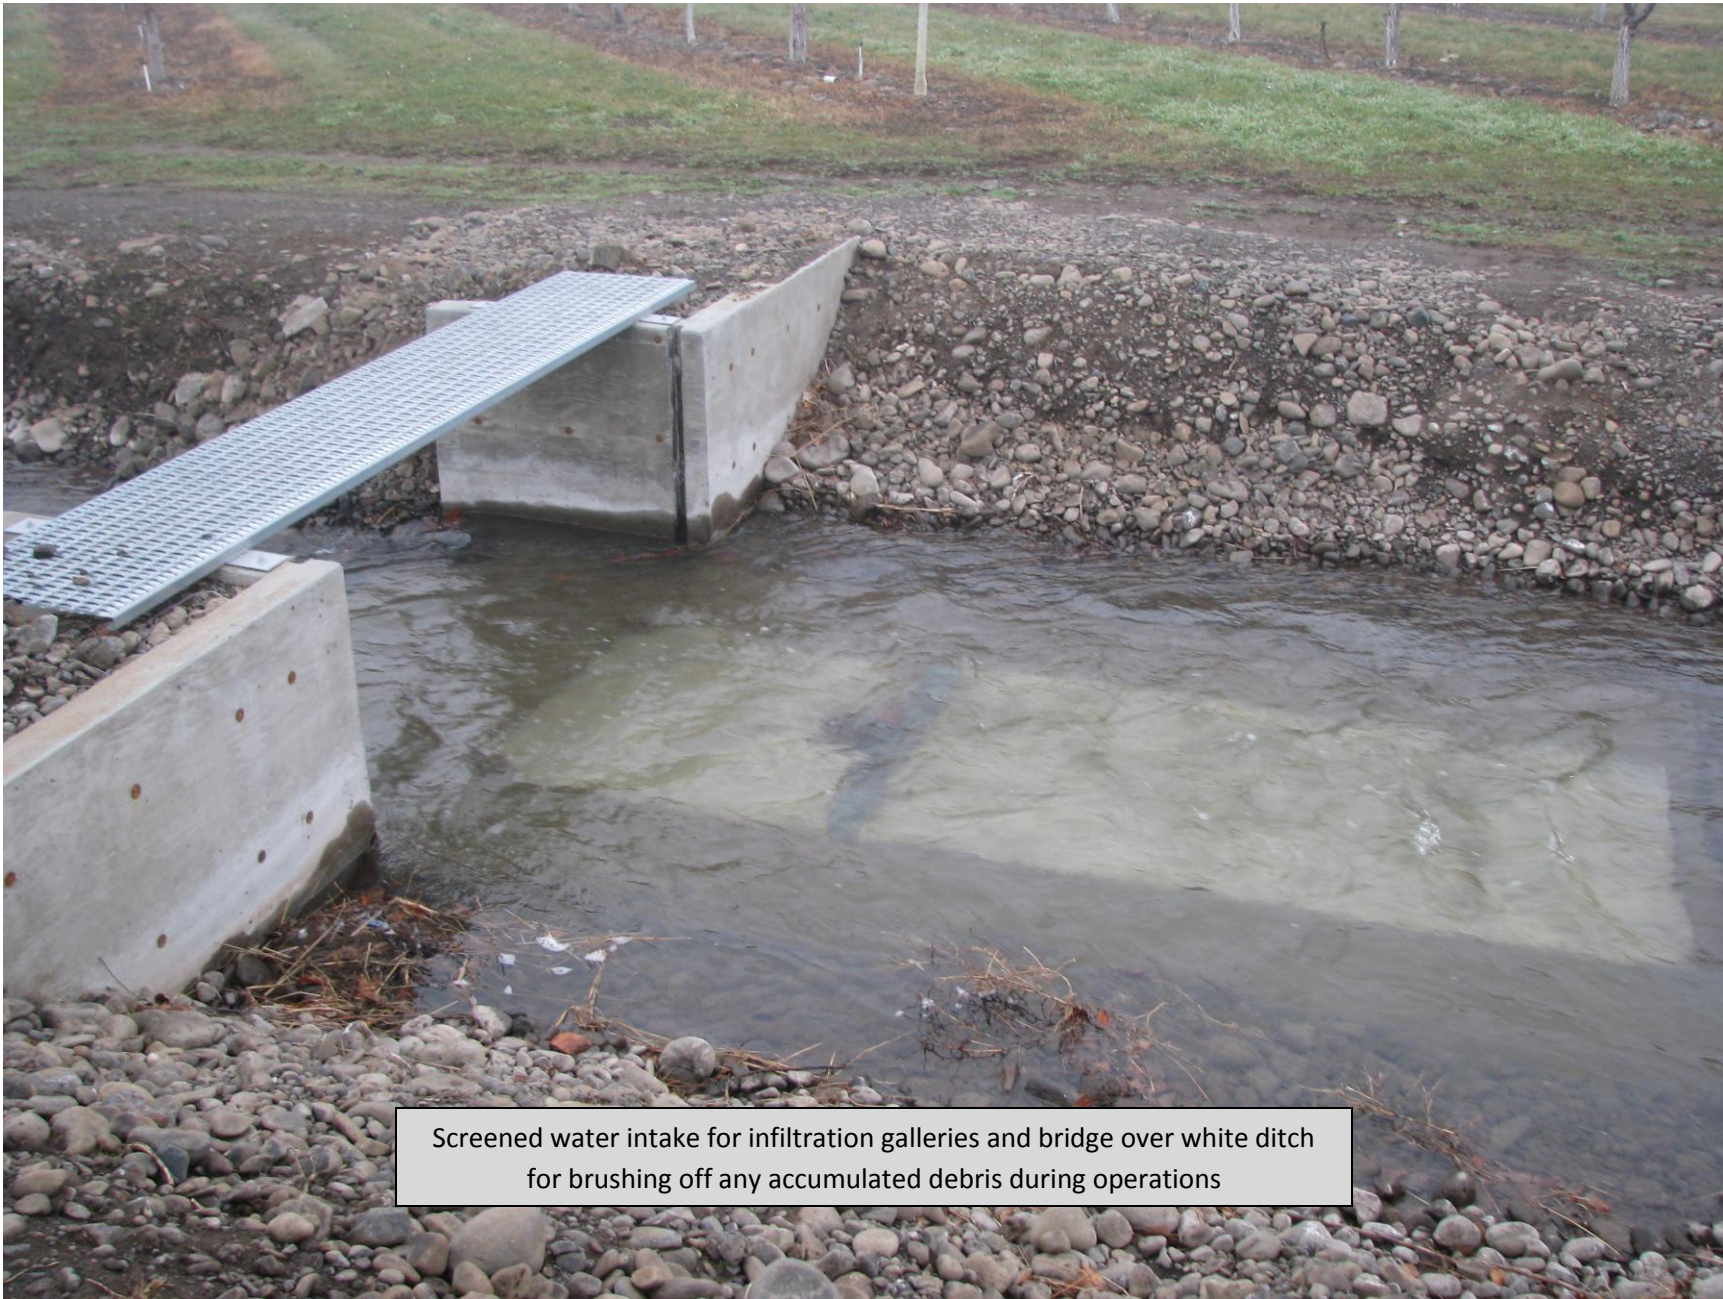
Screened water intake for infiltration galleries and bridge over white ditch for brushing off any accumulated debris during operations
