Aquifer Recharge as a Water Management Tool: Hudson Bay Recharge Testing Site Report (2004-9)

HBDIC Recharge Project Expansion with Basin #1 (foreground), spring 2008

April 18th, 2010

Bob Bower, Hydrologist, WWBWC
Kevin Lindsey, LHG (WA), GSI

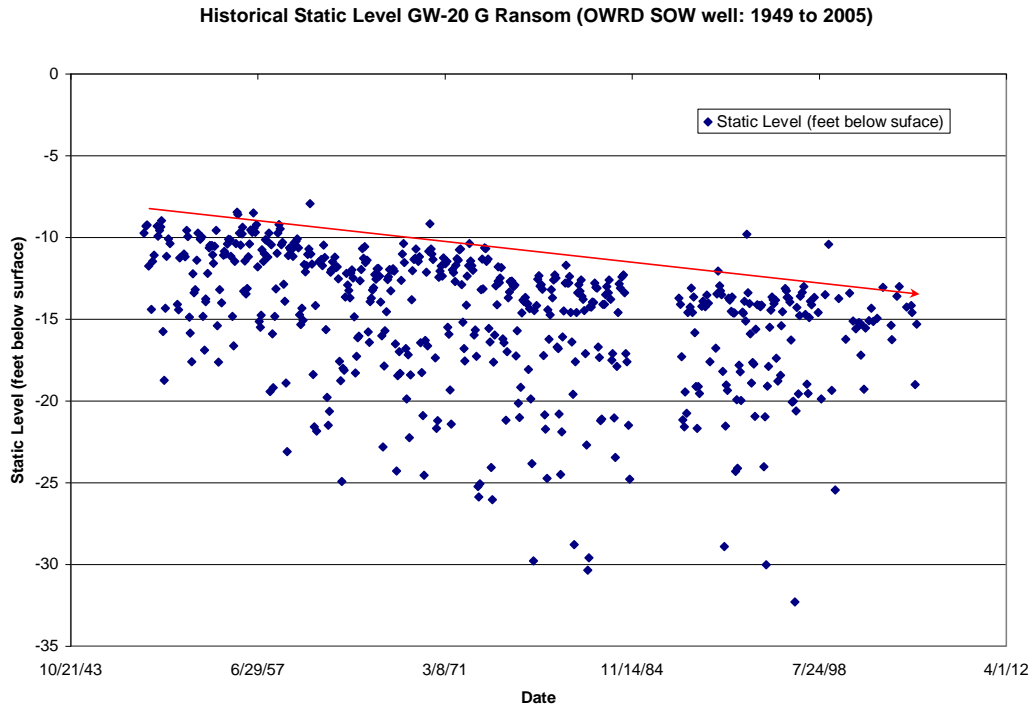
Figure 8. Depicting drop in aquifer at observation well next to Walla Walla River.

Taking a closer look at data from the OWRD SOW wells, SOW #850 shows approximately a 5 feet decline between 1940 and 2005 (**Figure 8**). The aquifer decline at this location is particularly

alarming because it is in an area near the Walla Walla River channel where considerable flow losses to the aquifer through the porous channel bottom is known to occur. Therefore, even with a steady source of recharge water available, aquifer level appears to be declining. This well location also sits on the geologic arc or contour of the ‘inner zone springs’. Consequently, water level changes seen in it may provide insights into conditions expected within this zone of springs.

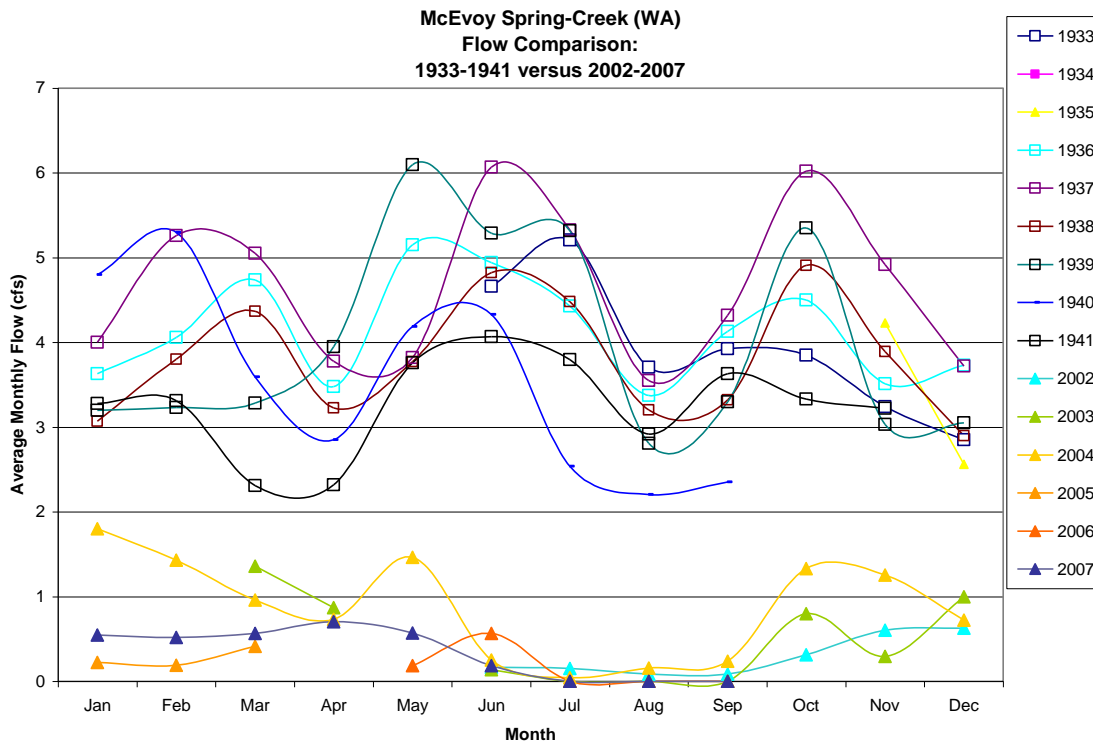
Figure 11. Historic versus Current Flow monitoring on McEvoy Spring Branch, tributary to the Walla Walla River

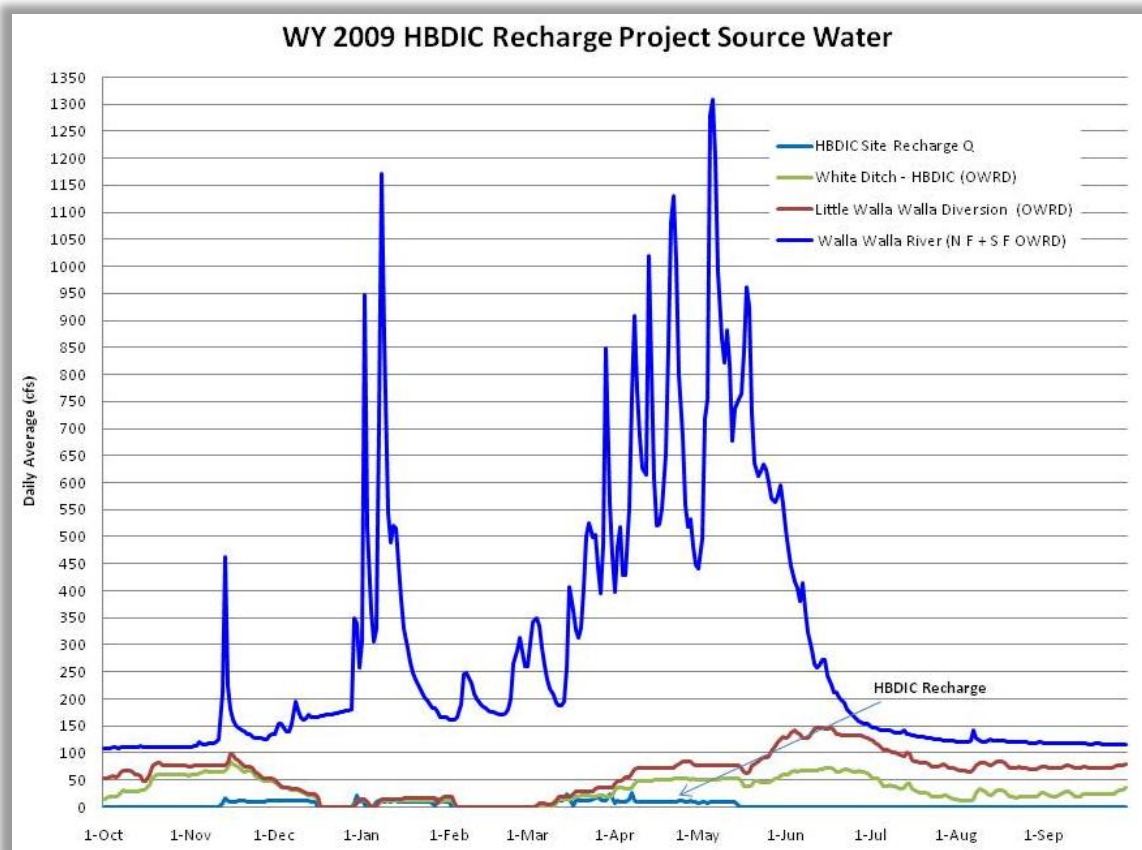
Figure 24. Comparison Walla Walla River source water to Diversions and Use (WY 2009).

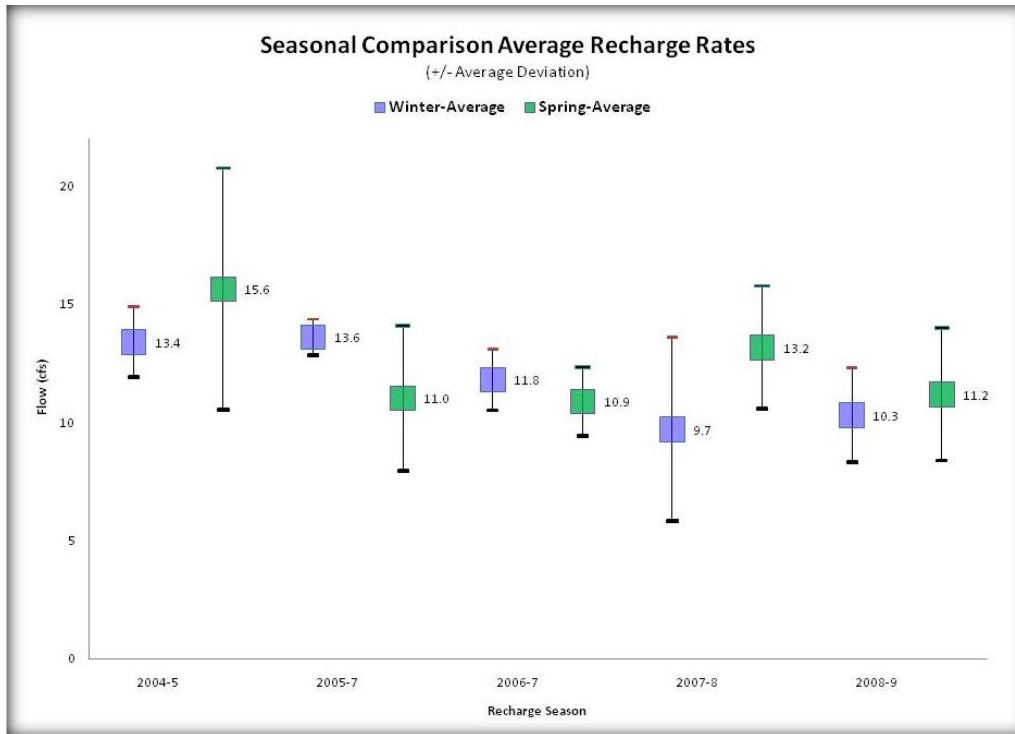
Figure 27. Comparison of fall vs. Winter Effective Recharge Rates for Temperature

While the HBDIC-WWBWC team did not conduct an in-depth research project coupling the *effective* rates of recharge with the water and air temperatures at the site, it is a well established fact that water becomes more viscous with decreasing temperatures. This physical factor would have the effect of making it more difficult to recharge at maximum *effective* rates during the cooler portions of the recharge season typically from November 1st through February 28th. **Figure 27** shows a basic comparison of average recharge rates for the first and second halves of each recharge season. While there does appear to be some variability in rates, it is not clear that temperature (e.g. first half (blue) dramatically influences the *overall effective* rate of recharge. A more in-depth site study where continuous water temperatures are measured against recharge rates would help to better define this potential operational consideration for the HBDIC site.

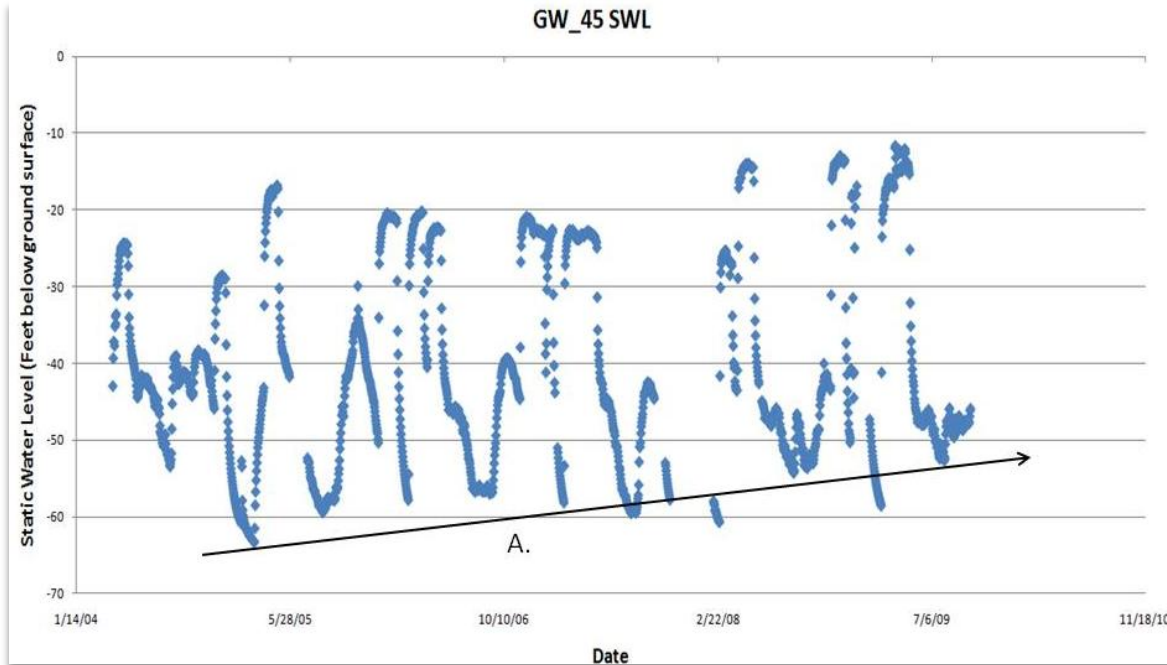
Figure 31. HBDIC On-site Observation Well Water Level Data (2004-9)

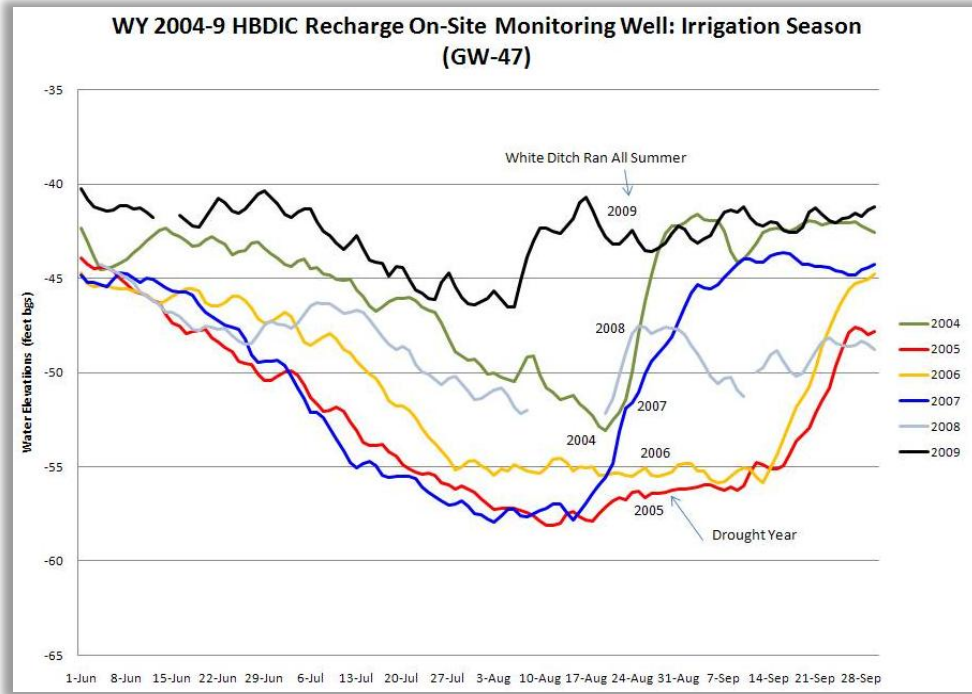
Figure 37. HBDIC Site Observation wells Irrigation Season water levels (2004-9)

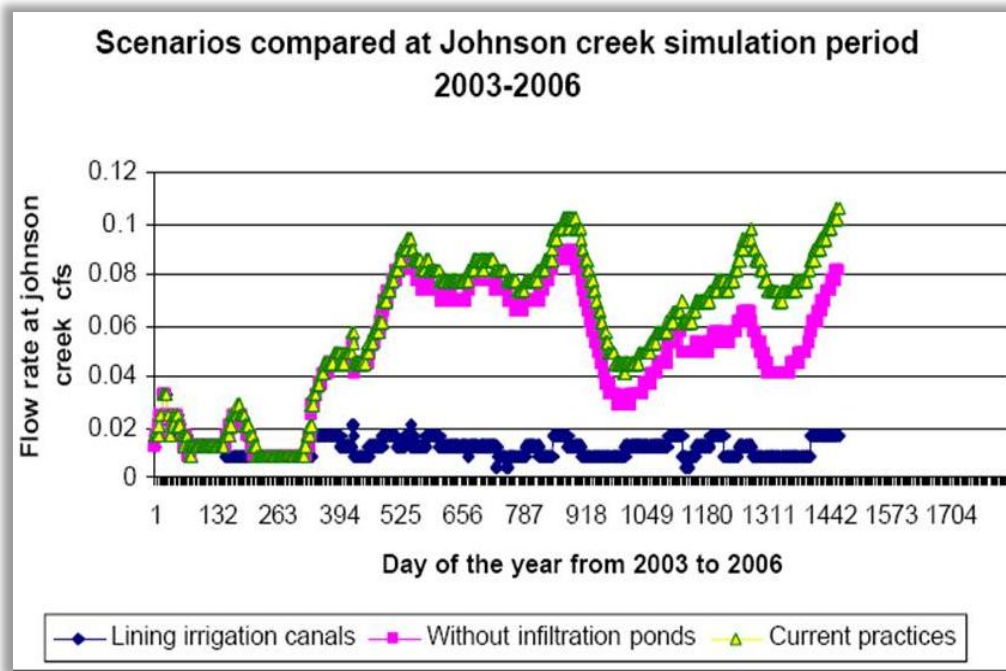
Figure 48. 2008 OSU IWFM Modeling Scenario for Johnson Creek (Petrides, 2008)

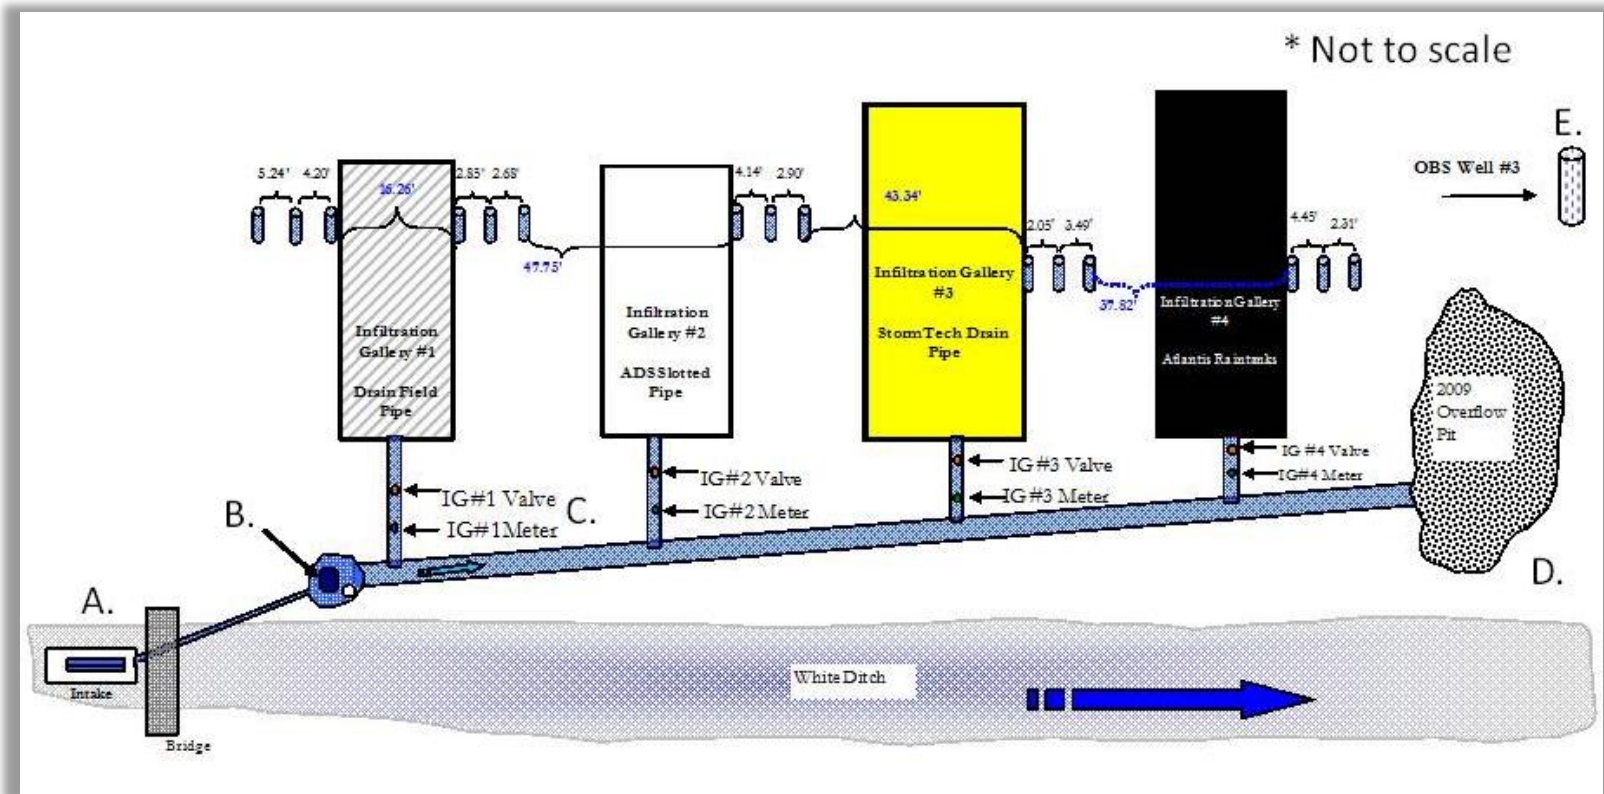
Figure 58 Infiltration Gallery Testing Area (HBDIC Site)

Starting in the fall of 2008, a portion of the HBDIC recharge site has been used as a test location for examining and comparing the performance of four different types of shallow aquifer recharge infiltration galleries. This test area is shown in **Figure 23** below. Many of the local irrigators would like to implement shallow aquifer recharge on their farms, but do not have the space for spreading basins. Subsurface Infiltration galleries are being tested on the HBDIC site as a potential solution. A diagram in Appendix III shows the layout of the four galleries, water turnout, the location of meters, and piezometers to track groundwater responses.

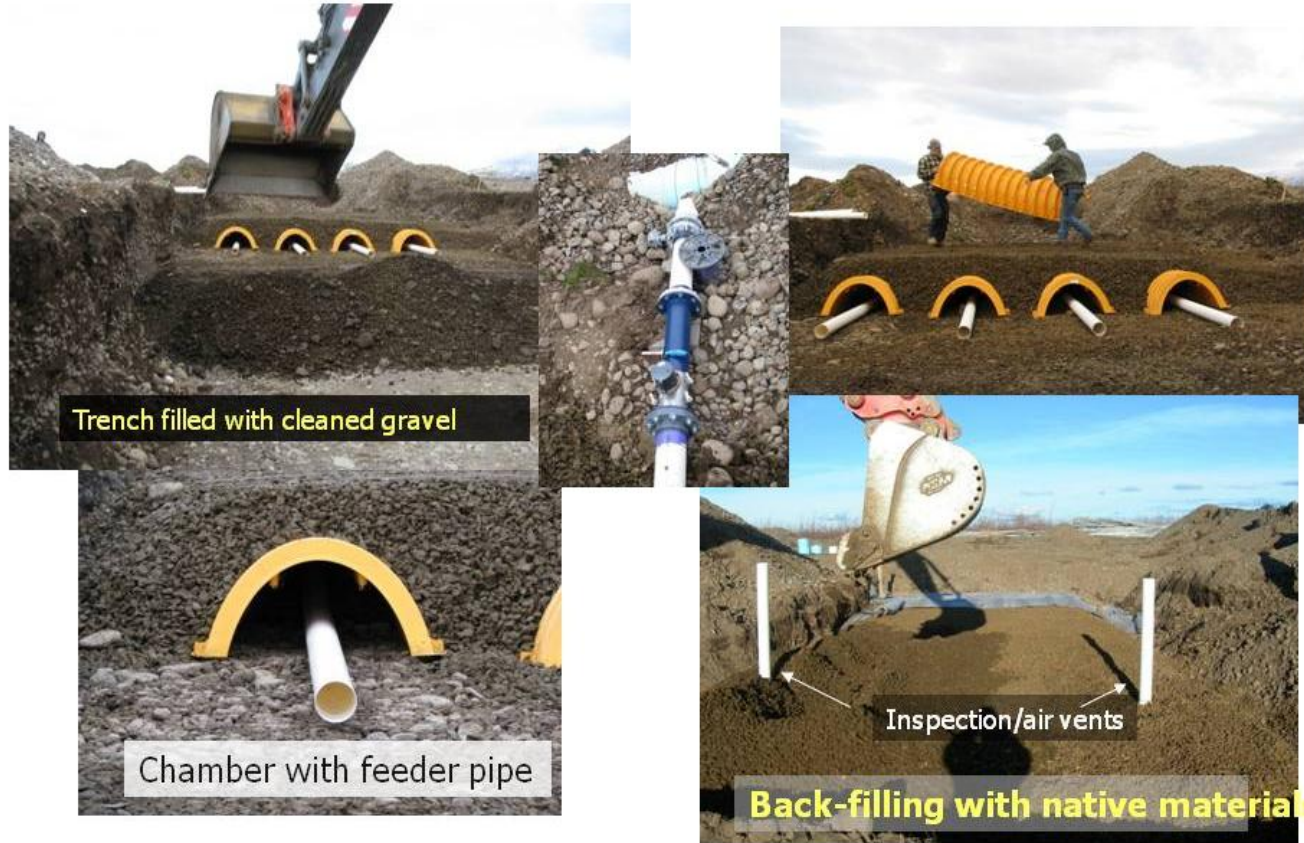
Infiltration Gallery: *Stormtech* SC-740™ Chamber

Figure 59. Infiltration Gallery #3 - Stormtech Chamber Installation (2008)

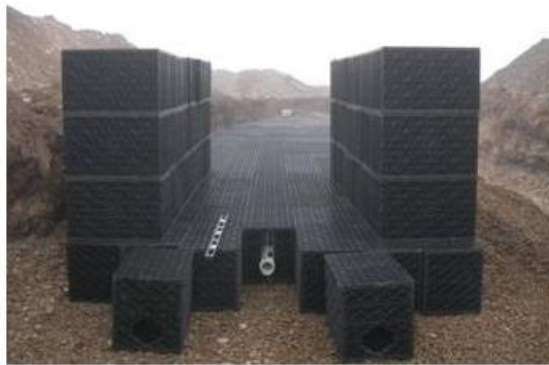
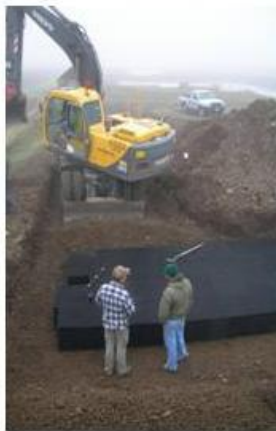
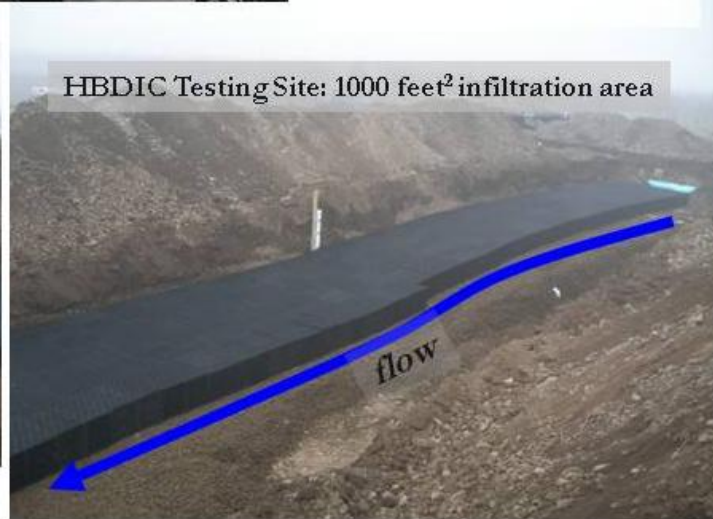
Raintanks being deployed

Intake: Valve and metered

Figure 60. Infiltration Gallery #4 - Atlantis Raintanks Installation (2008)

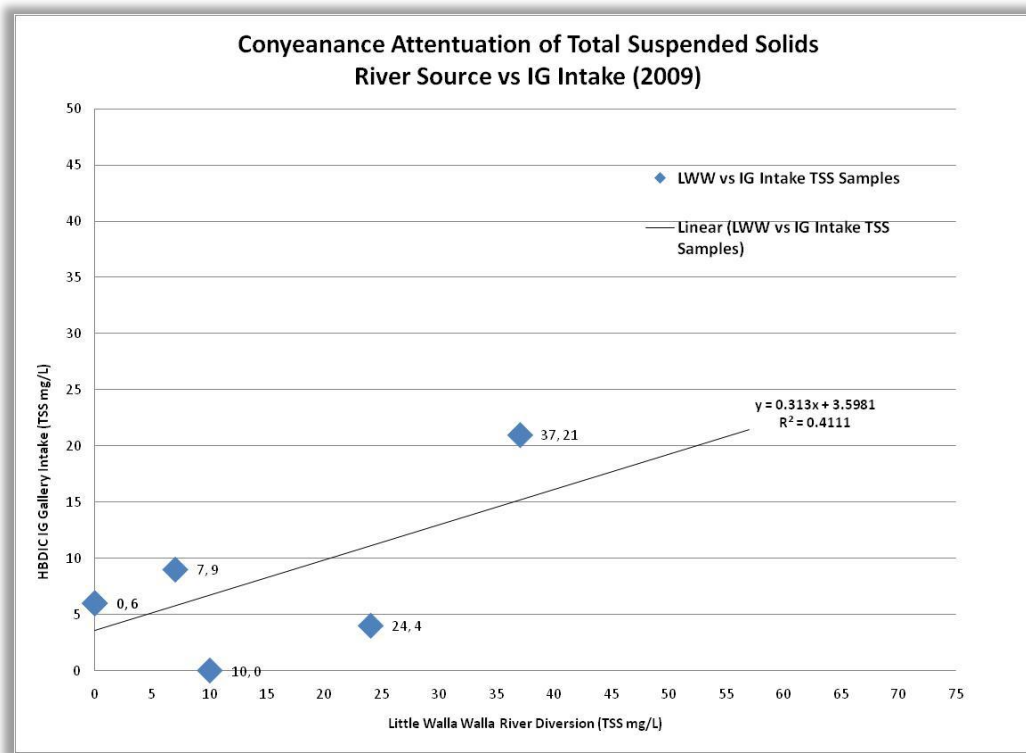
Figure 62. Preliminary Results of TSS and Conveyance Attenuation from Source to HBDIC Recharge Site
