Washington Walla Walla Basin Aquifer Recharge Report

August 2015

Walla Walla Basin Watershed Council
2015

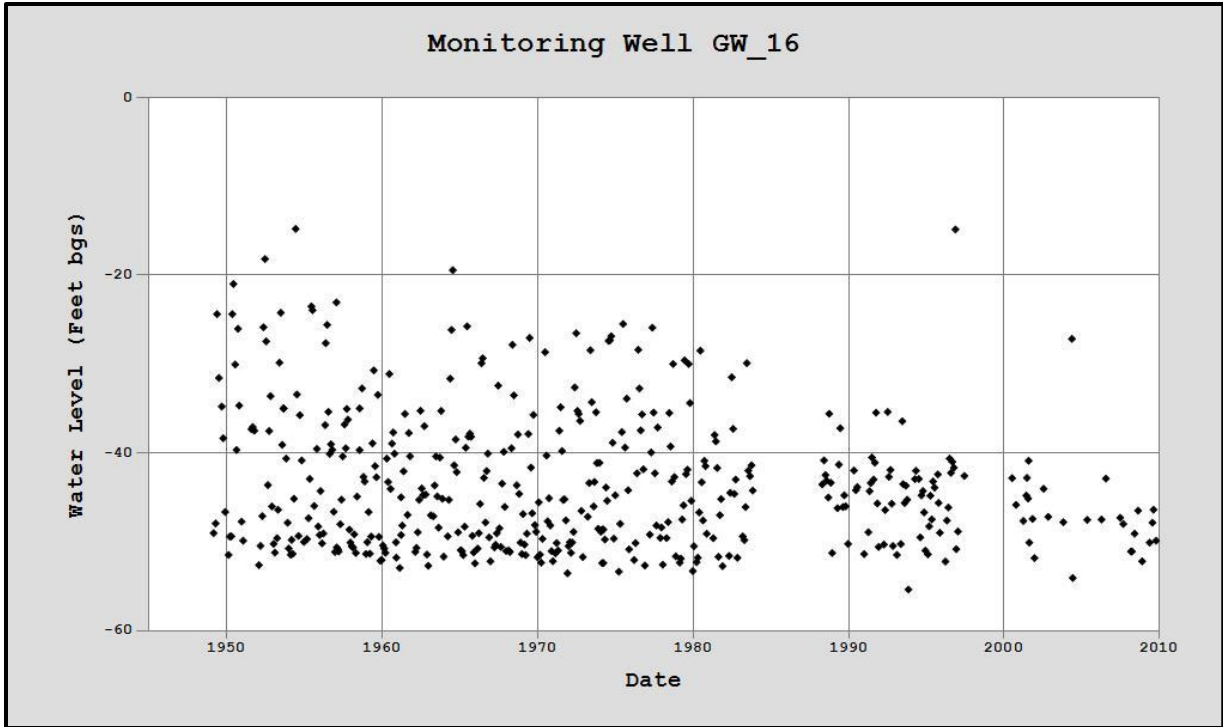
Figure 7 - Hydrograph for Monitoring Well GW_16 showing the long-term decline in the alluvial aquifer system in the Walla Walla Basin.

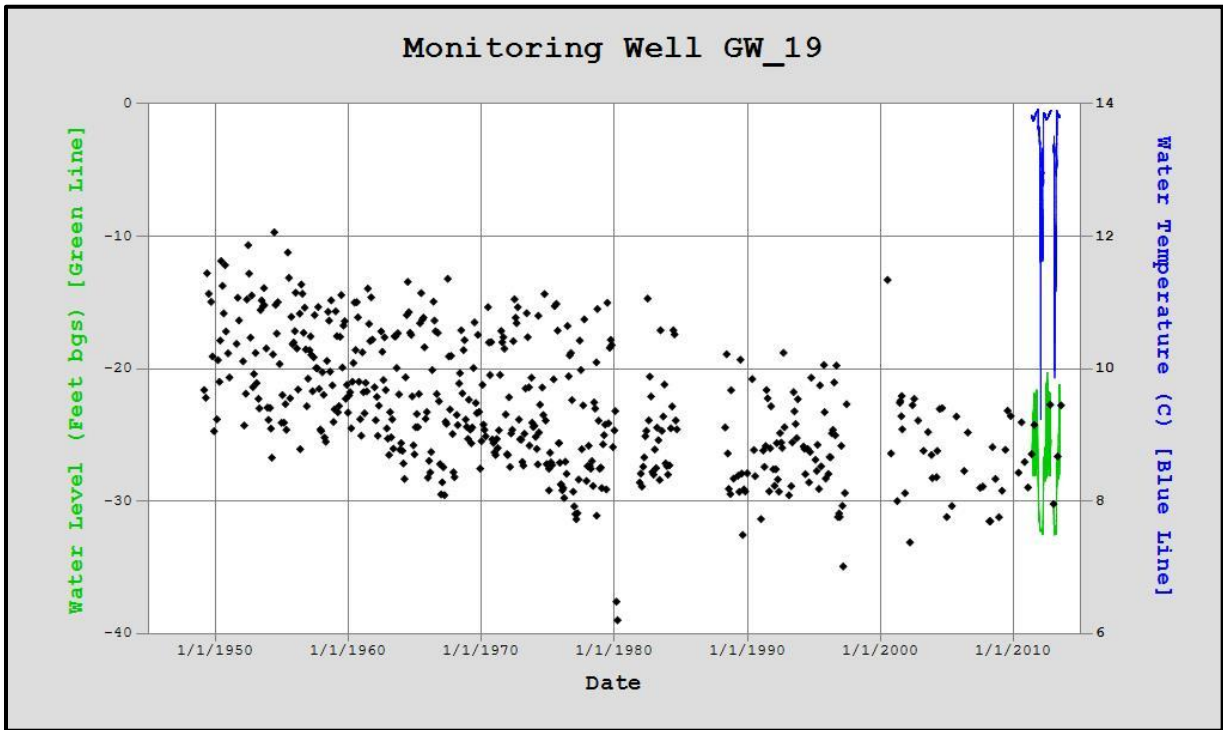
Figure 8- Hydrograph for Monitoring Well GW_19 showing the long-term decline in the alluvial aquifer system in the Walla Walla Basin.

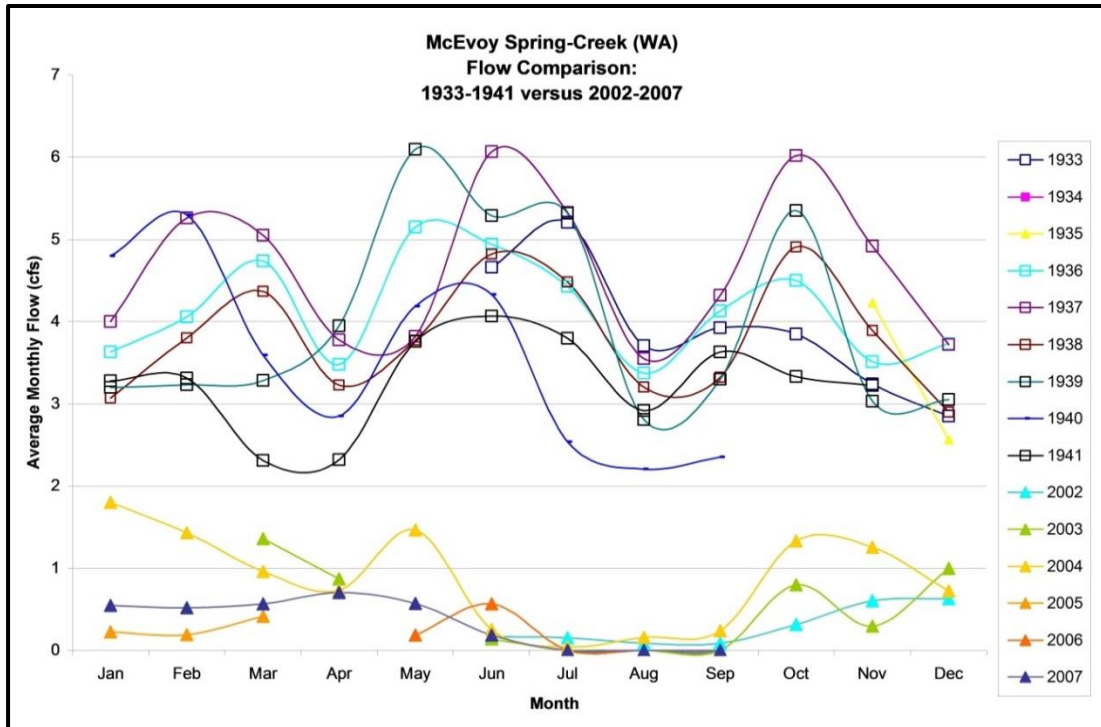
Figure 9 - Hydrograph for McEvoy Spring Creek located just north of the WA-OR state line. Hydrograph shows the decline in spring performance over the last 80 years.

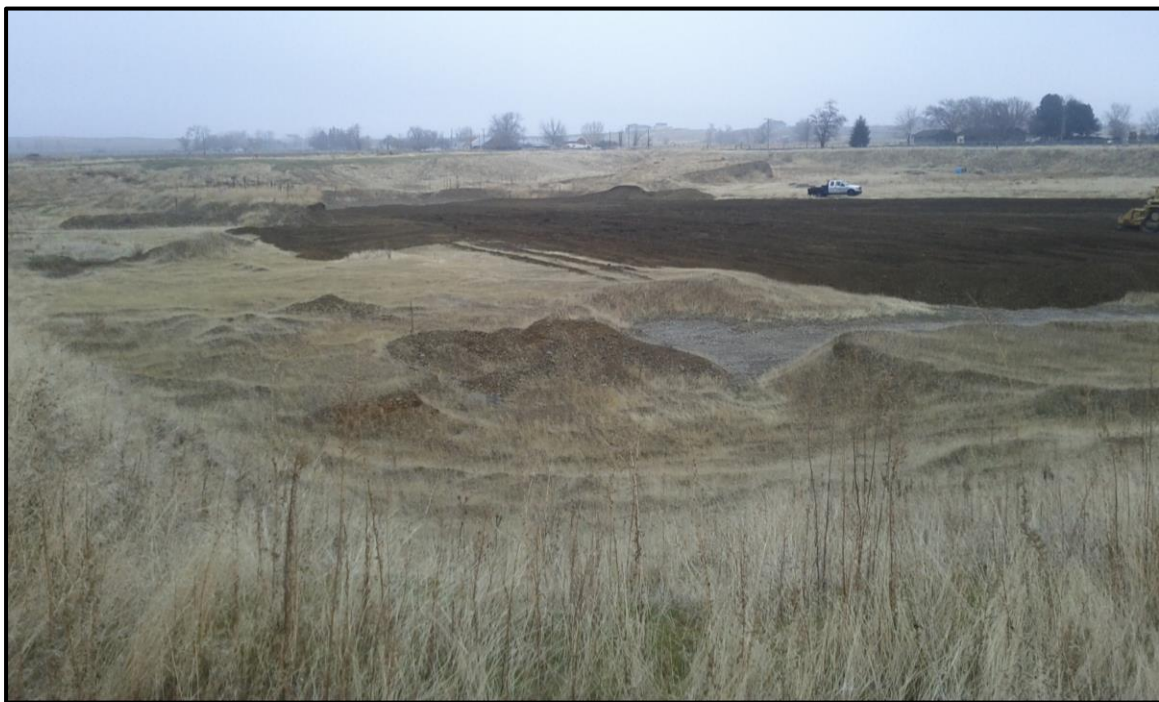
Figure 12 - Photo during expansion of the Locher Road site's main recharge basin, December 2011.

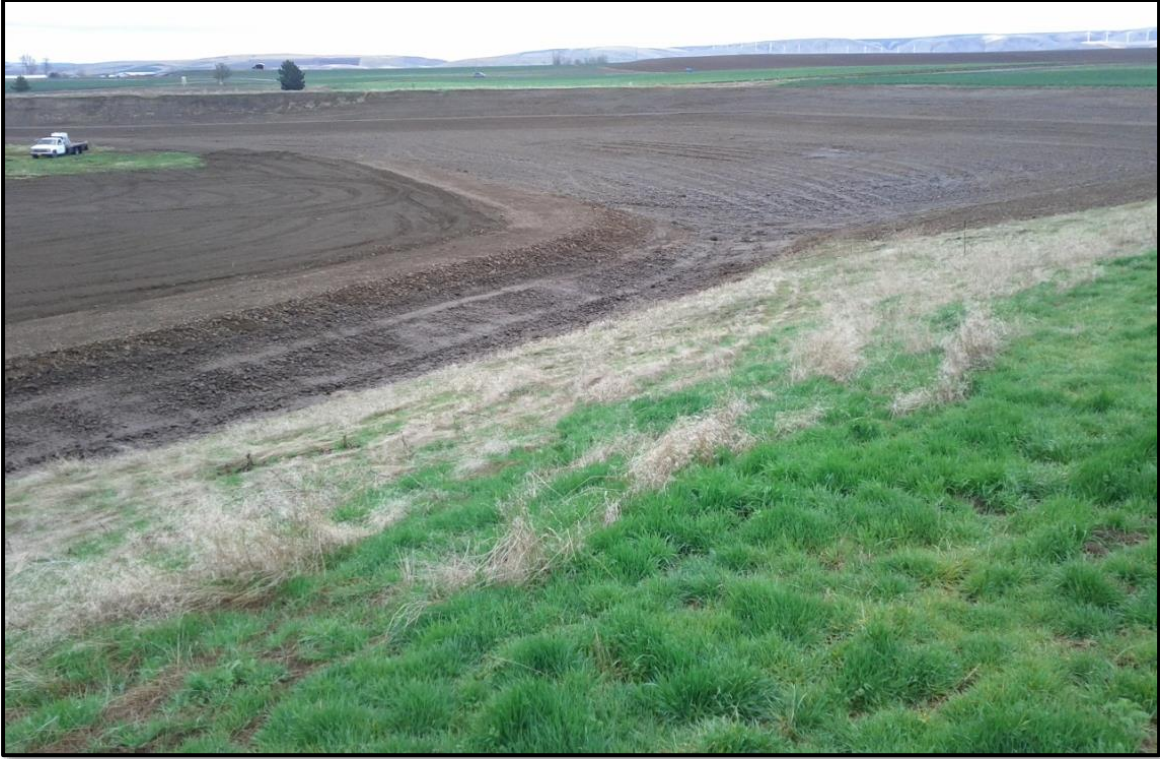
Figure 13 - Photo of the completed expansion of the Locher Road site's main recharge basin, December 2011.

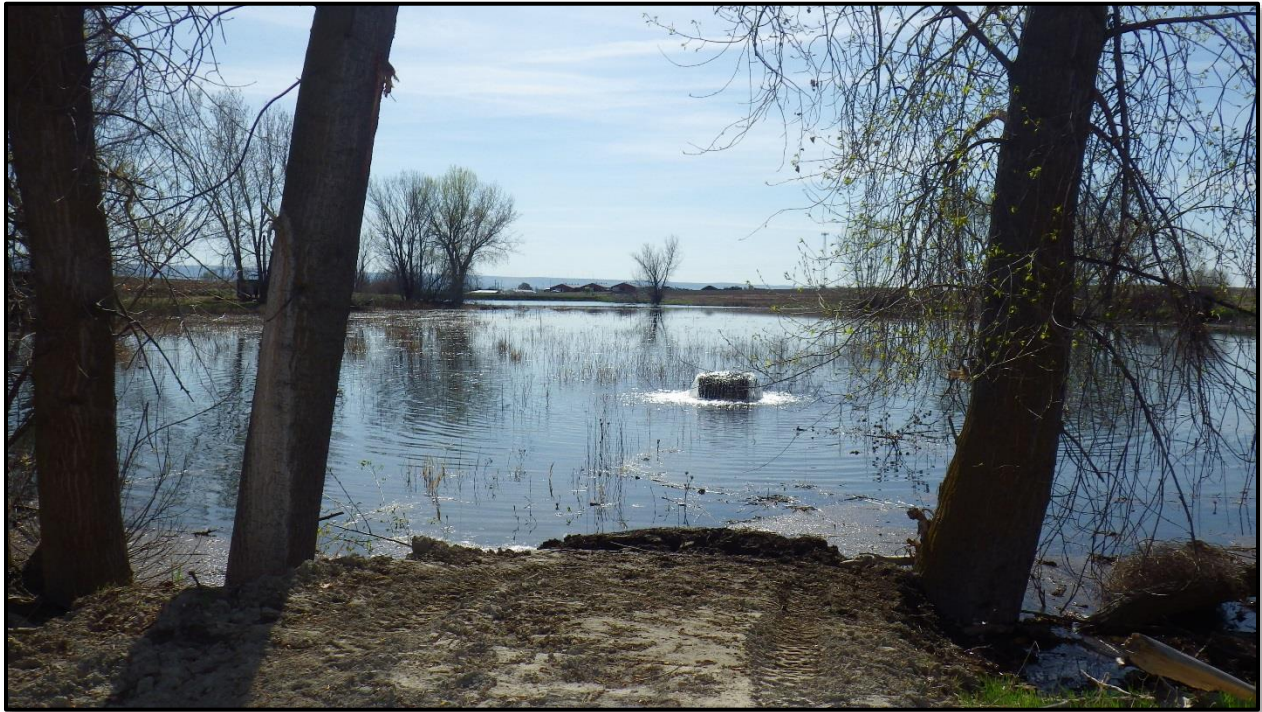
Figure 16 - Stiller Pond Aquifer Recharge site during operations.

In its current configuration the Stiller Pond site can recharge approximately 1-2 cfs depending upon other demands from the diversion system. Future plans include a new diversion structure and larger pump to allow the delivery of up to approximately 4 cfs to the site. Like the Locher Road site,

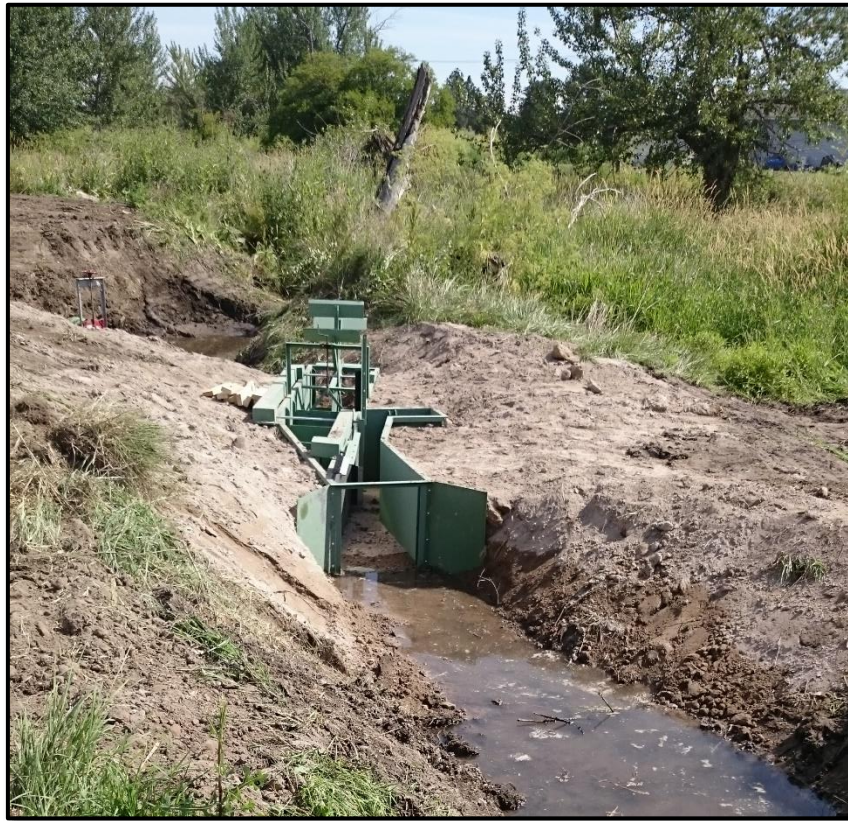
Figure 18 - Irrigation ditch, fish screen and intake (back left) for the Last Chance Road Aquifer Recharge site.

The Last Chance Road site was constructed in June 2015 (Figure 10, 17 and 18). The site did not operate during the 2015 recharge season, but is ready for future operations. The site includes two recharge features, an infiltration gallery and a new open ditch along the hillside. The project also installed a fish screen on the diversion from the West Little Walla Walla River. This site is currently permitted under a Local Water Plan with the Walla Walla Watershed Management Partnership (WWWMP) to recharge up to 250 acre-feet per year from November 1-May 30. Minimum instream flows (1 cfs) for the site will be measured at the WWBWC's gauge on the West Little Walla Walla River at Swegle Road (S-227). In its current configuration, the Last Chance Road site can recharge up to 1 cfs of water from the West Little Walla Walla River. If the site continues to operate, an Environmental Enhancement Project permit may be sought for the site (WWWMP, 2014).
