# WALLA WALLA BASIN WATERSHED COUNCIL

## Oregon Walla Walla Basin Aquifer Recharge Report

*2023 Water Year*

Submitted: February 2024

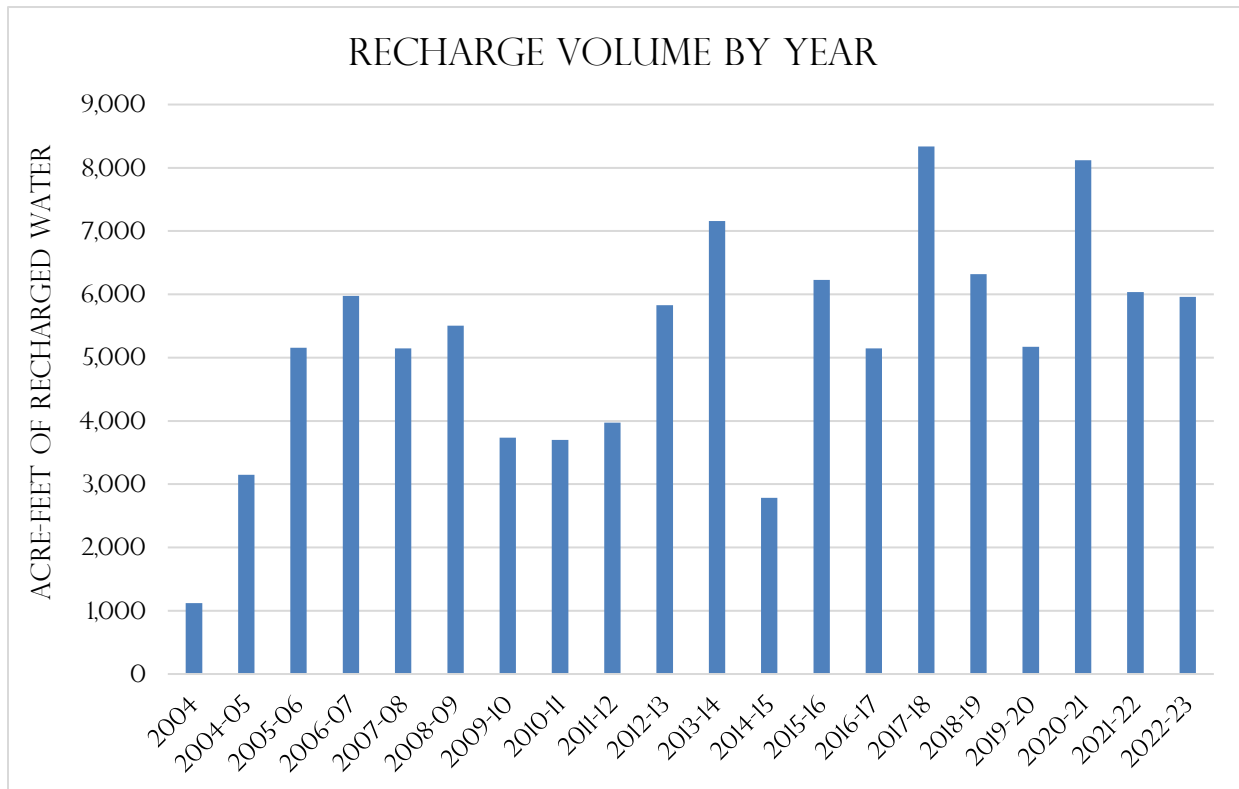
Figure 1. Recharge volume by year

This report describes groundwater level data, surface and groundwater quality data, and aquifer recharge operations during water year (WY) 2023 (October 1, 2022 – September 30, 2023) for the managed aquifer recharge program conducted by the Walla Walla Basin Watershed Council (WWBWC) in cooperation with the Hudson Bay District Improvement Company (HBDIC), Fruitvale Water Users Association (FWUA), and Walla Walla River Irrigation District (WWRID). The recharge program began operating in 2004 at one site and gradually expanded to the 15 sites operational in WY 2023. Figure 1 shows recharge volume by year.

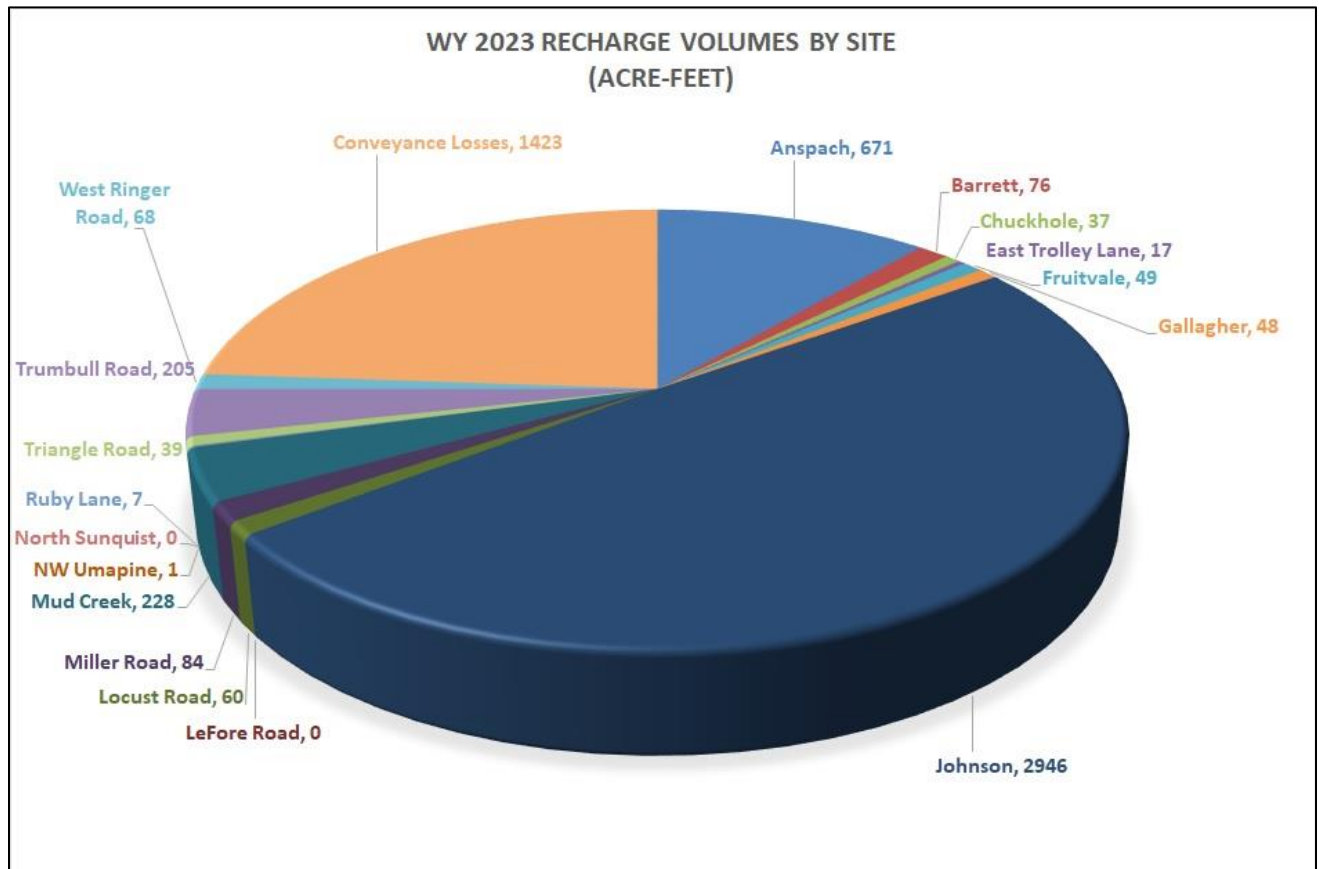
Figure 2. Recharge volumes by site during WY 2023.

Road, Ruby Lane, Triangle Road, and Trumbull Road. Figure 2 shows WY 2023 recharge volume for each active site by site, including estimated conveyance losses (i.e. canal seepage) that become groundwater recharge. The Lefore Road and North Sunquist recharge sites didn't operate in WY 2023 because site management and operational procedures were not yet fully developed.

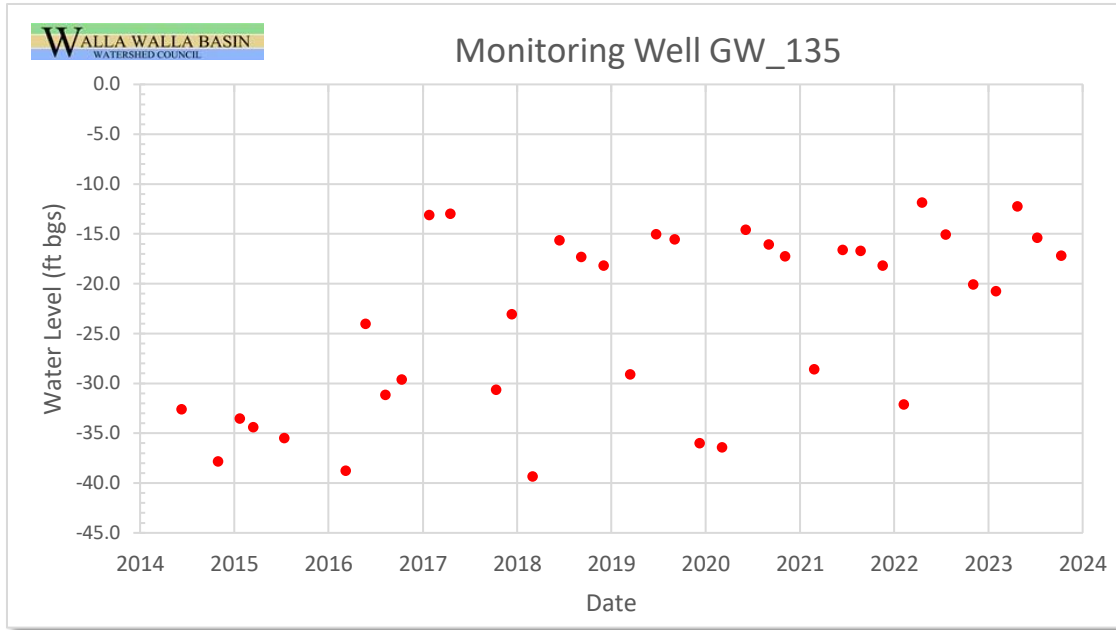
Figure 14. GW\_135 hydrograph from 2014-2023.

The site has two up-gradient wells, GW\_135 and GW\_141, and one cross-gradient well, GW\_23 (Figure 11). The shallowest groundwater elevations at GW\_141 rose by more than 10 feet during the early years of managed recharge (Figure 12). This year's groundwater trends look similar to the 2021 and 2022 seasons, both of which were high-volume recharge years at Anspach. GW\_141 is up-gradient of the recharge site, the timing of the seasonal patterns (Figure 13) suggests the well is influenced by managed recharge operations, perhaps as a result of groundwater mounding under the Anspach site. Quarterly measurements at GW\_135 show that the annual low elevation, typically in January/February, has steadily increased since 2018 (Figure 14). At cross-gradient GW\_23, quarterly readings preclude observing changes between each month; between years, groundwater levels may be stabilizing after declines in the three previous decades (Figure 15).

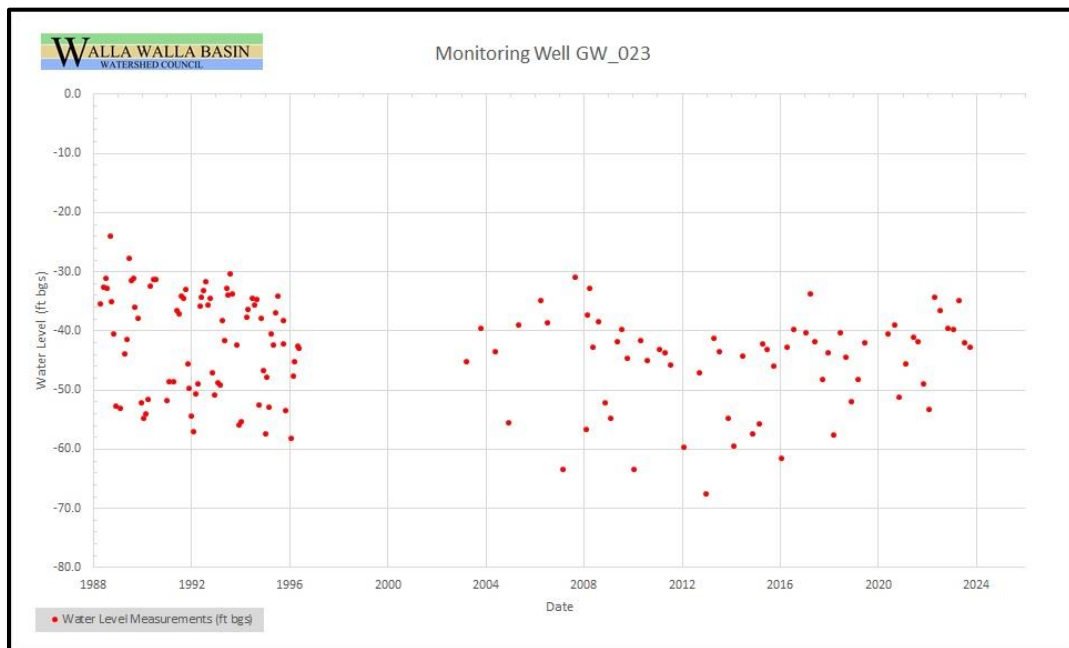
Figure 15. GW\_23 hydrograph from WY 1988-2023.

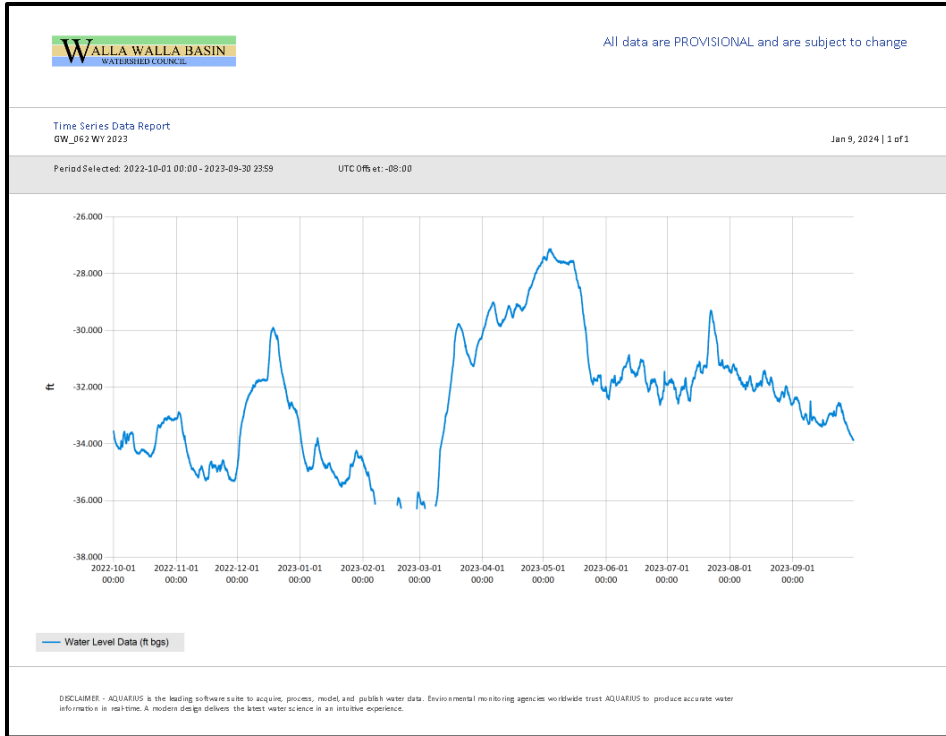
Figure 17. GW\_62 hydrograph from WY 2023.

GW\_62 is up-gradient of the site (Figure 16). Response to recharge operations at the Barrett site were observed at the up-gradient groundwater monitoring well, GW\_62, and includes influences from the Chuckhole recharge site (see below). Groundwater levels in the monitoring well increased to peak levels during recharge operations and decreased when recharge operations stopped (Figure 17). The 2006-2023 hydrograph for GW\_62 is included for longer term groundwater levels at the Barrett site, which began operation in WY 2014 (Figure 18).

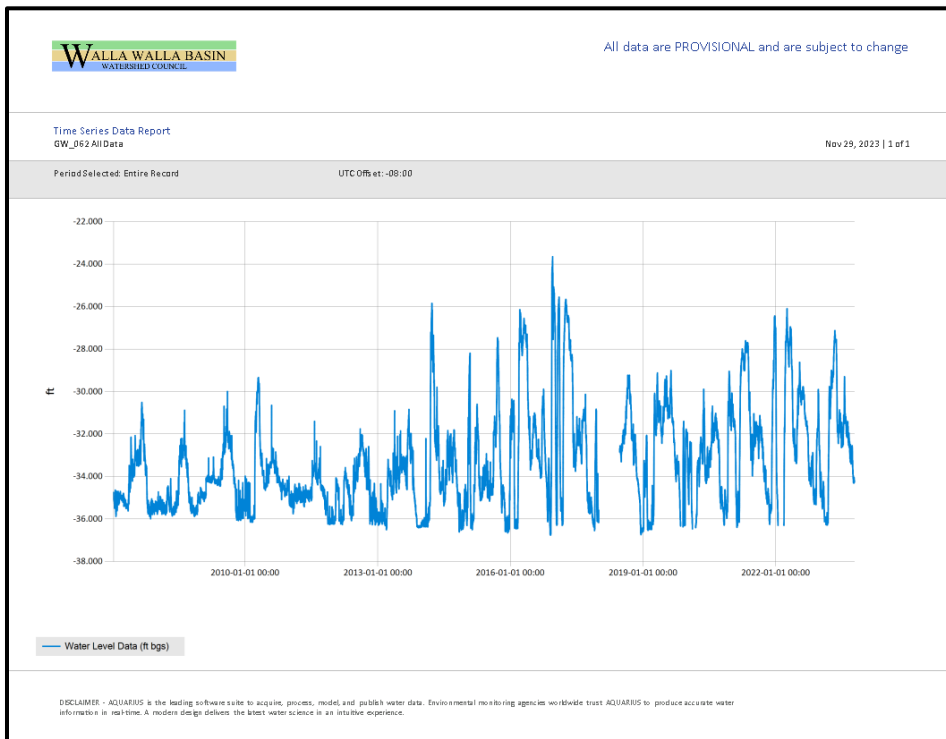
Figure 18. GW\_62 hydrograph from WY 2006-2023.

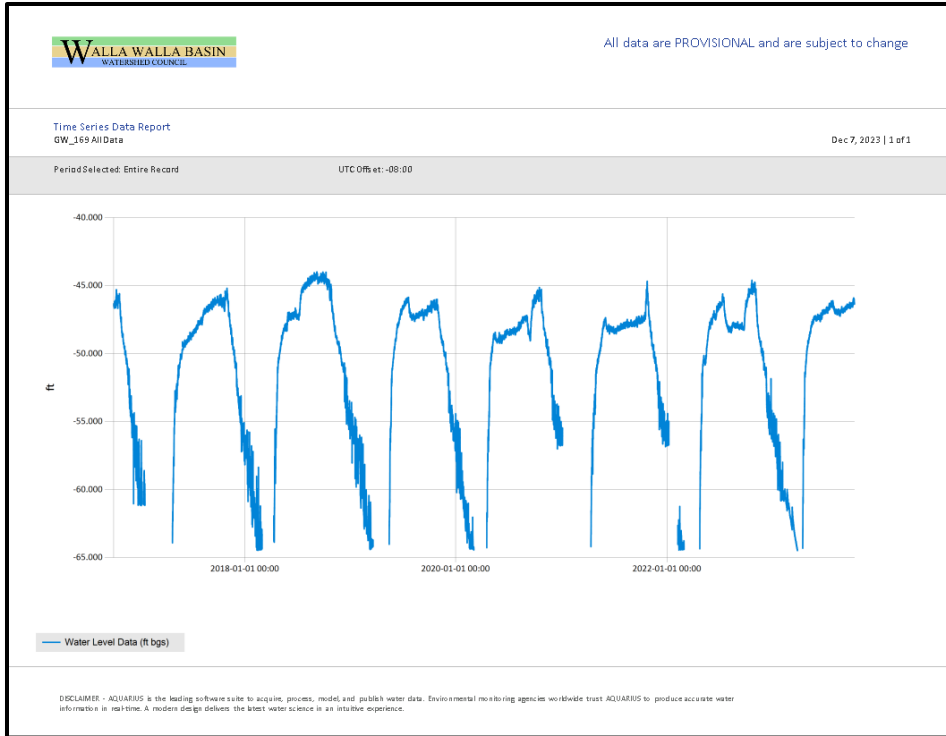
Figure 20. GW\_169 hydrograph from WY 2017-2023. Springtime data gaps represent times when the water level drops below the elevation of the sensor.

Three monitoring wells are in the vicinity of the site: GW\_169 up-gradient, GW\_62 down-gradient, and GW\_23 cross-gradient (Figure 19). As discussed above, GW\_62 water levels show the influence of the Barrett recharge site and the influence of the Chuckhole site. GW\_62 groundwater levels increase in November with the start of recharge at the Barrett site and peak in March/April, coinciding with the start of recharge at the Chuckhole site. Groundwater level decrease in mid-May when recharge operations at both sites are concluded for the year. At GW\_169 groundwater levels have increased during recharge season since the site began operating in 2016 (Figure 20). Each spring, the water level drops below the elevation of the sensor, producing the gaps seen on the hydrograph. At cross-gradient GW\_23, the static water level measurement collected during the brief 6-week recharge season was 5 feet above the previous measurement, taken in February, before the site turned on for the season (Figure 21).

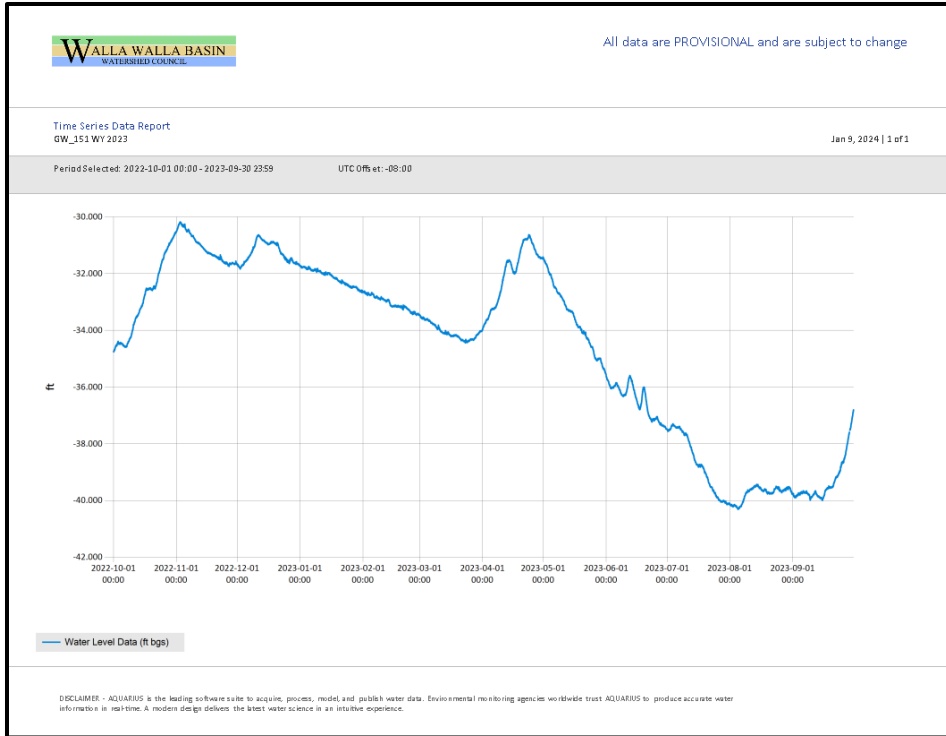
Figure 23. GW\_151 hydrograph from WY 2023.

GW\_151 is at the distal end of the infiltration gallery (Figure 22). The magnitude and timing of the changes in groundwater levels suggest multiple influences on the seasonal water table (Figures 23-24). The springtime peak may be due to recharge operations but the longer term trend since the site became active in 2017-2018 recharge season remains inconclusive.

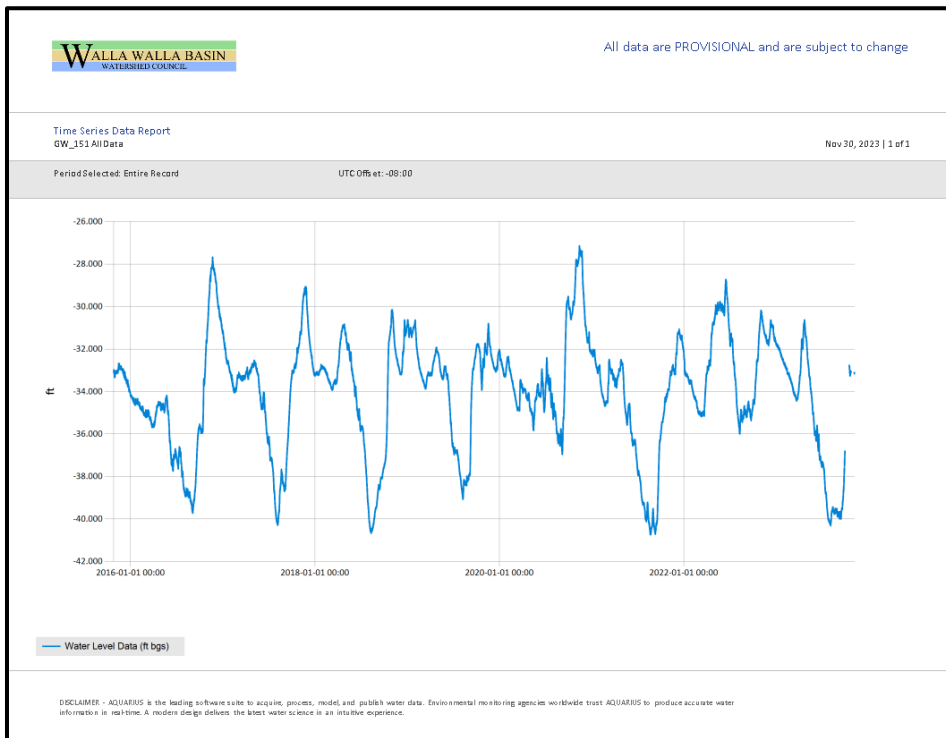
Figure 24. GW\_151 hydrograph from WY 2016-2023.

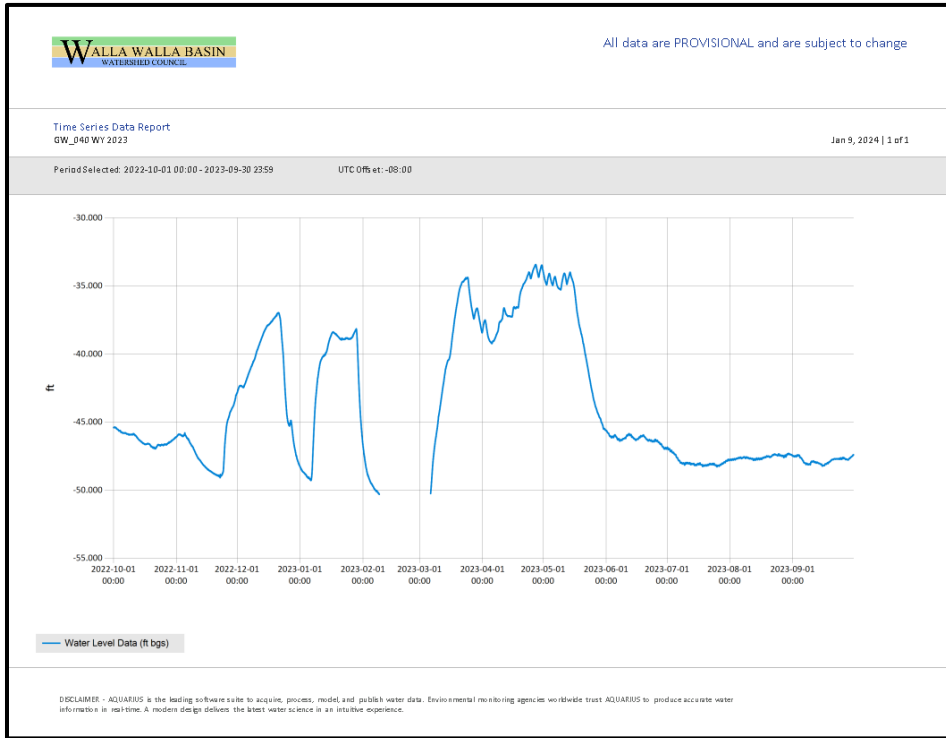
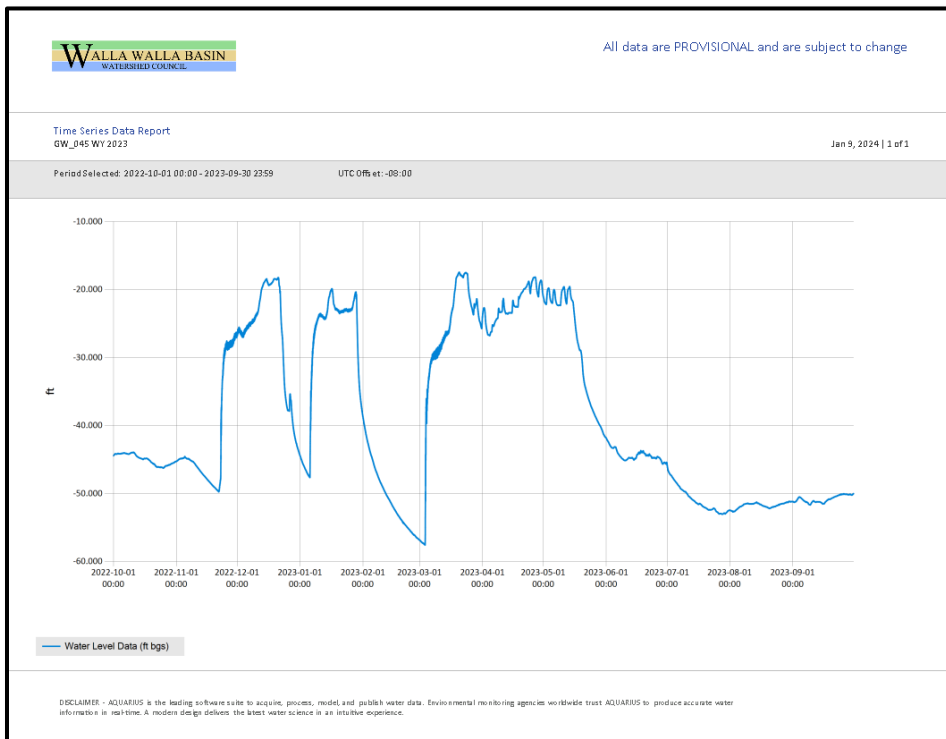
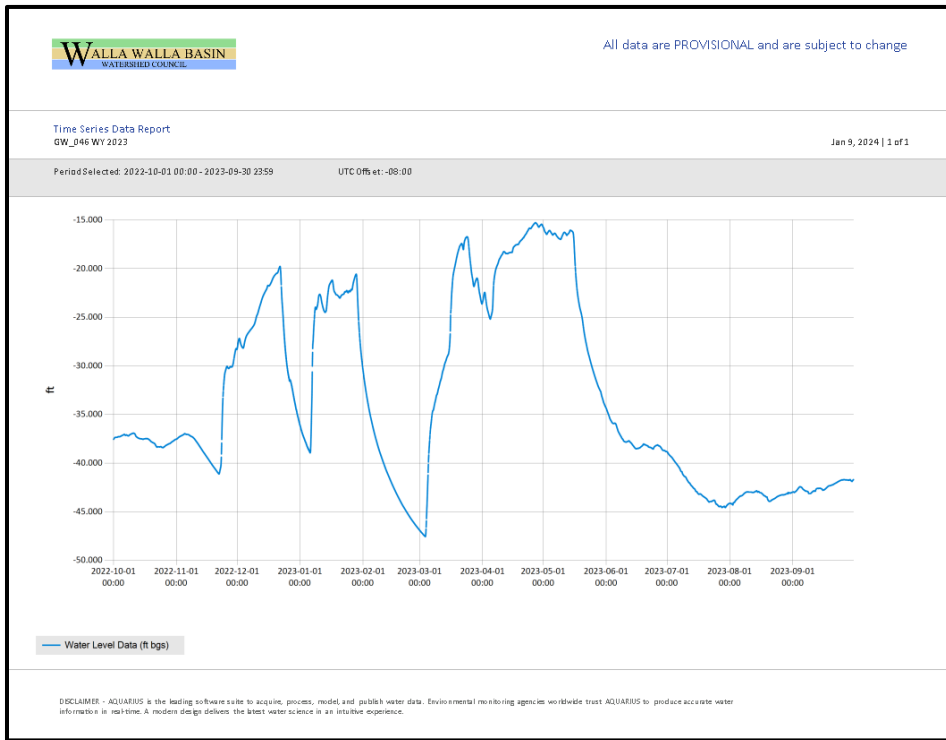
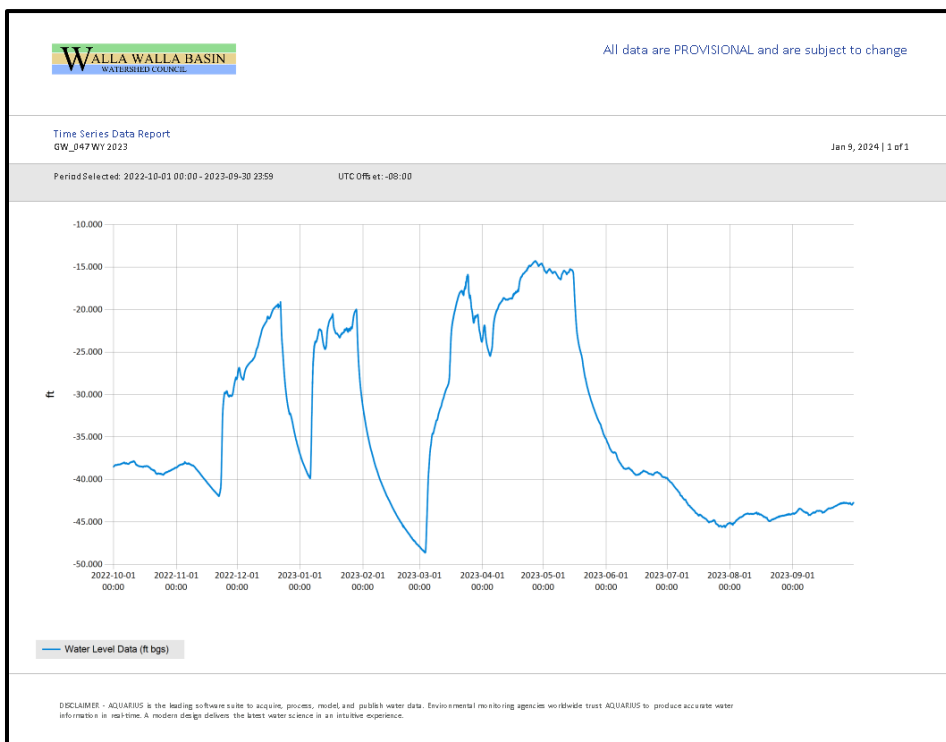
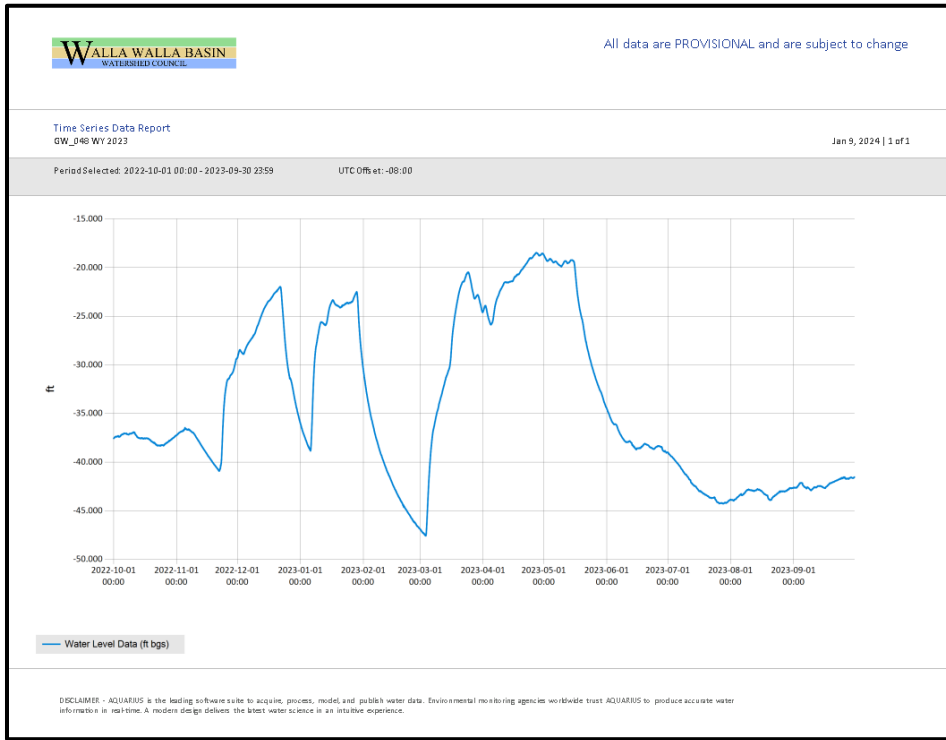
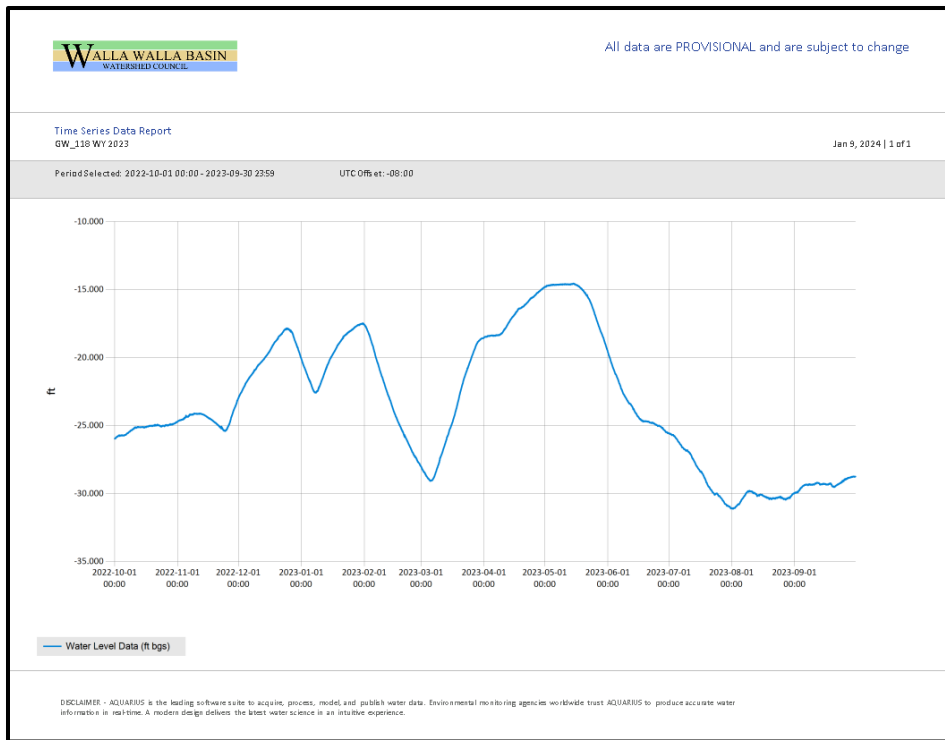
Figure 31. GW\_40 hydrograph from WY 2023.

Figure 32. GW\_45 hydrograph from WY 2023.

Figure 33. GW\_46 hydrograph from WY 2023.

Figure 34. GW\_47 hydrograph from WY 2023.

Figure 35. GW\_48 hydrograph from WY 2023.

Figure 36. GW\_118 hydrograph from WY 2023.

Groundwater monitoring wells (Figures 31-37) near the Johnson site were all observed to have a distinct increase in water levels in November shortly after operations began at the site. Up-gradient monitoring well GW\_40 also showed a strong response to recharge operations with water levels increasing rapidly during recharge operations and decreasing after recharge operations were suspended. GW\_40 water levels also show a response to nearby White Ditch flows during the fall.

Water levels in GW\_45, GW\_46 and GW\_47 were observed to decrease approximately 15-30 feet between approximately December 26<sup>th</sup> and January 5<sup>th</sup>, 2023, when recharge operations were interrupted. Water levels at these wells were observed to decrease again approximately 20-30 feet between approximately January 28<sup>th</sup> and March 3<sup>rd</sup>, when recharge operations were interrupted. However, water levels after the end of recharge season decreased slower than the rate of water level increase at the beginning of recharge operations, suggesting that groundwater storage was occurring beneath the site.

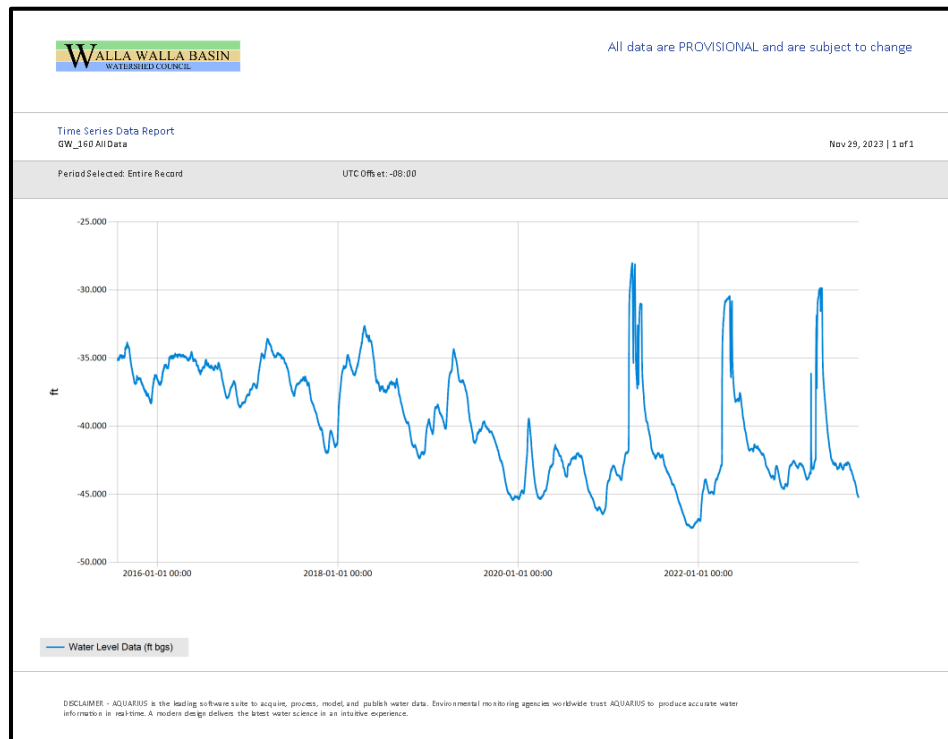
Figure 40. GW\_160 hydrograph from WY 2015-2023. The 2021, 2022 and 2023 peaks reflect Miller Road recharge operations.

GW\_152 is down-gradient and GW\_160 is cross-gradient of the site (Figure 38). The response to operations in WY 2018, when 78 ac-ft. was recharged, is in sharp contrast to the years during which recharge did not occur (Figure 39). The dramatic decline in groundwater elevations measured during the 2020-2023 water years compared to previous years is concerning, and the cause is unknown (Figure 40). The springtime peaks from 2021 to 2023 at GW\_160 and, to a lesser extent at GW\_152, reflect the first three years of recharge operations at the Miller Road recharge site.

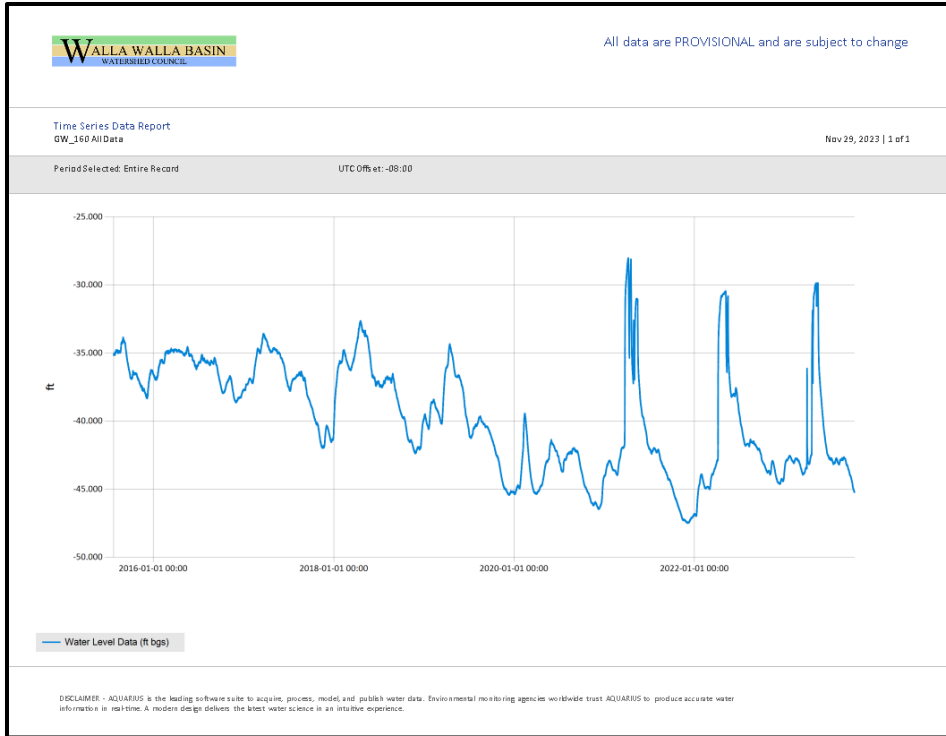
Figure 45. GW\_160 hydrograph from WY 2015-2023.

GW\_160 is located at the site of the infiltration galleries, while GW\_162 is 0.2 miles down gradient from the site (Figure 44). WY 2021 was the first season of operation at this site. The hydrographs from GW\_160 and GW\_162 show a significant influence from the recharged water (Figures 45-46). Annual low groundwater elevations have continually dropped, however, the low groundwater elevation increased in WY 2023 relative to the previous three years.

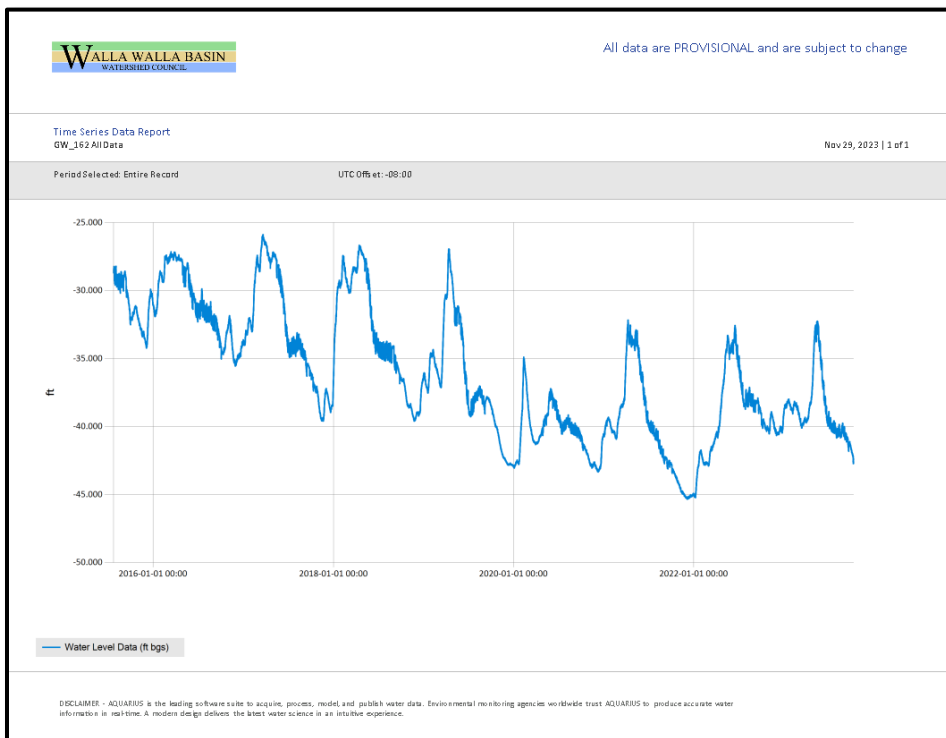
Figure 46. GW\_162 hydrograph from 2015-2023.

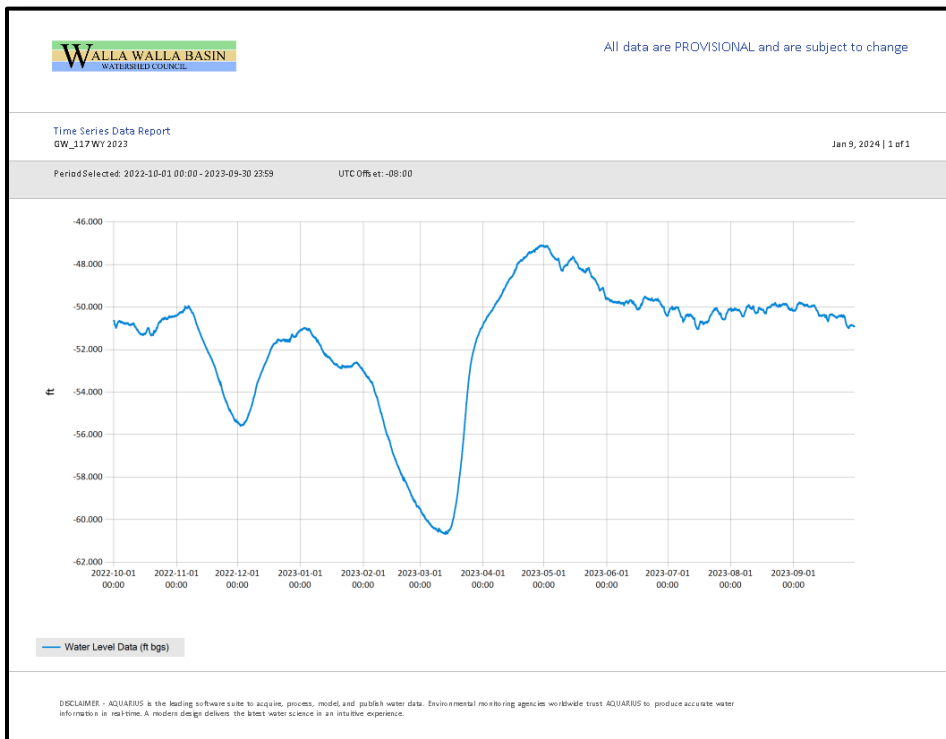
Figure 49. GW\_117 hydrograph from WY 2023.

GW\_117 water levels rose during recharge season, peaked in May and leveled off at a higher summertime elevation compared to the fall (Figure 49). The 2009-2023 dataset from GW\_117 suggests multiple influences (Figure 51).

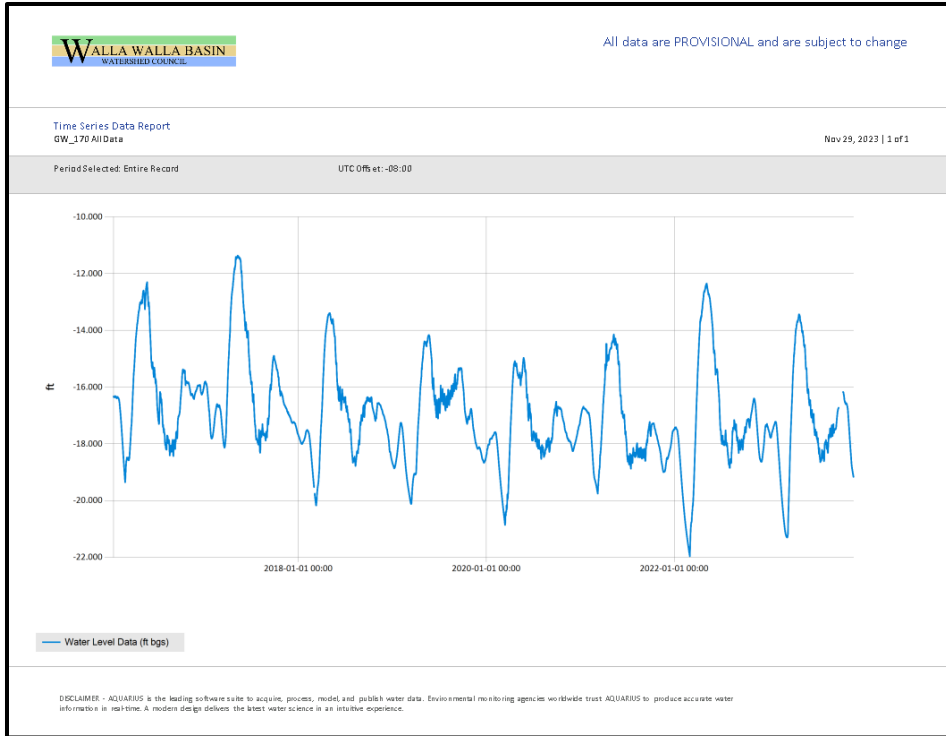
Figure 50. GW\_170 hydrograph from WY 2016-2023.

Monitoring wells GW\_170 and GW\_117 are located up-gradient approximately 0.1 and 0.9 miles from the site, respectively (Figure 47). The roughly 40-foot difference in groundwater levels between the two wells illustrate the highly variable conditions in the alluvial aquifer (Figures 48-49). At nearby GW\_170, groundwater levels increased during the recharge season, particularly from March-May. However, the springtime elevation increase was present prior to when Mud Creek recharge operations began in WY 2017, suggesting groundwater levels are responding to other factors as well, possibly recharge at the down-gradient recharge sites (Figure 50).

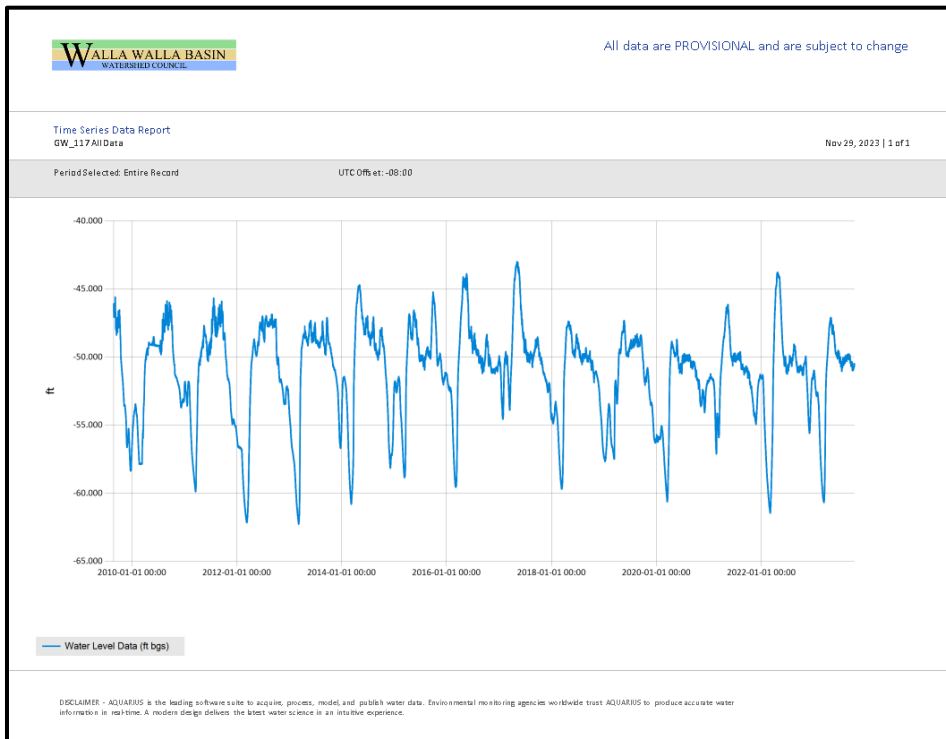
Figure 51. GW\_117 hydrograph from WY 2009-2023.

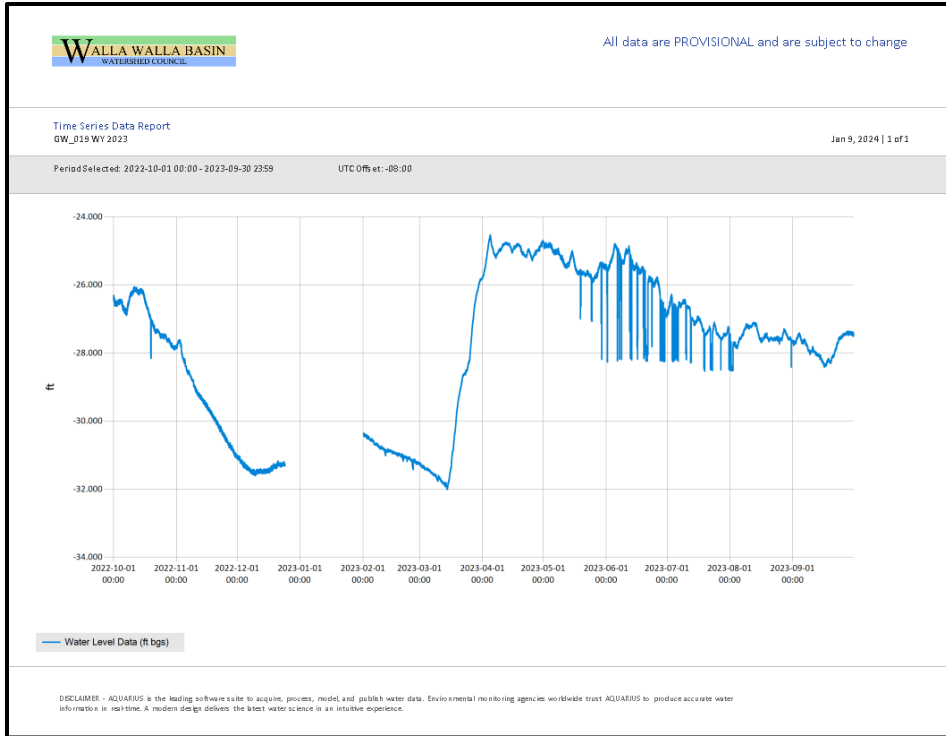
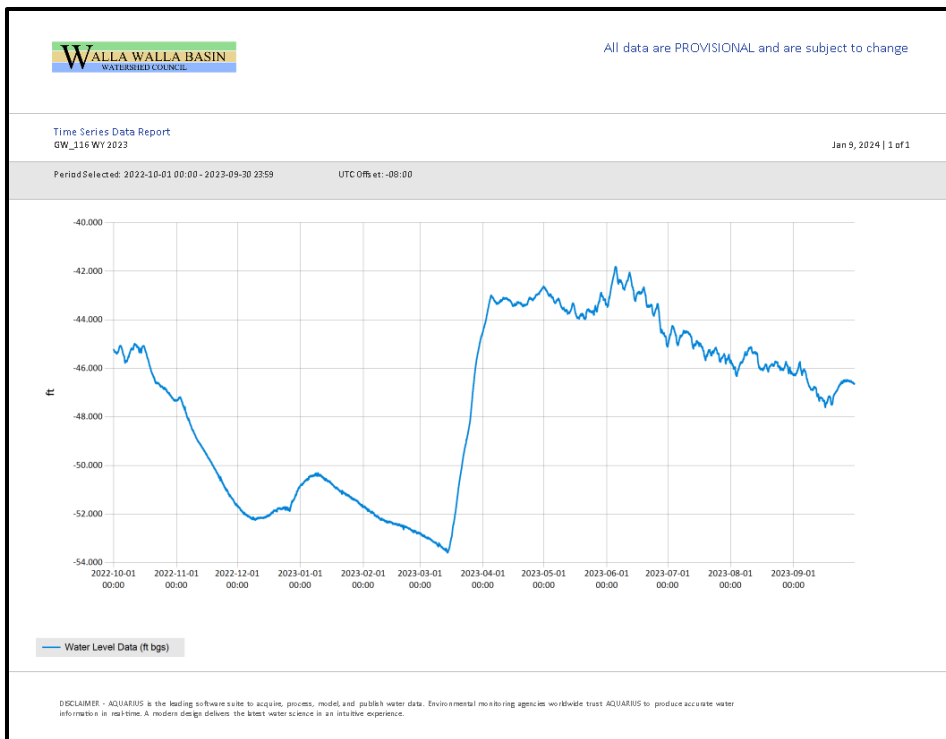
Figure 62. GW\_19 hydrograph from WY 2023.

Figure 63. GW\_116 hydrograph from WY 2023.

GW\_116 is 0.3 miles up-gradient of the site and GW\_19 is 0.2 miles down-gradient of the site (Figure 61). In WY 2021, the first year of Ruby Lane recharge operation, difficulties were encountered in getting enough water into the recharge site intake pipeline. There was inadequate water available in the irrigation ditch to back up and enter the infiltration gallery intake. In WY 2022 and 2023, issues with keeping the screen to the intake clean were experienced, limiting the amount of recharge. Based on the timing of annual peaks and troughs, groundwater levels in both the up and down-gradient wells appear to be more influenced by high summertime flow rates and conveyance losses in the Little Walla Walla River than by the limited recharge operations at Ruby Lane (Figures 62-63).

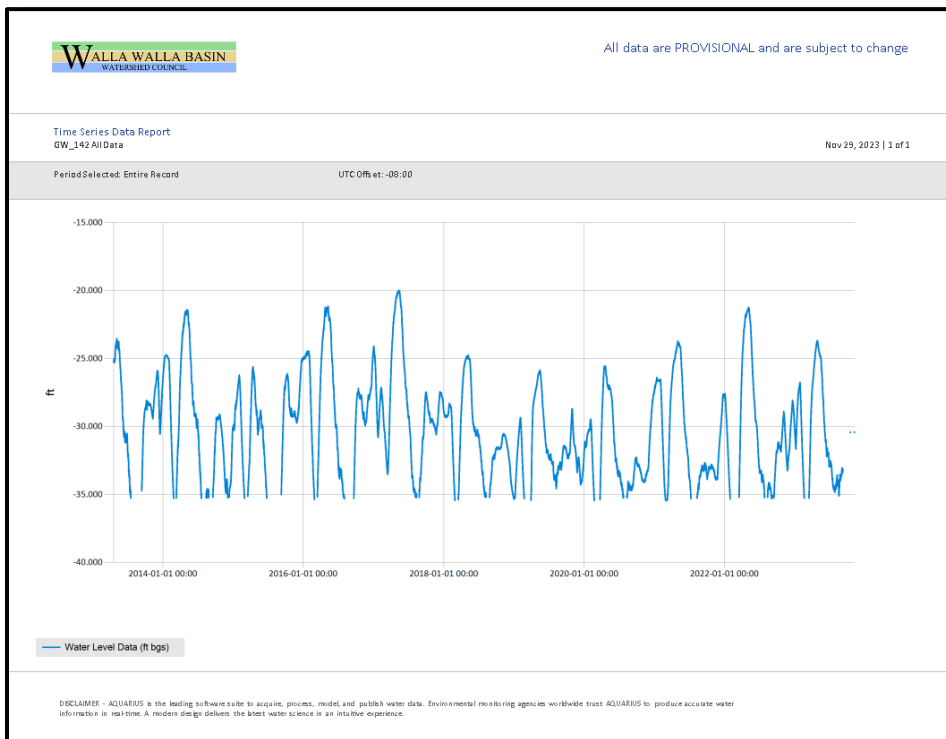
Figure 71. GW\_142 hydrograph from WY 2013-2023. Data gaps represent times when the water level dropped below the elevation of the sensor.

The operation of the Trumbull site, which began in WY 2013, coincides with a rise in the lowest annual elevations at GW\_117, however the 2023 low elevation was greater than the previous water year (Figure 70). At GW\_142, the peaks of the hydrograph have been relatively stable over the last 7 years (Figure 71).

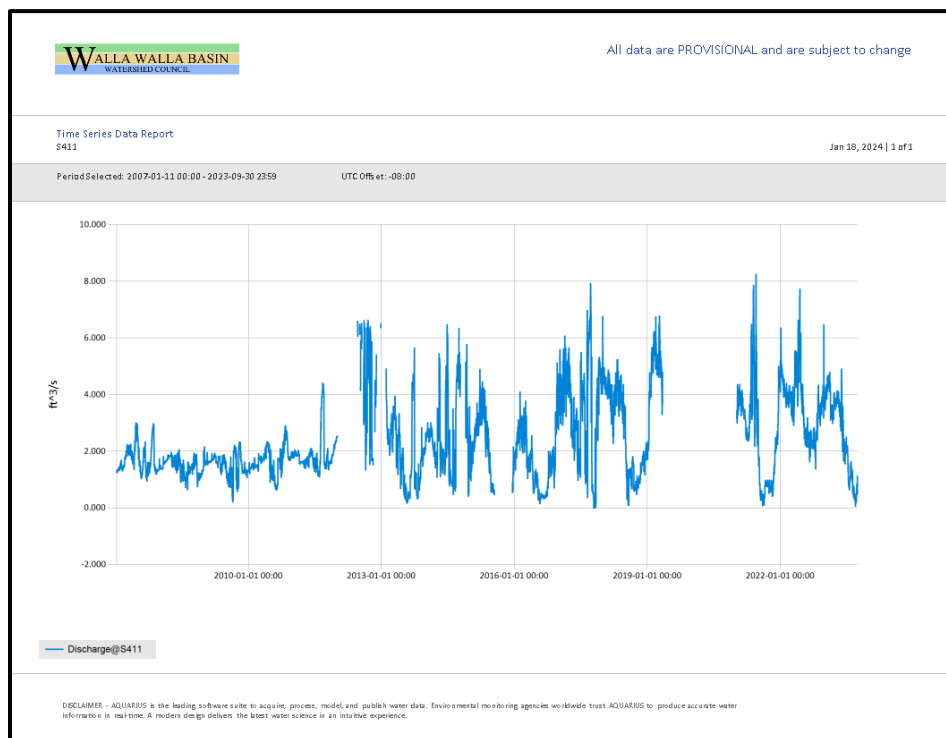
Figure 81. Hydrograph showing stream flow at S-411 Swartz Creek near Umapine Highway, 2007-2023.

The hydrograph for Swartz Creek flow (S-411) shows a notable annual flow increase beginning in 2012-2013, which is when recharge operations began up-gradient at the Anspach, Barrett, and Trumbull sites (Figure 81). It is important to note that this flow monitoring location is downstream of multiple irrigation tailwater inputs, so spring production is not the only factor affecting annual flow volumes. However, the WWBWC is not aware of increases in tailwater inputs upstream of the monitoring location that persist from 2012 to 2023.
