**Shallow Aquifer Monitoring in the Walla Walla Basin**  
***2019-2020 Water Year***  
***Final Report***

**Submitted: January 2021**

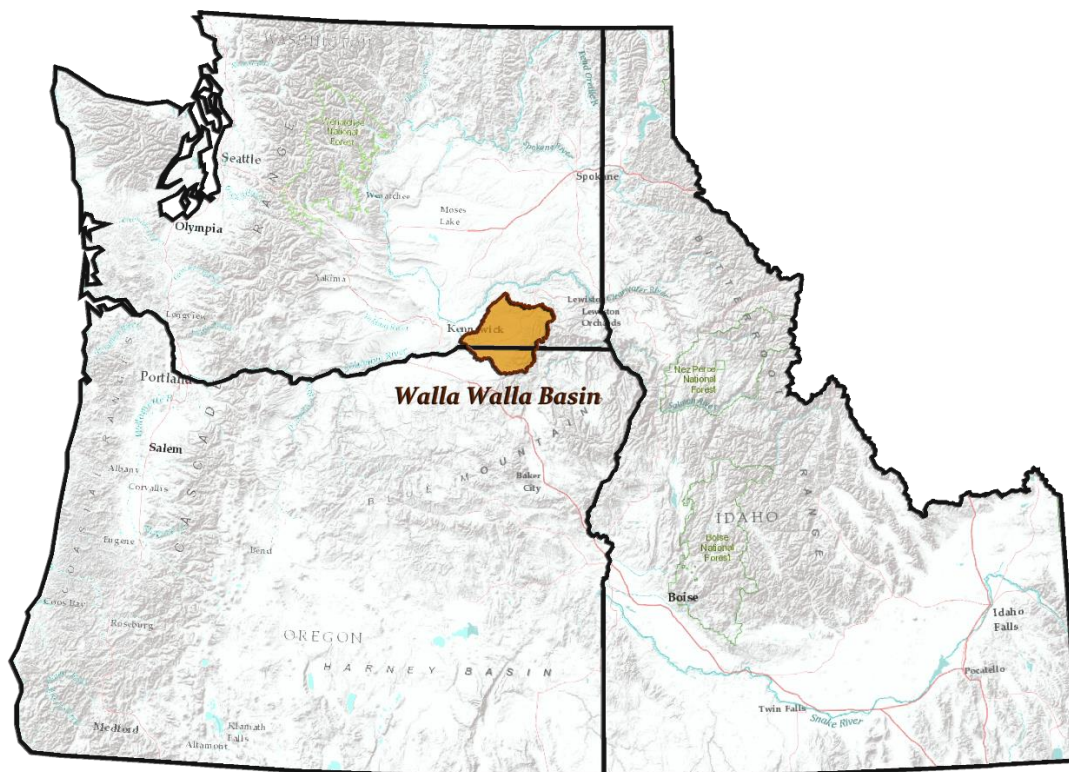
Figure 1. The bi-state Walla Walla River basin in northeastern Oregon and southeastern Washington. Due to lack of funding, we are currently not monitoring Washington wells.

The Walla Walla River basin is a bi-state region located in northeastern Oregon and southeastern Washington (Figure 1). The river basin covers approximately 1,760 square miles, with an underlying shallow alluvial aquifer of about 200 square miles (Figure 2). Shallow depth-to-water in certain locations in the valley and year-round supply make the shallow aquifer a highly important source of water for irrigated agricultural lands as well as domestic and livestock uses.

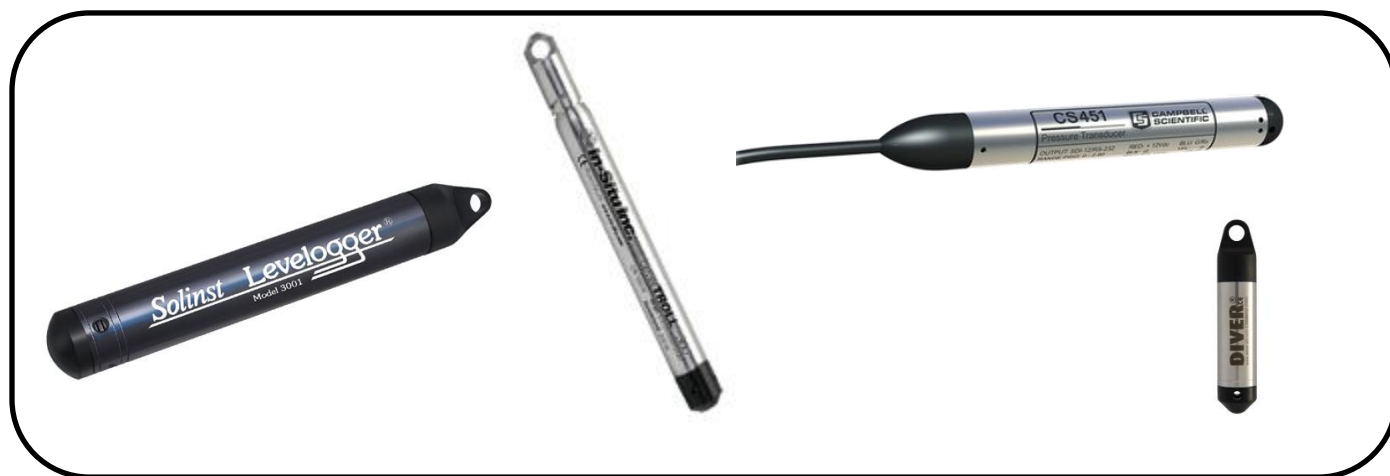
Figure 4. Pressure transducers used in the Shallow Aquifer Monitoring Network. Continuously monitored wells were equipped with one of the above types of pressure transducers.

During the 2020 water year, over two thirds of the monitoring wells were continuously monitored using one of four different pressure transducers (Figure 4) that were suspended below the water level but not resting on the bottom of the well. Pressure transducers were suspended using 1/16<sup>th</sup> inch aviation cable, 14 gauge speaker wire, fishing line or a communication cable provided by the manufacturer. The pressure transducers electronically determine and record the water pressure (pounds per square inch or feet of water) and water temperature (°C) on a programmed log interval (typically every 15 or 60 minutes). Transducer data were downloaded on a quarterly schedule. Manual water level measurements were made during the quarterly download to standardize the pressure transducer data. Water level measurements were collected manually using an e-tape (Solinst Water Level Meter, Model 102, [www.solinst.com](http://www.solinst.com)). All water level values were measured from an established measurement point, adjusted for top of grade (“stickup height”) and recorded as “feet below ground surface.”
