# WALLA WALLA BASIN WATERSHED COUNCIL

## Streamflow Monitoring in the Walla Walla Basin

*2023 Water Year*

### FINAL REPORT

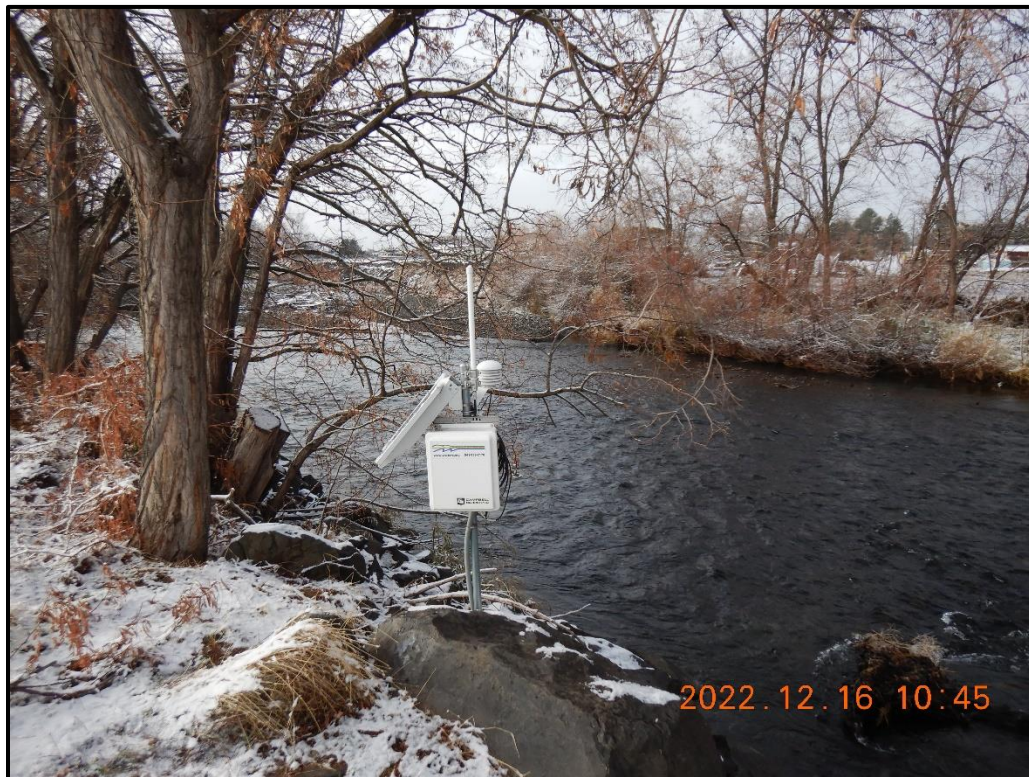
**Figure 4. At this near real-time monitoring site on the South Fork Walla Walla River (S-107), a cabled sensor secured to a boulder collects water level data. A communication cable transmits the information to a data logger and radio housed in the gauge box. Using radio telemetry, water level, and temperature data are sent to the WWBWC office to be processed and published online.**

Since 2013, WWBWC has strategically installed real-time flow monitoring sites where hourly flow data can benefit the public, tribal, state, and federal agency staff and local resource managers. Figure 4 shows an example of a near real-time monitoring site. Ten stream sites were monitored during the 2023 water year using near real-time telemetry equipment. WWBWC used electronic sensors and data loggers manufactured by Campbell Scientific to record gauge height at a programmed interval (typically every 15 minutes). These stage data were relayed to the WWBWC

office using satellite or radio telemetry and then processed through customized rating equations (see details below) to produce discharge values that were published hourly online.

Monitoring staff visited the near real-time sites every two weeks to measure stage and visually inspect equipment. Manual discharge measurements were taken approximately every six weeks using a SonTek FlowTracker Handheld Acoustic Doppler Velocimeter, OTT MF Pro flow meter Marsh-McBirney Flo-Mate 2000 flow meter, or Price AA current meter (Figure 5). Water temperature was measured using a calibrated NIST-traceable YSI 30 handheld meter ([www.ysi.com](http://www.ysi.com)).

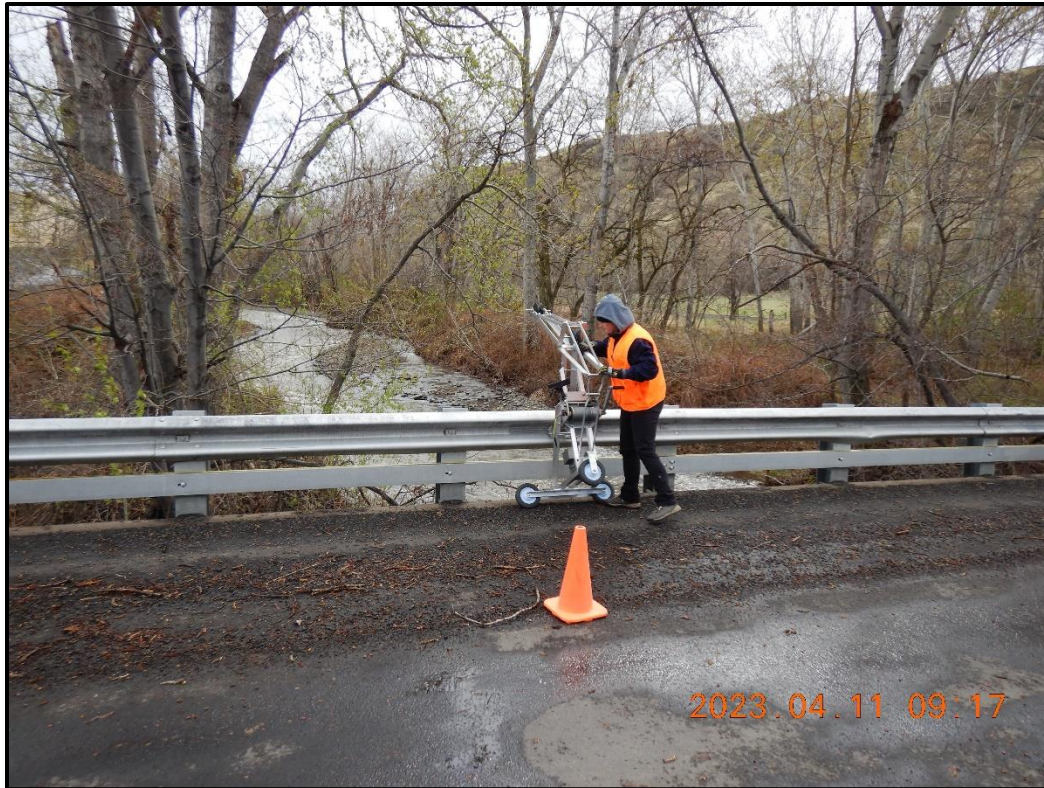
**Figure 5. Staff setting up a bridge board flow measurement on North Fork Walla Walla River (S-104) using a Price AA current meter and AquaCalc Pro Plus.**

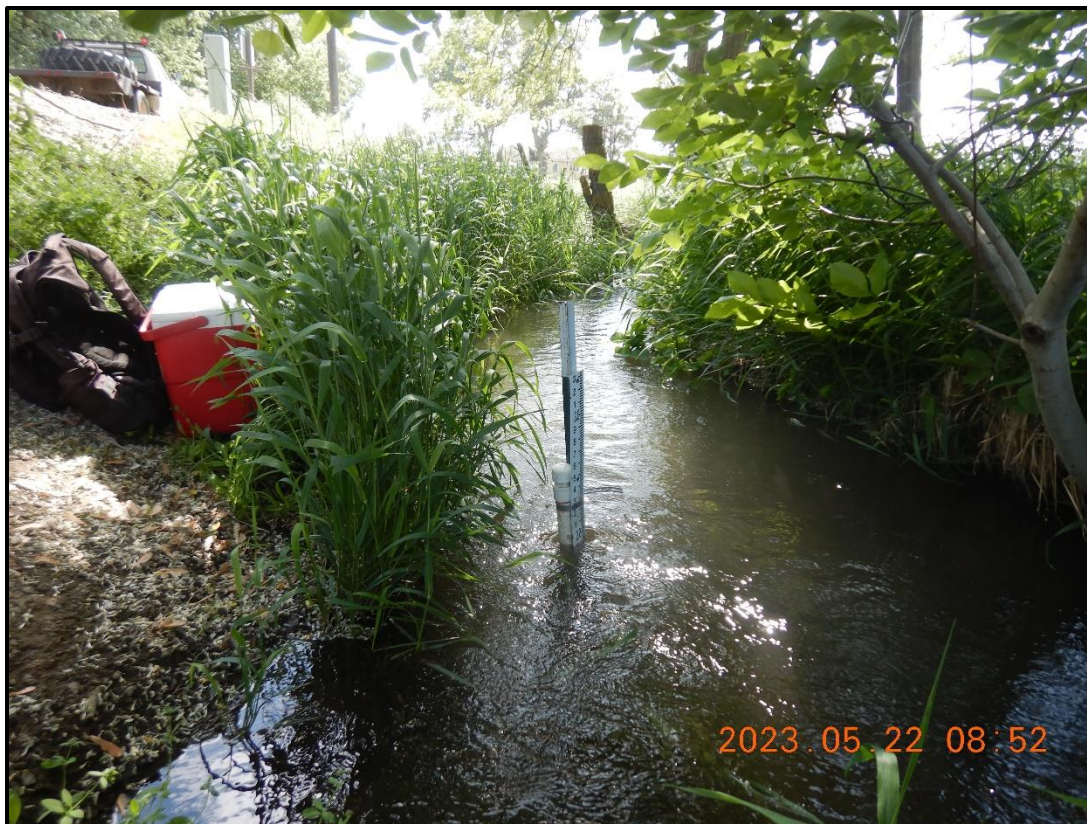
**Figure 6. At this stand-alone monitoring site on the West Little Walla Walla River (S-222), a staff gauge and perforated PVC stilling well enclose a suspended pressure transducer. These are the typical components installed at stand-alone monitoring sites that were visited quarterly for manual data download**

Many of WWBWC's streamflow monitoring sites are stand-alone stations not equipped with telemetry capability. We visit these sites quarterly to take stage and discharge measurements and to download data. For the 2023 water year monitoring period, these sites were equipped with Solinst pressure transducers programmed to log water level and temperature measurements at a set interval (typically every 15). Figure 6 shows an example of data logger deployment in a perforated PVC stilling well anchored to a t-post in the off-center of the channel.

A monitoring technician visited each site every three months to read the staff gauge and take a manual discharge measurement. Also, during the quarterly visit, stage and water temperature data were downloaded from the logger, site maintenance was conducted (for example, weeds or other debris removed), the water temperature was measured, and photographs were taken.
