# Streamflow Monitoring in the Walla Walla Basin

## *2024 Water Year*

### FINAL REPORT

**Submitted: March 2025**

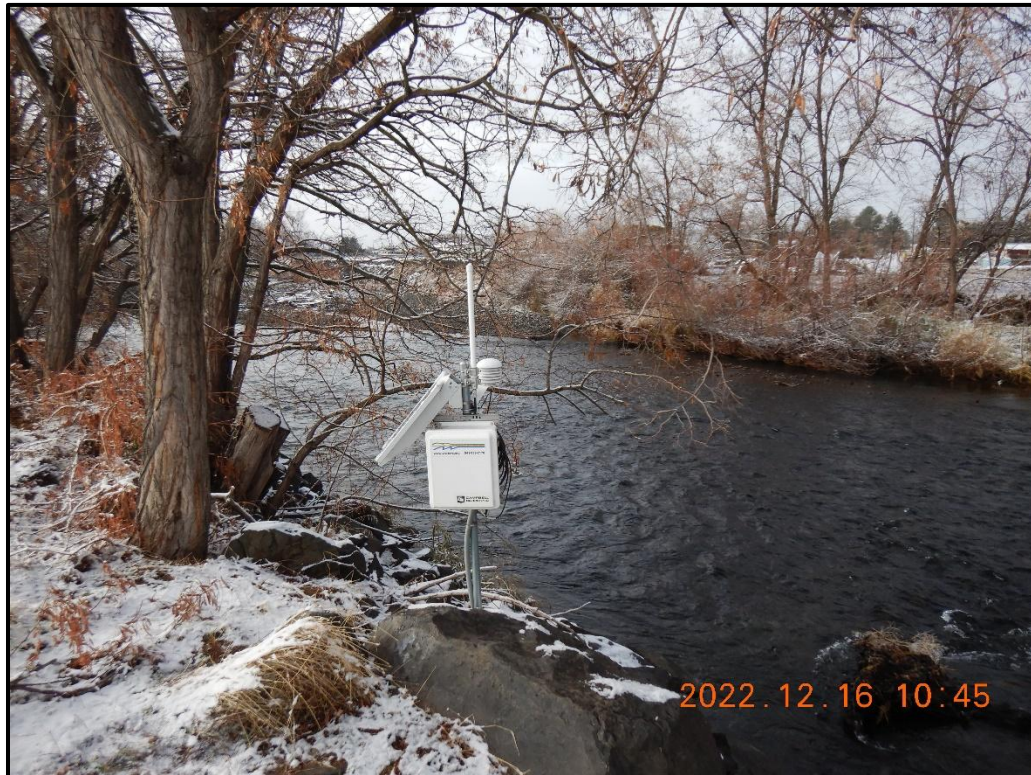
**Figure 5. At this near real-time monitoring site on the South Fork Walla Walla River (S-107), a cabled sensor secured to a boulder collects water level data. A communication cable transmits the information to a data logger and radio housed in the gauge box. Using radio telemetry, water level, and temperature data are sent to the WWBWC office to be processed and published online.**

Monitoring staff visited the near real-time sites every two weeks to measure stage and visually inspect equipment. Manual discharge measurements were taken approximately every six weeks using a SonTek FlowTracker Handheld Acoustic Doppler Velocimeter, OTT MF Pro flow meter Marsh-McBirney Flo-Mate 2000 flow meter, or Price AA current meter (Figure 6). Water temperature was measured using a calibrated NIST-traceable YSI 30 handheld meter ([www.ysi.com](http://www.ysi.com)).

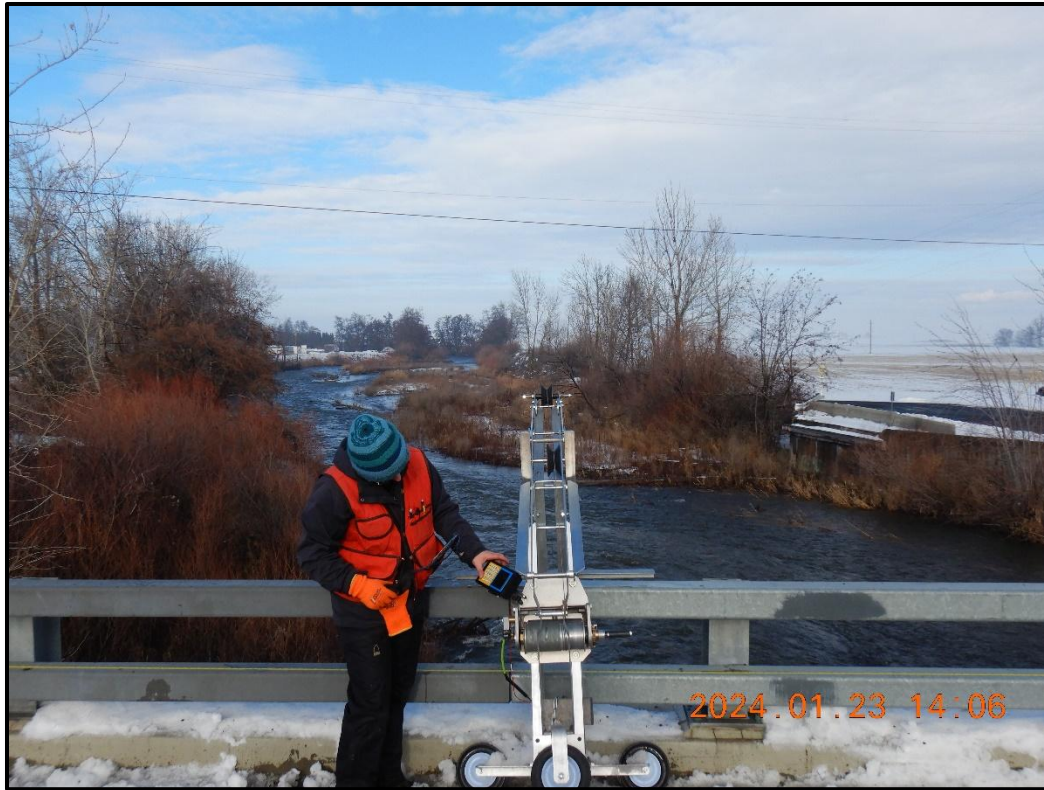
**Figure 6. Staff performing a high flow bridge measurement on Walla Walla River at Tum-A-Lum Bridge (S-107) using a Price AA current meter and AquaCalc Pro Plus.**

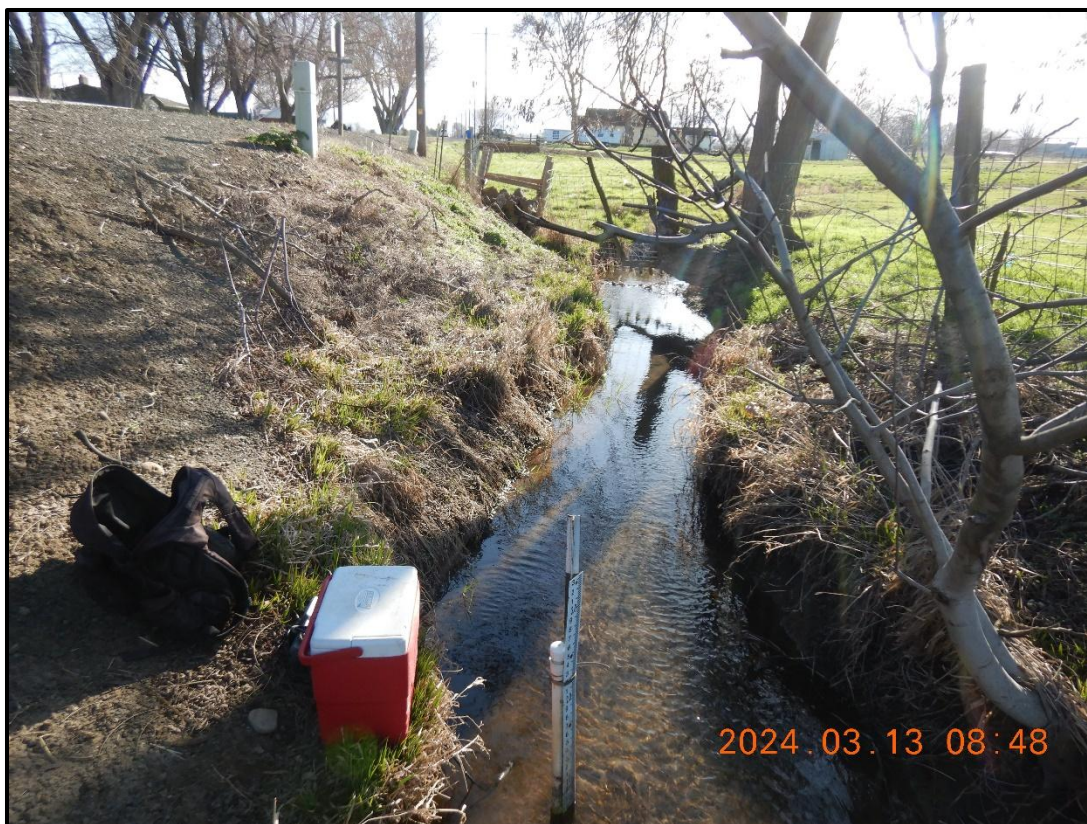
**Figure 7.** At this stand-alone monitoring site on the West Little Walla Walla River (S-222), a staff gauge and perforated PVC stilling well enclose a suspended pressure transducer. These are the typical components installed at stand-alone monitoring sites that were visited quarterly for manual data download.

Many of WWBWC's streamflow monitoring sites are stand-alone stations not equipped with telemetry capability. We visit these sites quarterly to take stage and discharge measurements and to download data. For the 2024 water year monitoring period, these sites were equipped with Solinst pressure transducers programmed to log water level and temperature measurements at a set interval (every 15 minutes). Figure 7 shows an example of data logger deployment in a perforated PVC stilling well anchored to a t-post in the off-center of the channel.

A monitoring technician visited each site every three months to read the staff gauge and take a manual discharge measurement. Also, during the quarterly visit, stage and water temperature data were downloaded from the logger, site maintenance was conducted (for example, weeds or other debris removed), the water temperature was measured, and photographs were taken.

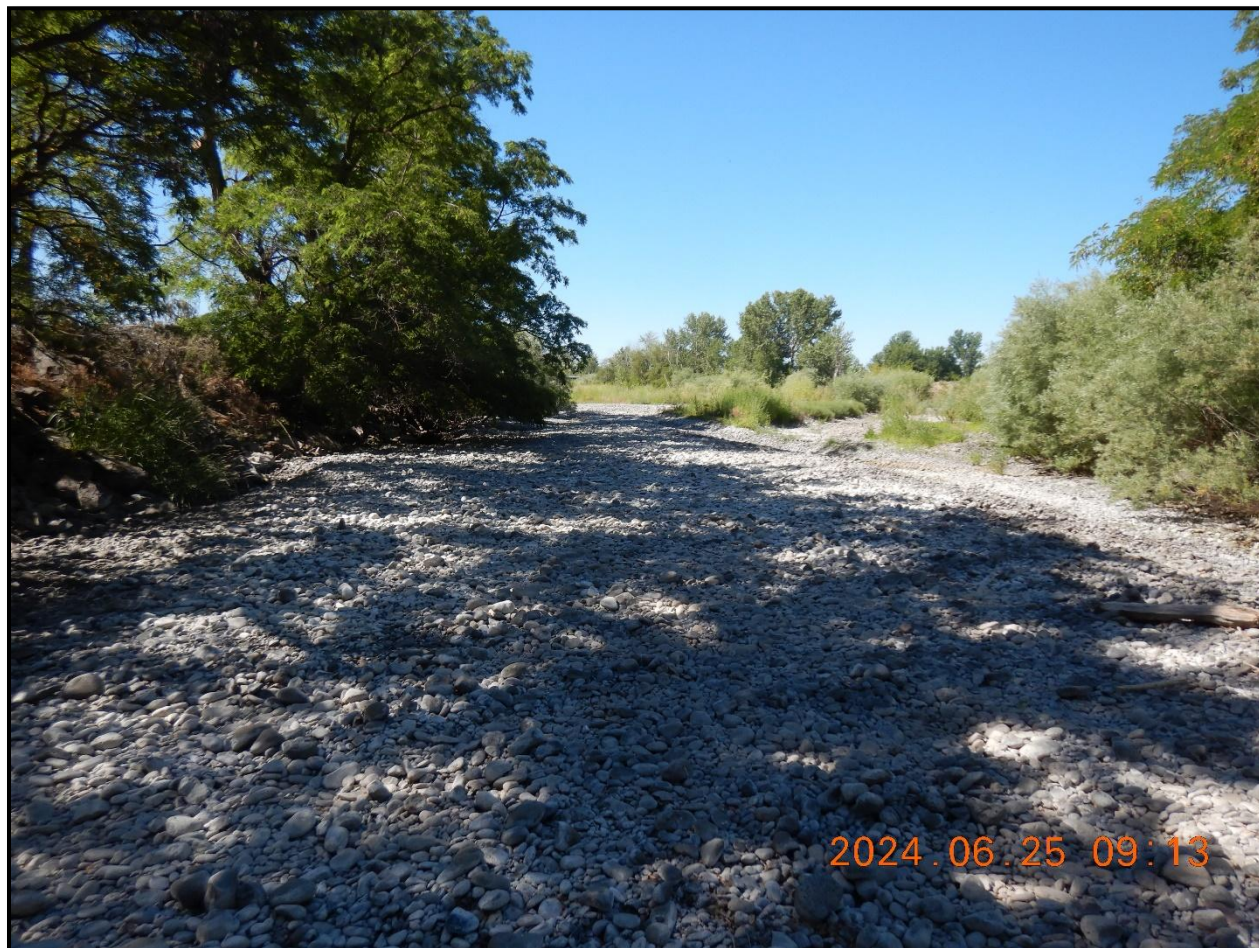
**Figure 19. Walla Walla River below Tum-A-Lum Bridge (S-107) during the dry period in Water Year 2024.**

About 2.4 miles downstream of Nursery Bridge, the Walla Walla River below Tum-A-Lum Bridge (S-107) had daily median base flows ranging from 14-37 cfs during August and September, with the lowest daily median flow of 0.0 cfs occurring on 06/22/2024 through 06/25/2024 (Figure 16). The four day dry period in the river was due to inaccuracy of the state's Nursery Bridge ghost gauge based on an overprediction of flow at the state's Milton-Freewater gauge and high seepage rates in the levee reach (Figure 18). The WWBWC contacted OWRD on 06/24/2024 to notify them the Walla Walla River was dry below Tum-A-Lum Bridge. By the next day, OWRD took manual discharge measurements to check the flow in the river before they made a regulatory action to divert less water into the Little Walla Walla, leaving more water in the mainstem.
