# **Water Year 2013**

## **Oregon Walla Walla Basin Aquifer Recharge Report**

# Oregon Walla Walla Basin Aquifer Recharge Report

Walla Walla Basin Watershed Council

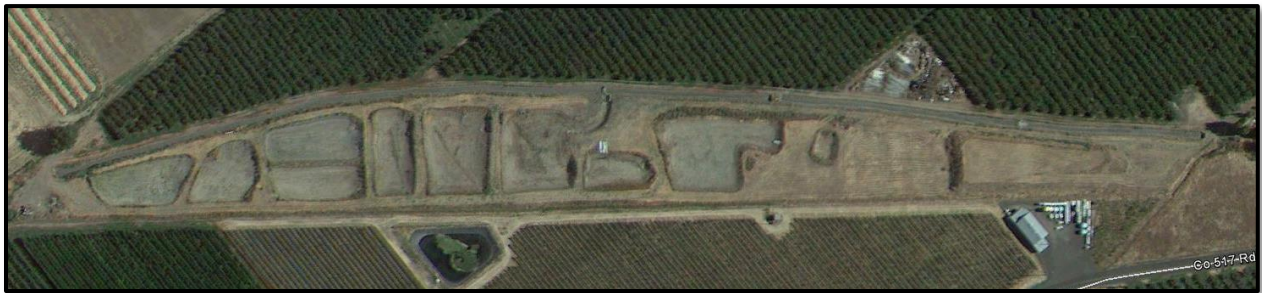
Figure 11 - Aerial photo of the Johnson site from 2013 showing the current configuration of the site with 10 spreading basins and 3 active infiltration galleries (between the spreading basins and the pile of fill).

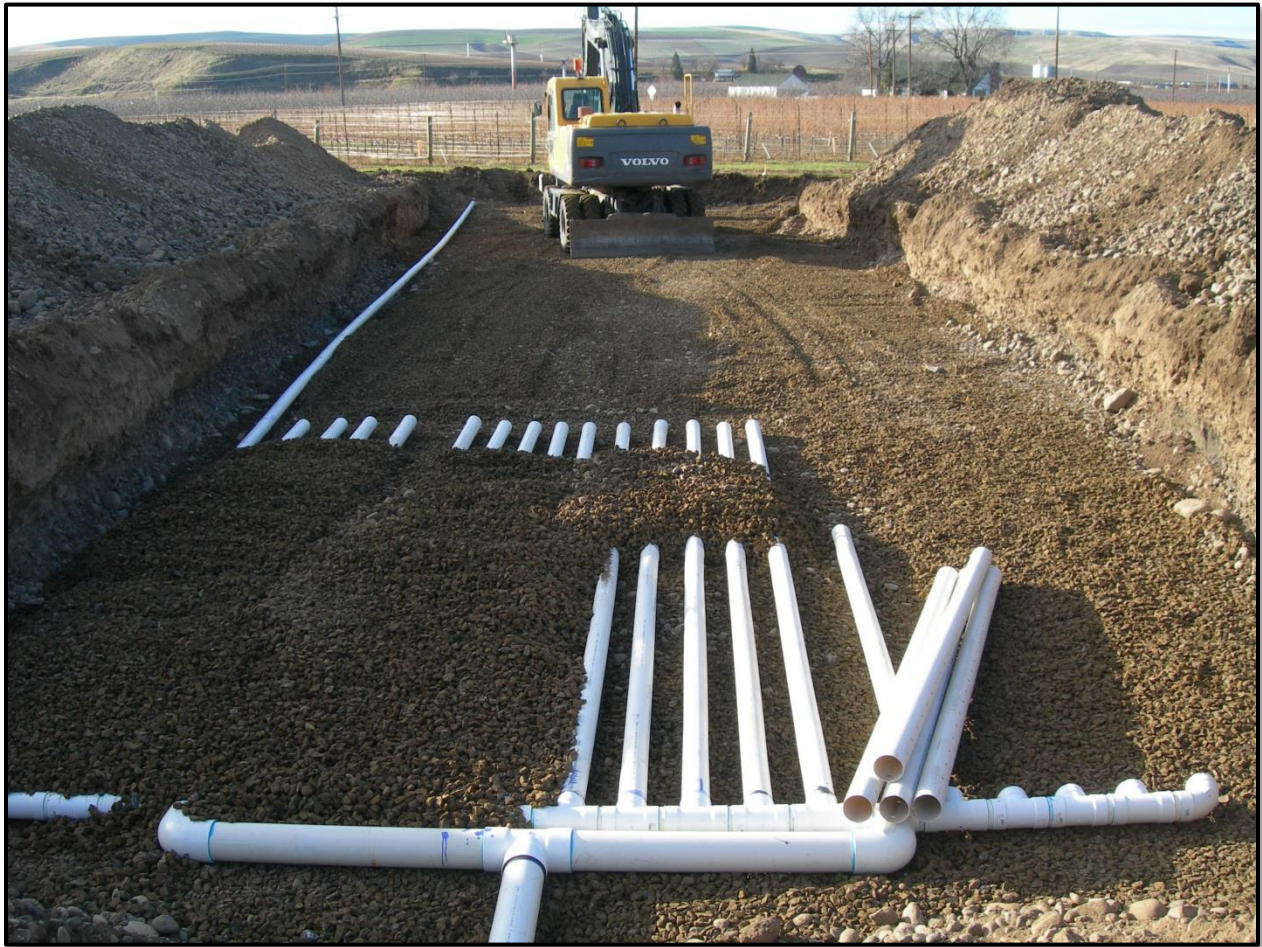
Figure 12 - Photograph of infiltration gallery #2 (IG2) being installed at the Johnson Aquifer Recharge site. IG2 is 4" perforated drain field pipe installed over washed gravel and buried in ~1 foot of washed gravel with geo-textile fabric on top of the gravel. See Appendix D for designs.

During Phase II, four infiltration galleries (IG) were installed at the Johnson site for testing purposes. IG #1 was constructed of corrugated 4" perforated pipe, IG #2 was constructed of 4" drain field pipe, IG #3 was 4" drain field pipe inside Stormtech stormwater chambers and IG #4 was drain field pipe inside Atlantis stormwater devices. During the first season of testing IG #1 clogged up and has not been utilized since. IG #2, IG #3 and IG #4 have all continued to function and have been operated during each recharge season. The four different infiltration gallery designs were installed to create a cost-benefit analysis of the different design types and to determine each design's longevity.

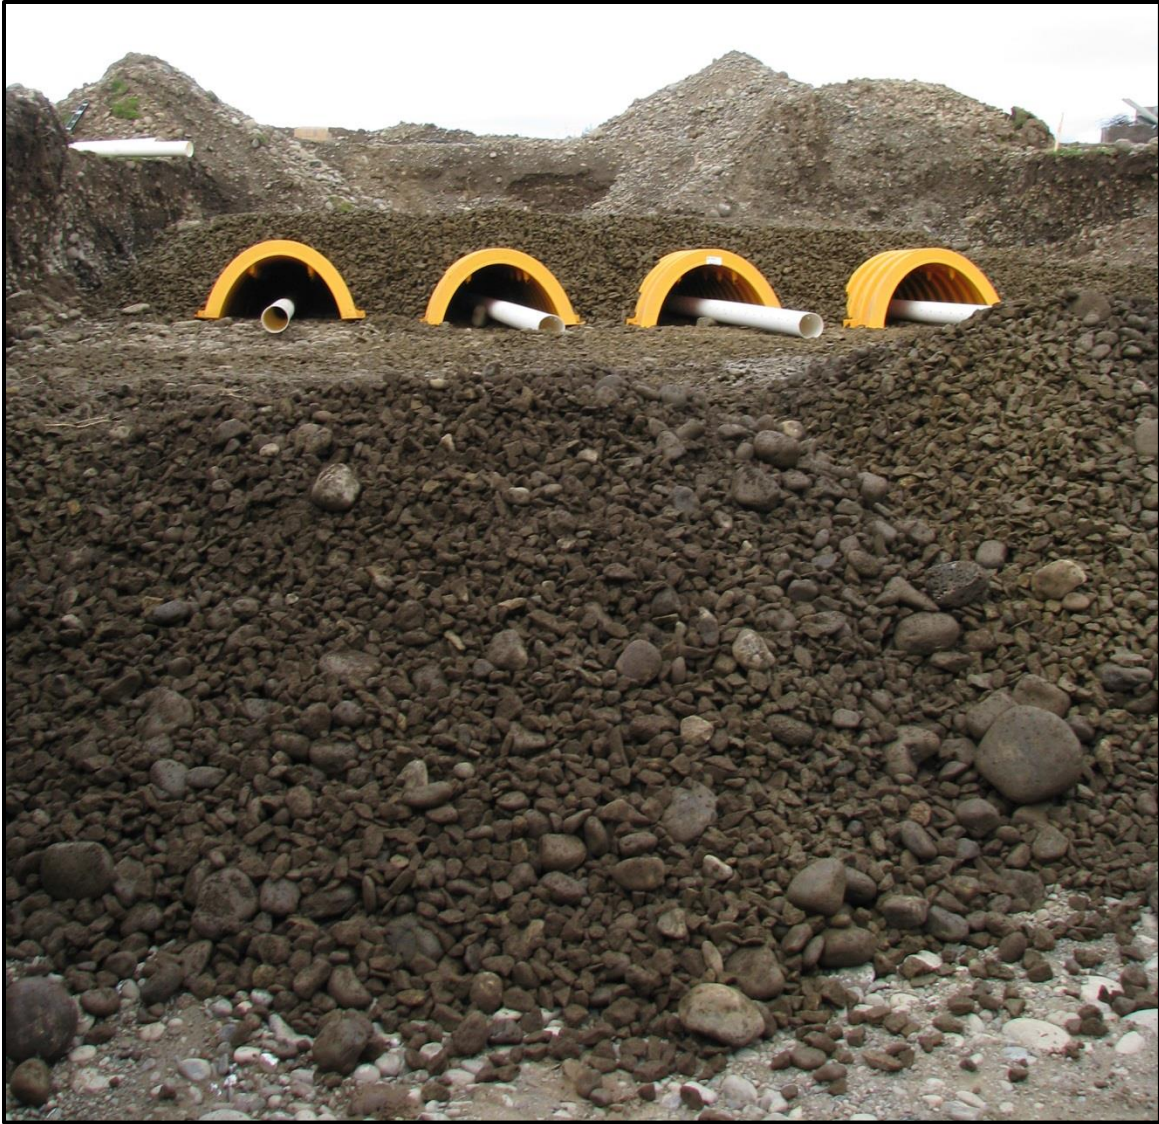
Figure 13 - Photograph of infiltration gallery #3 (IG3) at the Johnson Aquifer Recharge site. IG3 is 4" perforated drain field pipe installed within Stormtech stormwater chambers (yellow covers) over washed gravel and buried in ~2 foot of washed gravel with geo-textile fabric on top of the gravel. See Appendix D for designs.

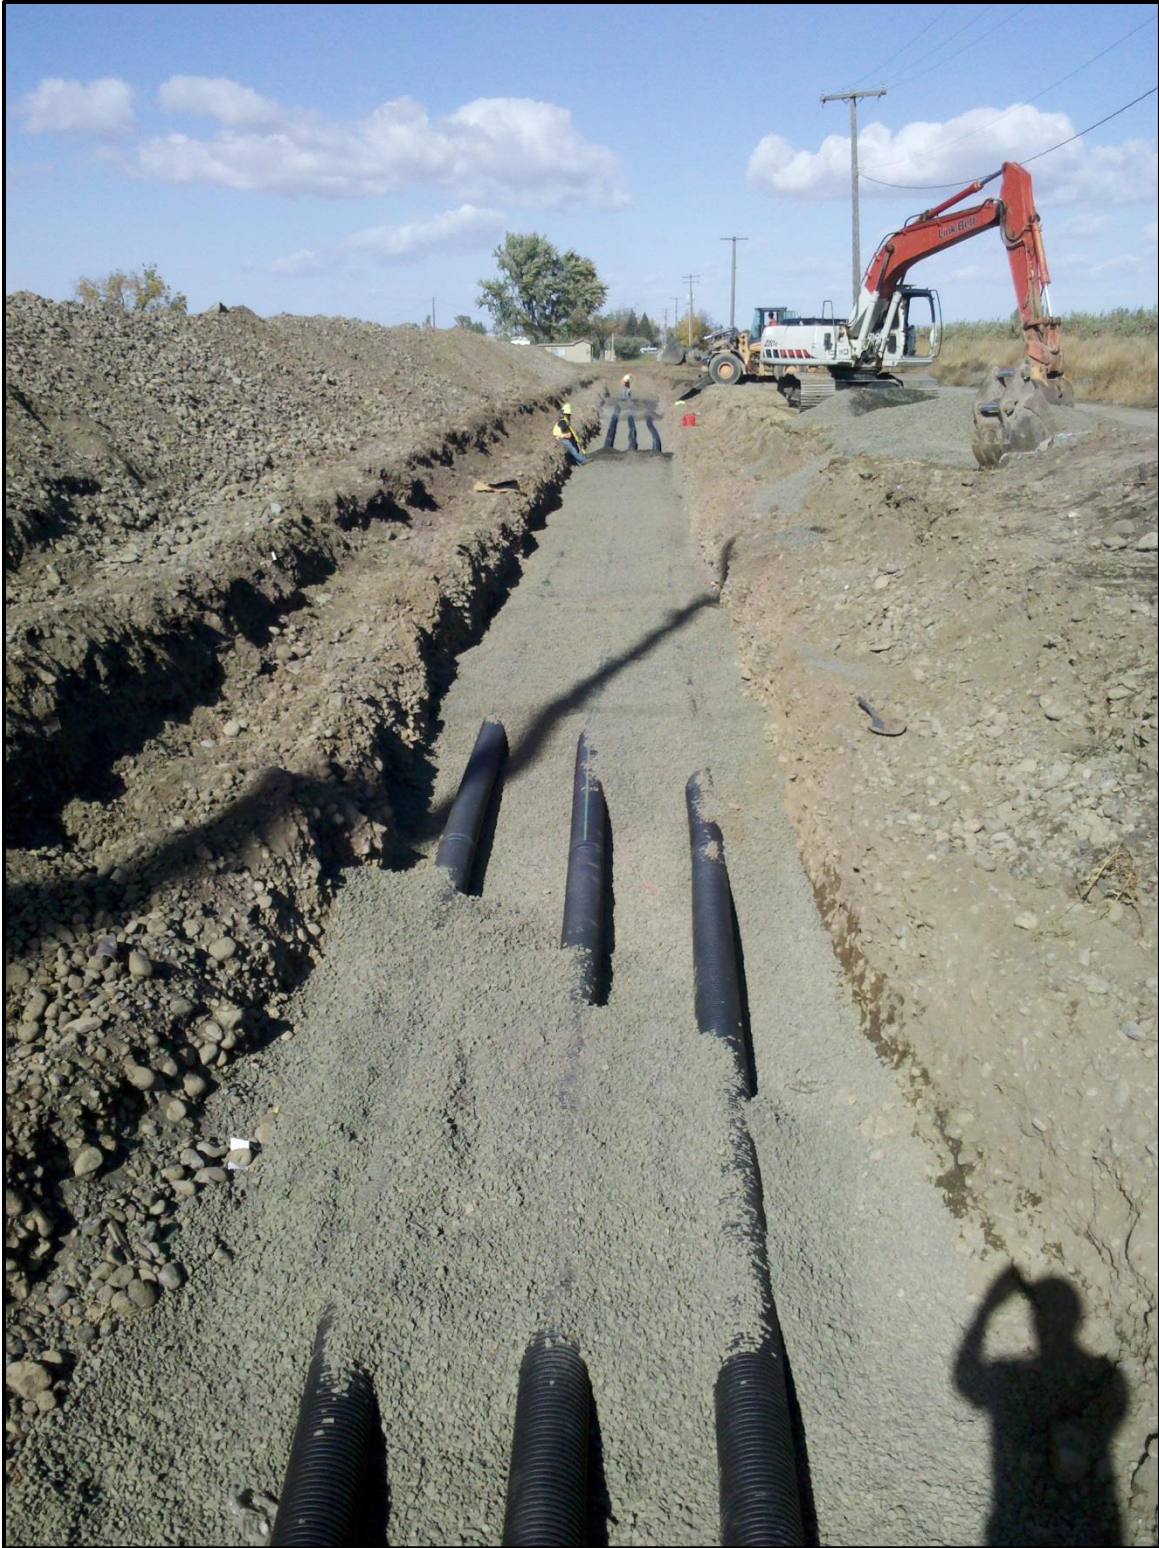
Figure 15 - The Trumbull Aquifer Recharge site under construction in October 2012. This recharge site utilizes 8" perforated pipes instead of the 4" pipes used at the Johnson site. The site is approximately 300 feet long with three 8" pipes running the entire length. See Appendix D for designs.

The Trumbull AR site (Trumbull site) was constructed in October 2012 using a combination of Bonneville Power Administration (BPA) and Oregon Watershed Enhancement Board (OWEB) funding. The site consists of three 8" perforated pipes extending approximately 300 feet each in length from the source water discharge and inline flow meter (Figure 15). These pipes are buried 6 feet under the ground with approximately 1-2 foot of cleaned gravel under them and approximately 0.5-1 feet of cleaned gravel on top of them (See Appendix D for complete designs). Recharge water is delivered down the HBDIC system. The Trumbull site's water source is at the structure that splits the HBDIC canal into the Hyline pipeline and the Richardz ditch. The site has its own turnout and valve so it can operate independent of the ditch or pipeline. The site was designed to operate at a recharge rate of between 2 to 3 cfs. The site was operated for a short duration during the end of the 2012-2013 recharge season at an average rate of slightly more than 2 cfs.

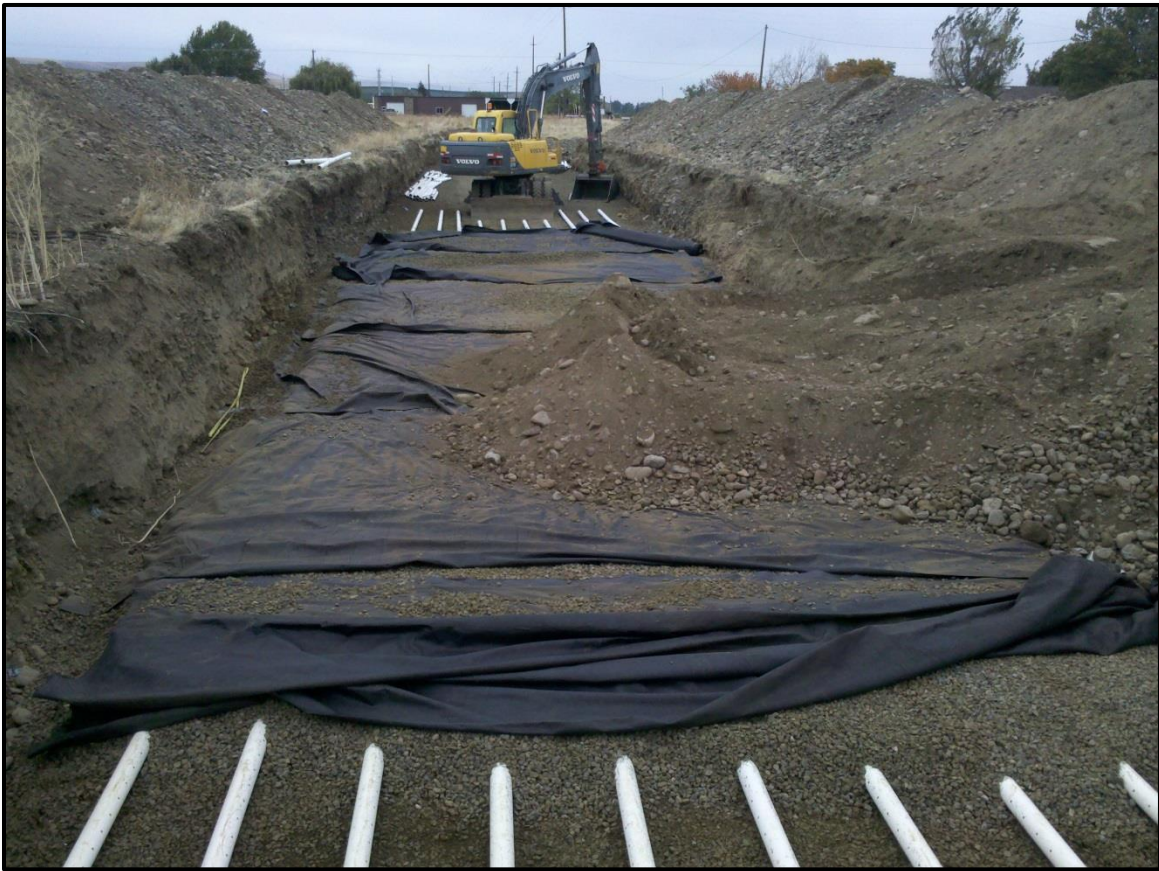
Figure 16 - The Anspach Aquifer Recharge site during construction in October 2012. This recharge site utilizes 10 4" perforated pipes that run approximately 200 feet. See Appendix D for designs.

The Anspach AR site (Anspach site) was constructed in October 2012 using a combination of BPA and OWEB funding. The site consists of 10 4" perforated drain field pipes extending approximately 200 feet each from the source water manifold (Figure 16). These pipes are buried 6 to 7 feet under the ground with approximately 1 to 2 foot of cleaned gravel under them and approximately 0.5 to 1 feet of cleaned gravel on top of them (See Appendix D for complete designs). Water for this site is delivered down the HBDIC's White Ditch and then turned into a private pipeline/ditch. The Anspach site's turnout and valve are situated along this private ditch (Figure 17). The site was designed to operate at a recharge rate of approximately 1 cfs. The site was operated for a short duration during WY2012 near the end of water availability and approximately 0.50 cfs of recharge was applied. The lower than expected recharge rate was due to limitations in the delivery capacity of the private ditch to convey more water. In addition, the recharge site is located below other users on the private ditch/pipeline and is thus influenced by their usage.

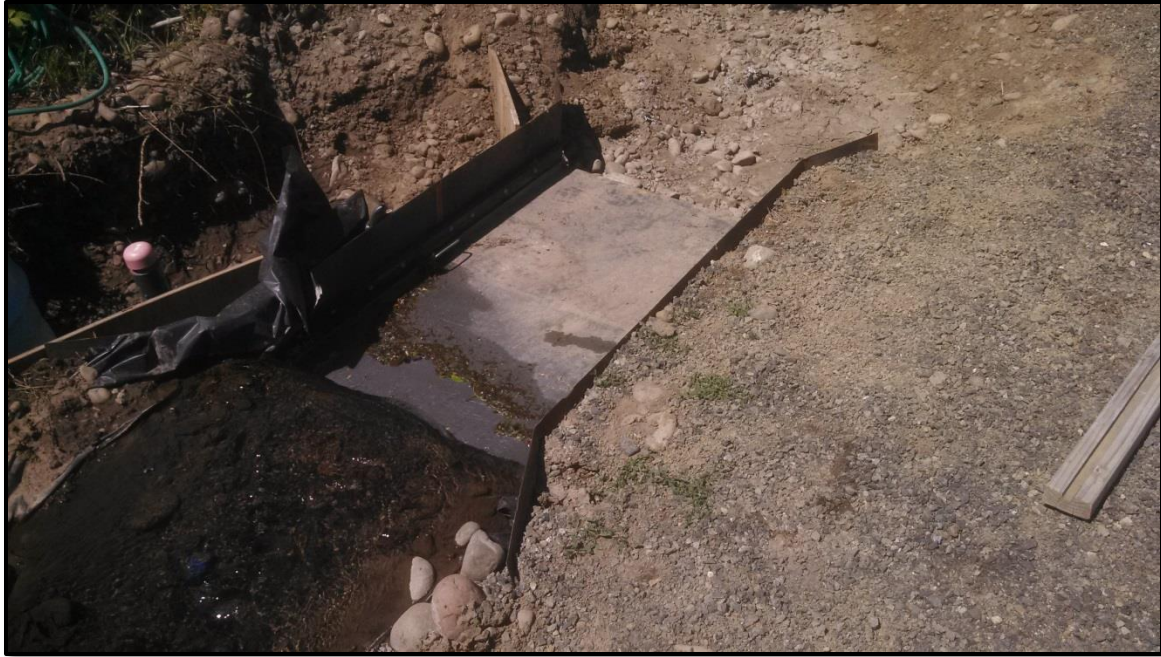
Figure 17 - The turnout structure for the Anspach Aquifer Recharge site. The structure was built by Custom Technology Co. Inc. based in Yakima, WA. The 8" pipe emerges from a flange on the far side of the structure after the water has passed through a 0.062" perforated punch screen. The screen is removable for cleaning purposes. See Appendix D for designs.

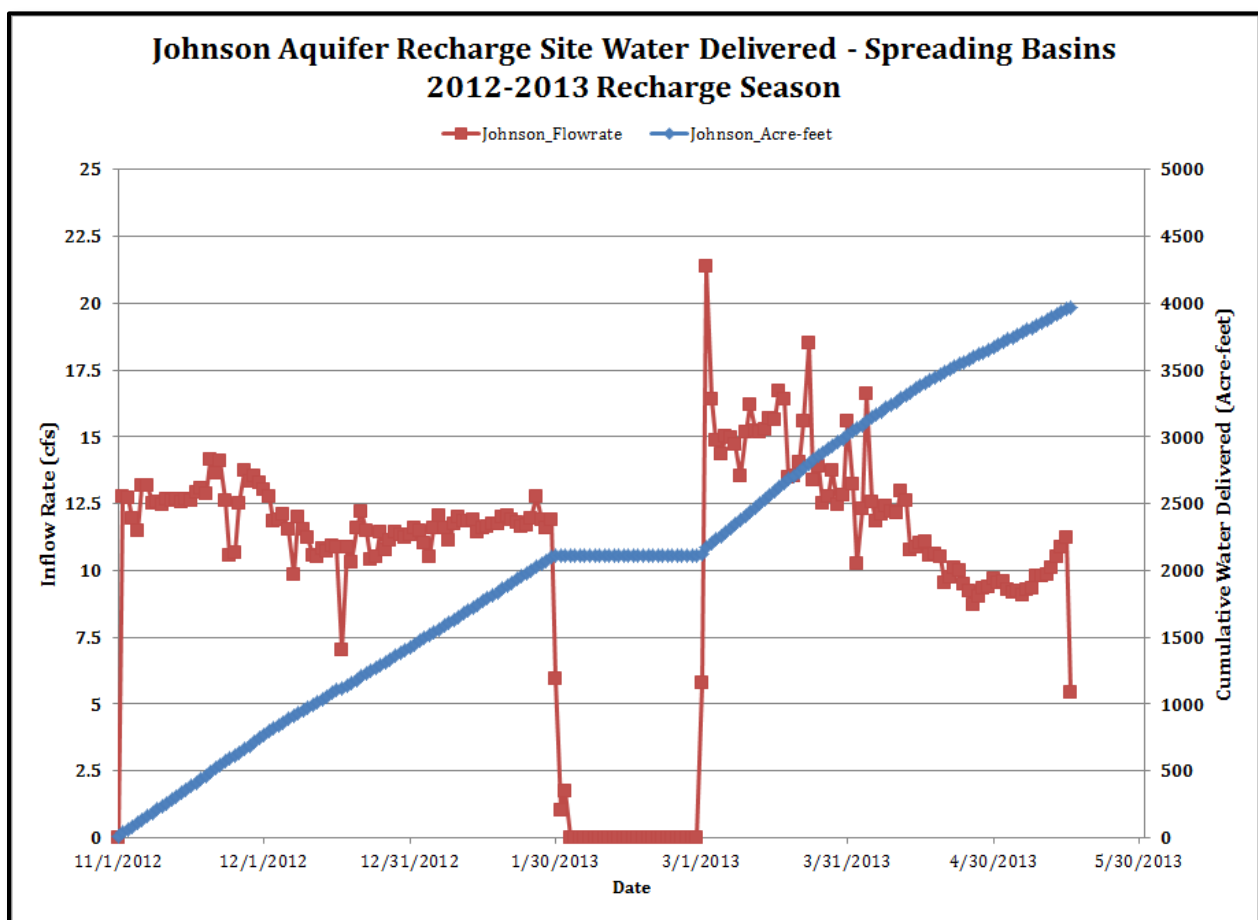
Figure 18 - Hydrograph for the Johnson site showing inflow rates and cumulative water delivered to the site's spreading basins.

The Johnson site had its best year for recharge since it was constructed in 2004. The Johnson site ran for 168 days during the WY 2013 recharge season. The site started receiving recharge on November 1<sup>st</sup>, 2012 and continued to receive recharge until February 1<sup>st</sup>, 2013 when the Little Walla Walla Diversion was shut down for yearly maintenance on the fish screens. Recharge operations resumed on March 1<sup>st</sup>, 2013 and terminated May 15<sup>th</sup>, 2013, as required by LL-1433. The Johnson site received a total of 4,555.5 acre-feet for recharge in total at an average rate of 27 acre-feet per day (Figures 18-20). The total calculated volume includes the 10 spreading basins (3,972.1 acre-feet) and the 2 active infiltration galleries (583.4 acre-feet).

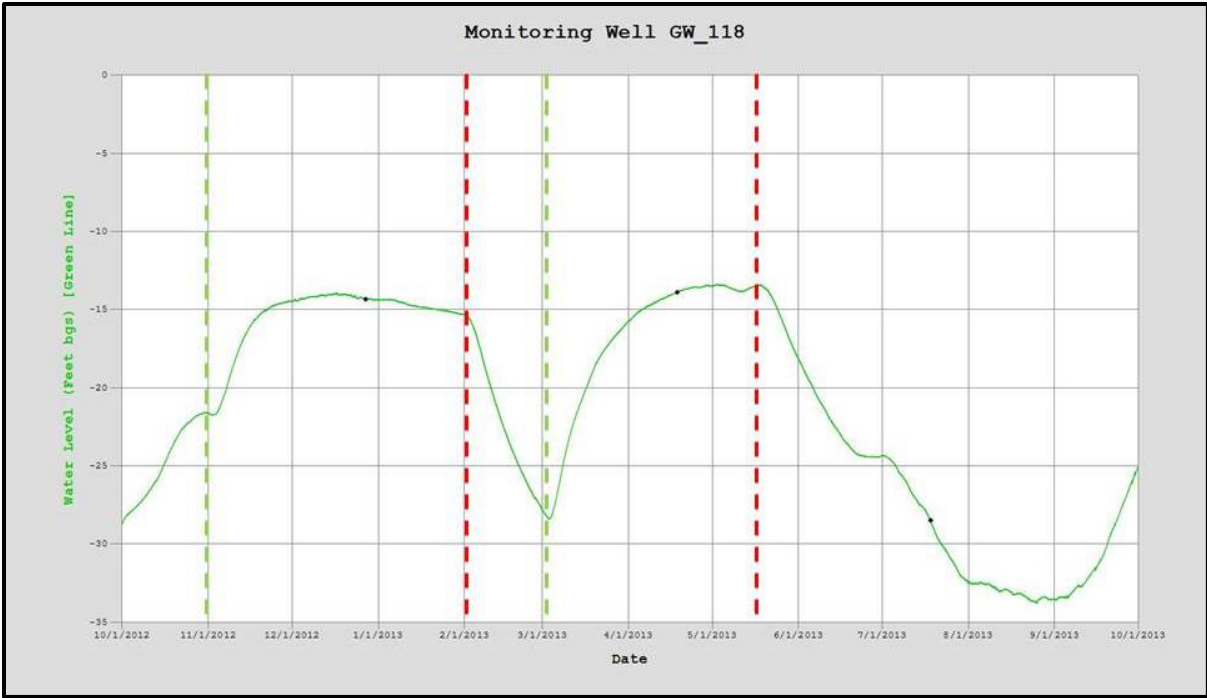
Figure 28 - Hydrograph for monitoring well GW\_118. Green dotted lines indicate start of recharge operations and red dotted lines indicate end of recharge operations.

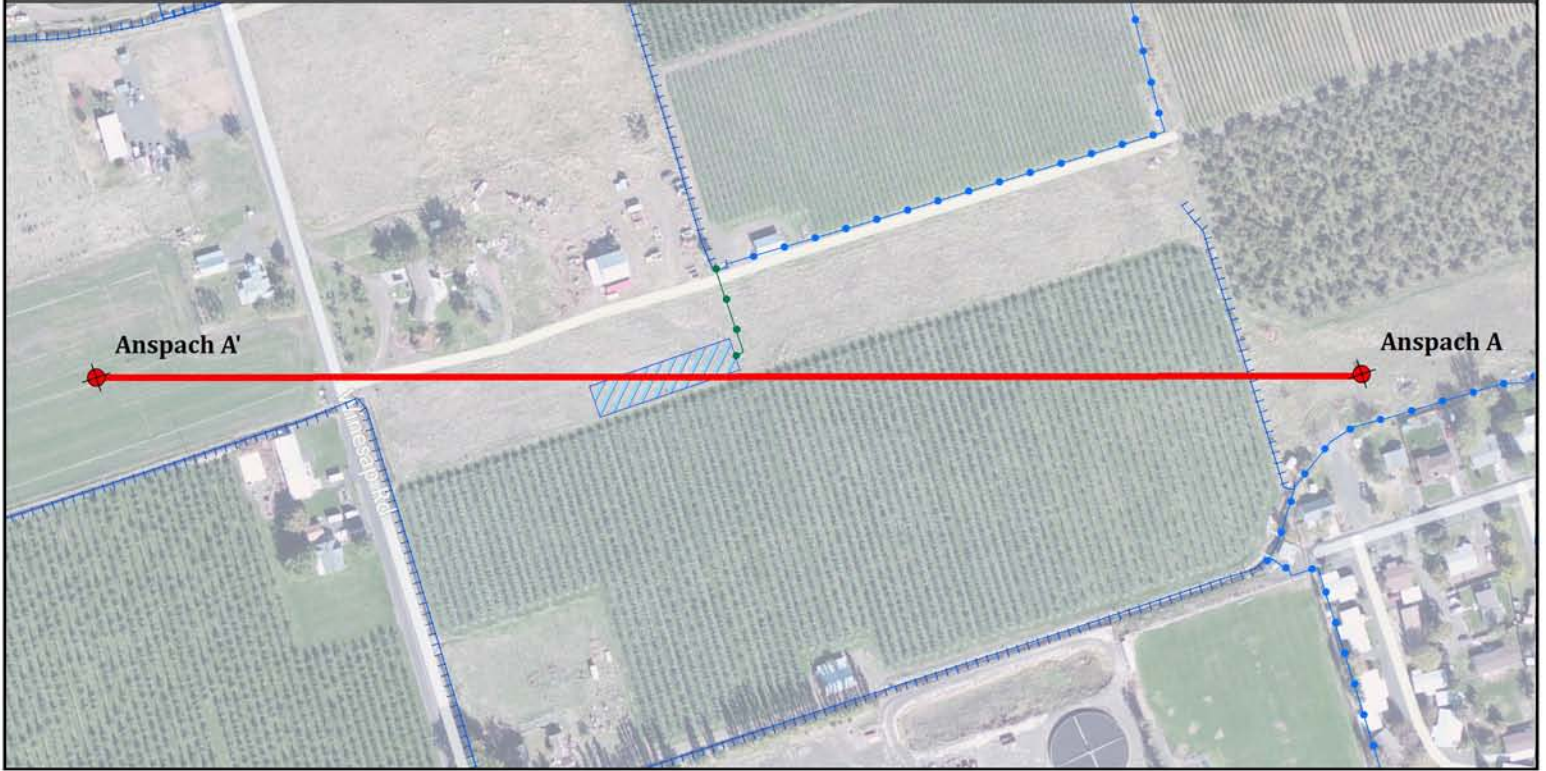
# Figure 13. Anspach Recharge Project

Anspach A'

## Geologic Cross Section

Figure 13 provides a geologic cross-section of the Anspach site. Geologic units present at the Anspach site are as follows:

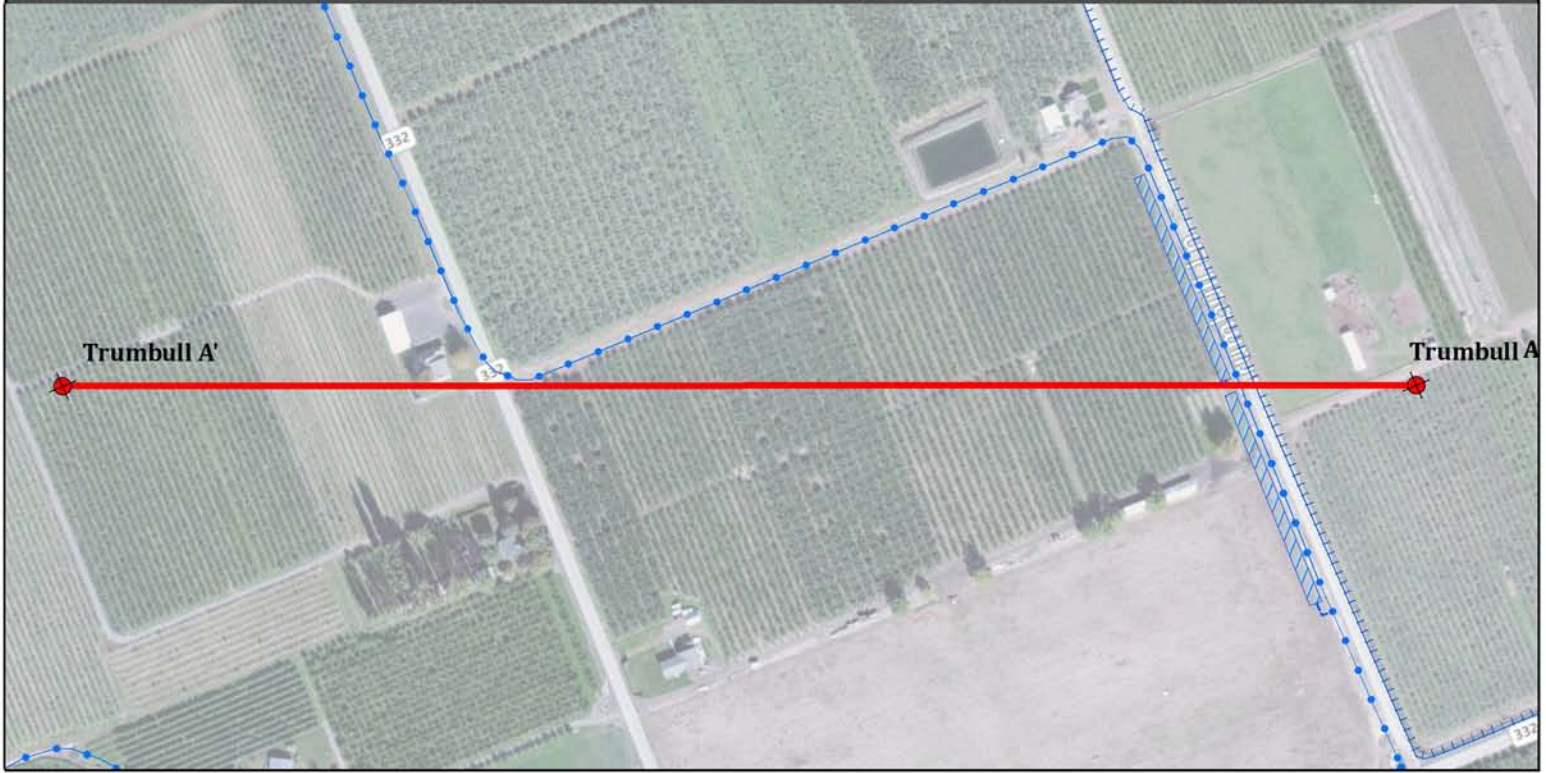
# Figure 14. Trumbull Recharge Project

Trumbull A'

## Geologic Cross Section

Figure 14 provides a geologic cross-section of the Trumbull site. Note, the specific location of the infiltration gallery currently envisioned for this site has yet to be determined. Geologic units present in the vicinity of the Trumbull site are as follows:

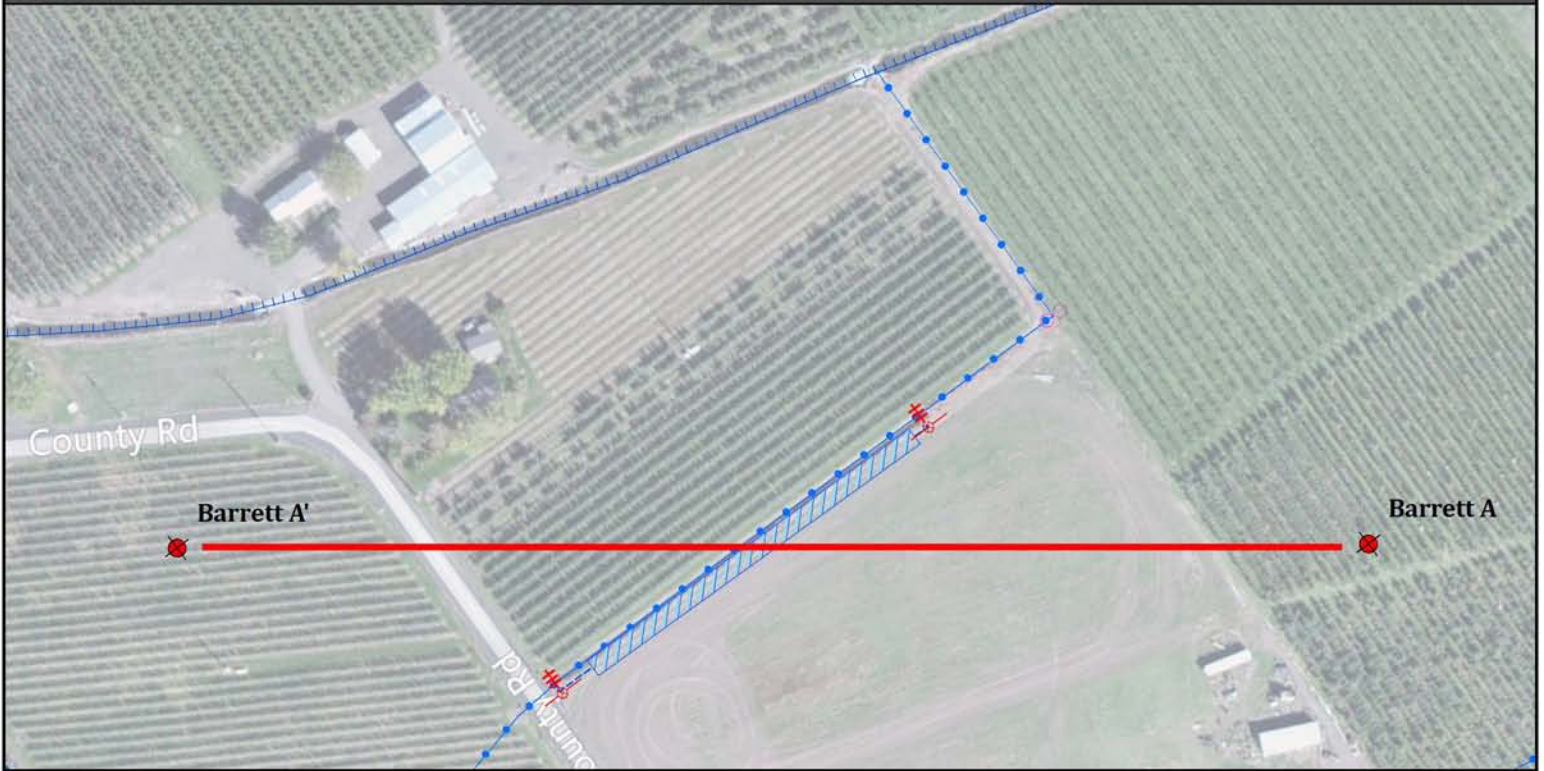
# Figure 16. Barrett Recharge Project

Barrett A'

## Geologic Cross Section

Figure 16 provides a geologic cross-section of the Barrett site. Geologic units present in the vicinity of the site are as follows:

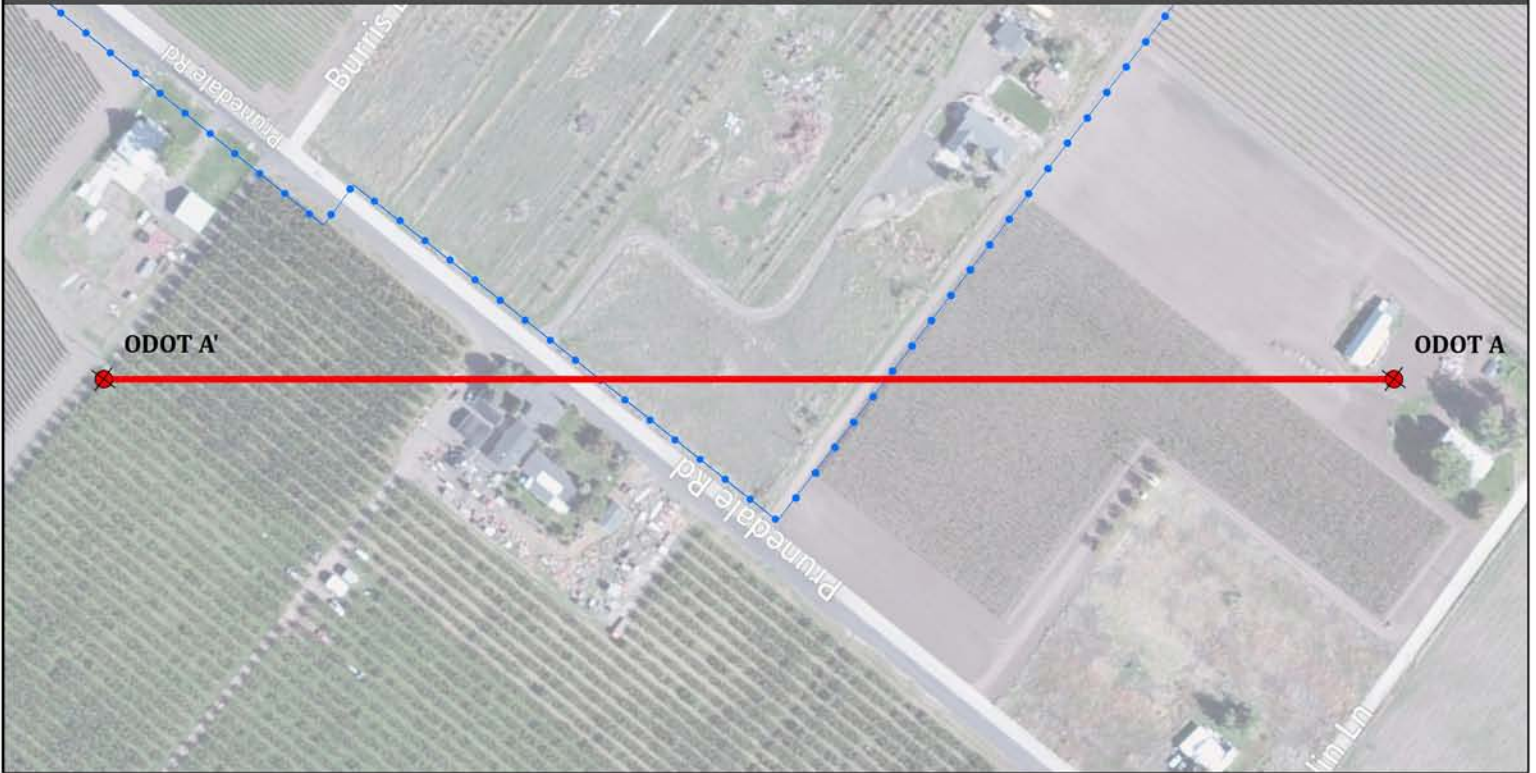
# Figure 18. ODOT Recharge Project

## Geologic Cross Section

Figure 18 provides a geologic cross-section of the ODOT site. Geologic units present in the vicinity of the site are as follows:
