Water Year 2014

Oregon Walla Walla Basin Aquifer Recharge Report

Water Year 2014
Oregon Walla Walla Basin Aquifer Recharge Report

Walla Walla Basin Watershed Council

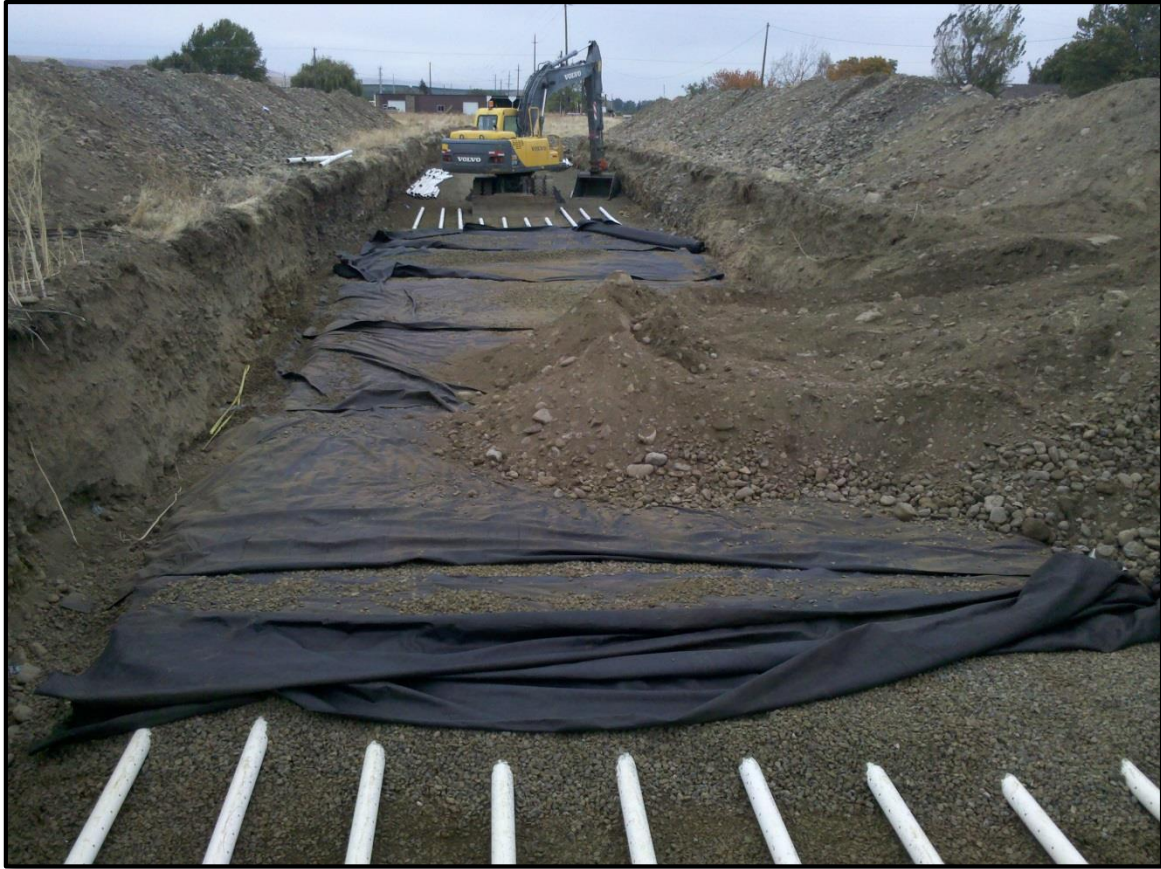
Figure 10 - The Anspach Aquifer Recharge site during construction in October 2012. This recharge site utilizes 10 4-inch perforated pipes that run approximately 200 feet. See Appendix C for designs.

The Anspach AR site (Anspach site) was constructed in October 2012 using a combination of Bonneville Power Administration (BPA) and Oregon Watershed Enhancement Board (OWEB) funding. The site consists of a turnout structure built by Custom Technology Co. Inc. based in Yakima, WA. An 8-inch pipe emerges from a flange on the side of the turnout structure after the water has passed through a 0.062-inch perforated punch screen. The screen is removable for cleaning purposes. The pipe then manifolds into 10 4-inch diameter perforated drain field pipes buried 6 to 7 feet below ground surface (bgs) and extending approximately 200 feet from the source water manifold (Figure 10). The perforated pipes sit on top of approximately 1 to 2 feet of cleaned gravel and are overlaid with approximately 0.5 to 1 foot of cleaned gravel (See Appendix C for designs). Water for this site is delivered down the HBDIC's White Ditch and then turned into a private pipeline/ditch. The Anspach site's turnout and valve are situated along this private ditch (Figure 11). The site was designed to operate at a recharge rate of approximately 1 cfs. During the WY2014 recharge season, the site was operating at 0.50-0.75 cfs. The lower than expected recharge rate was due to limitations in the water delivery capacity of the private ditch to convey more water. In addition, the recharge site is located below other users on the private ditch/pipeline and was influenced by their water usage.

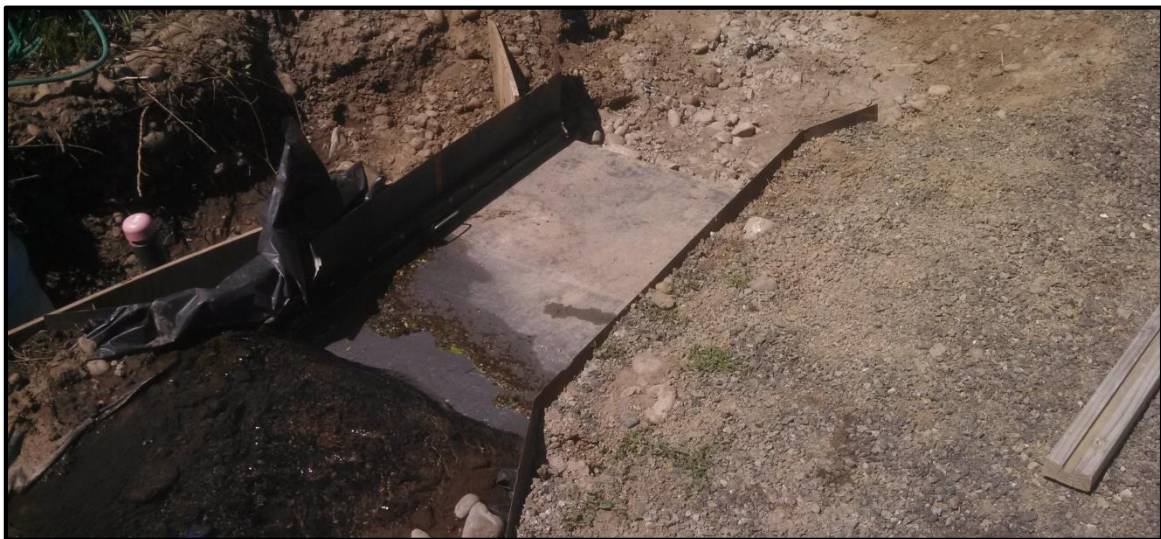
Figure 11 - The turnout structure for the Anspach Aquifer Recharge site.

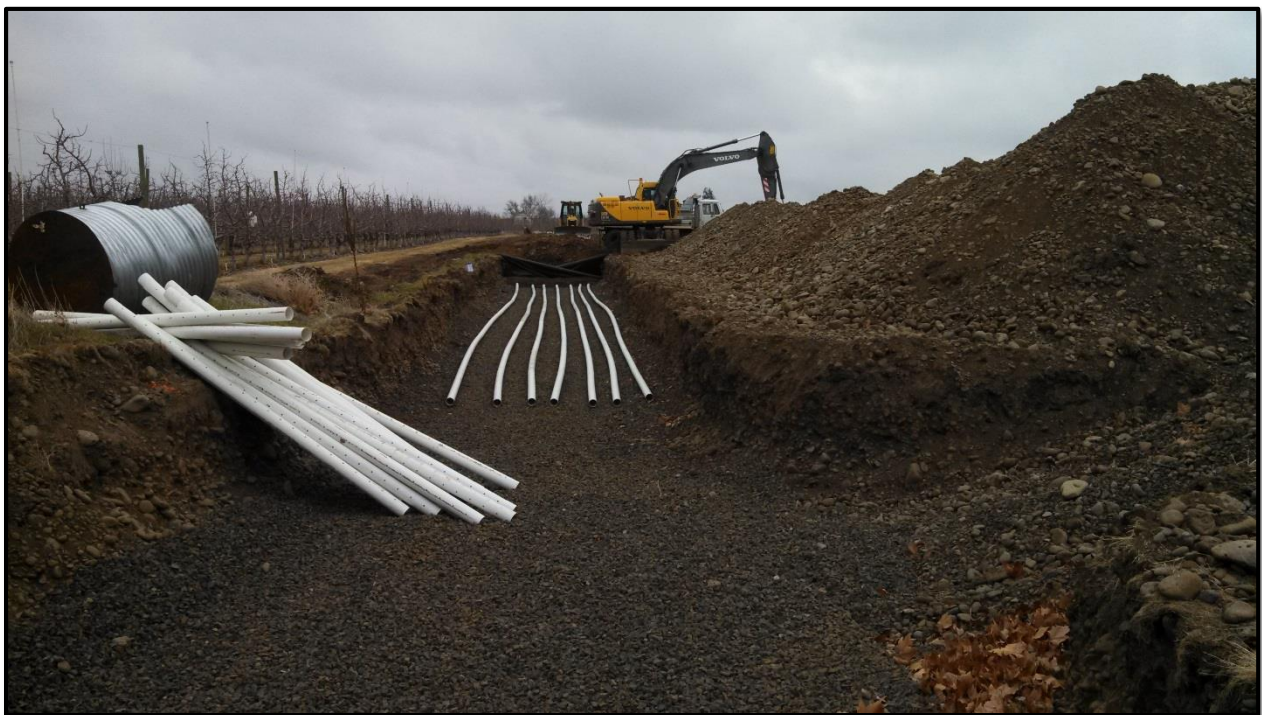
Figure 12 - The Barrett Aquifer Recharge site during construction in January 2014. This recharge site utilizes 7 4-inch perforated pipes that run approximately 600 feet. See Appendix C for designs.

The Barrett AR site (Barrett site) was constructed in the winter of 2014 using OWEB funding. The site consists of 7 4-inch perforated drain field pipes buried 4 to 5 feet deep and extending approximately 600 feet from the source water manifold (Figure 12). The perforated pipes sit on top of approximately 1 to 2 feet of cleaned gravel under them and are overlaid with approximately 0.5 to 1 foot of cleaned gravel (See Appendix C for designs). Water for this site is delivered down the HBDIC's White Ditch and then turned into the Barrett pipeline. The Barrett site's turnout and valve are situated along the pipeline (Figure 13). The site was designed to operate at a recharge rate of approximately 2-3 cfs. During the WY2014 recharge season, the site was operating at 2-4 cfs. The greater than expected recharge rate was likely due to head pressure in the pipeline, the sediments being more hydraulically conductive than anticipated and large depth to groundwater.

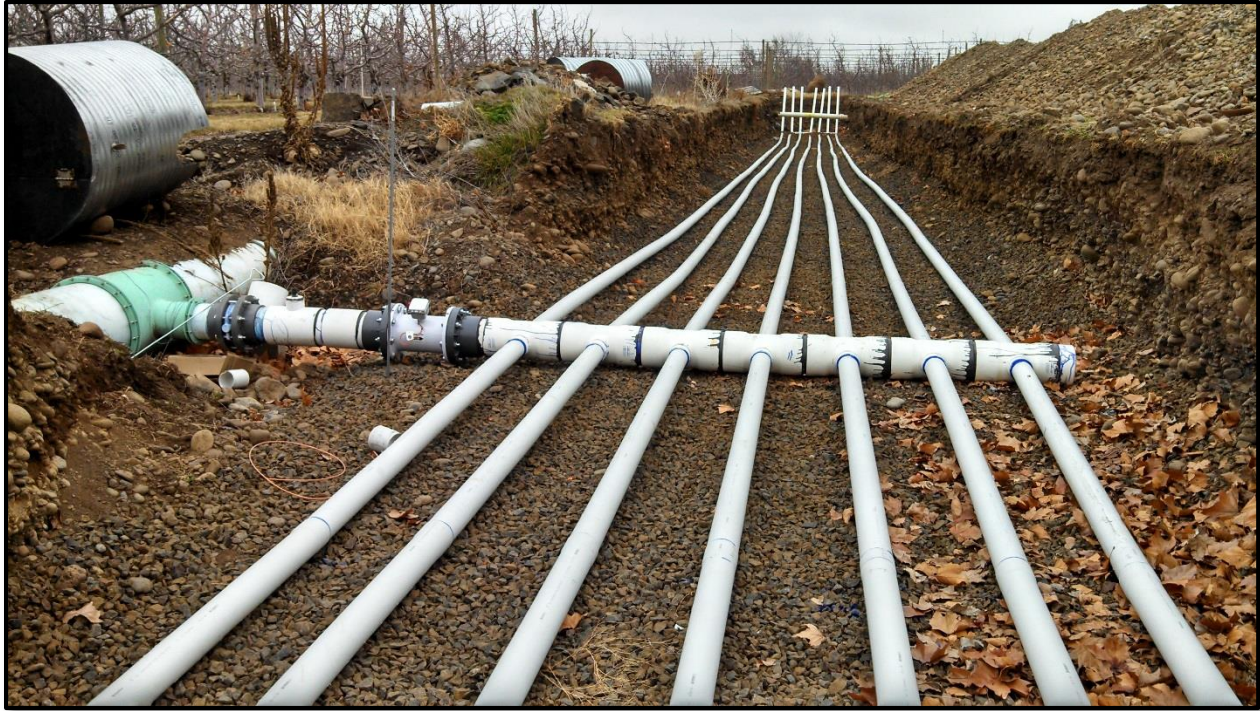
Figure 13 - Turn out structure, flow meter, valve and pipe manifold for the Barrett Aquifer Recharge site. See Appendix C for design details.

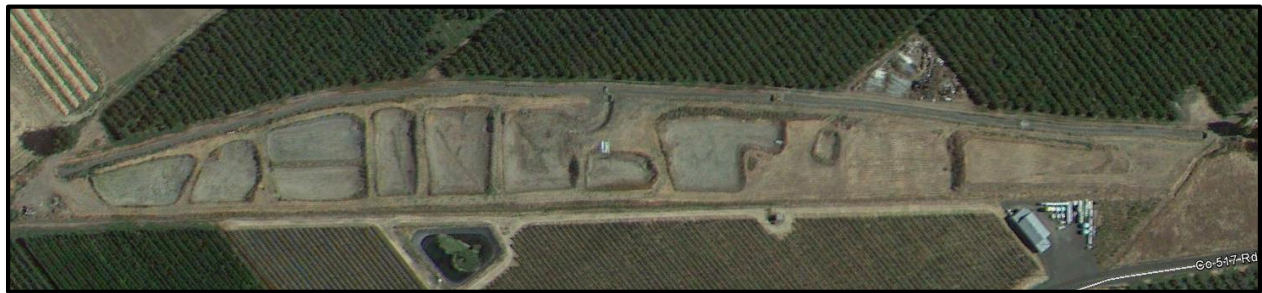
Figure 15 - Aerial photo of the Johnson site from 2013 showing the current configuration of the site with 10 spreading basins and 3 active infiltration galleries (between the spreading basins and the pile of fill material).

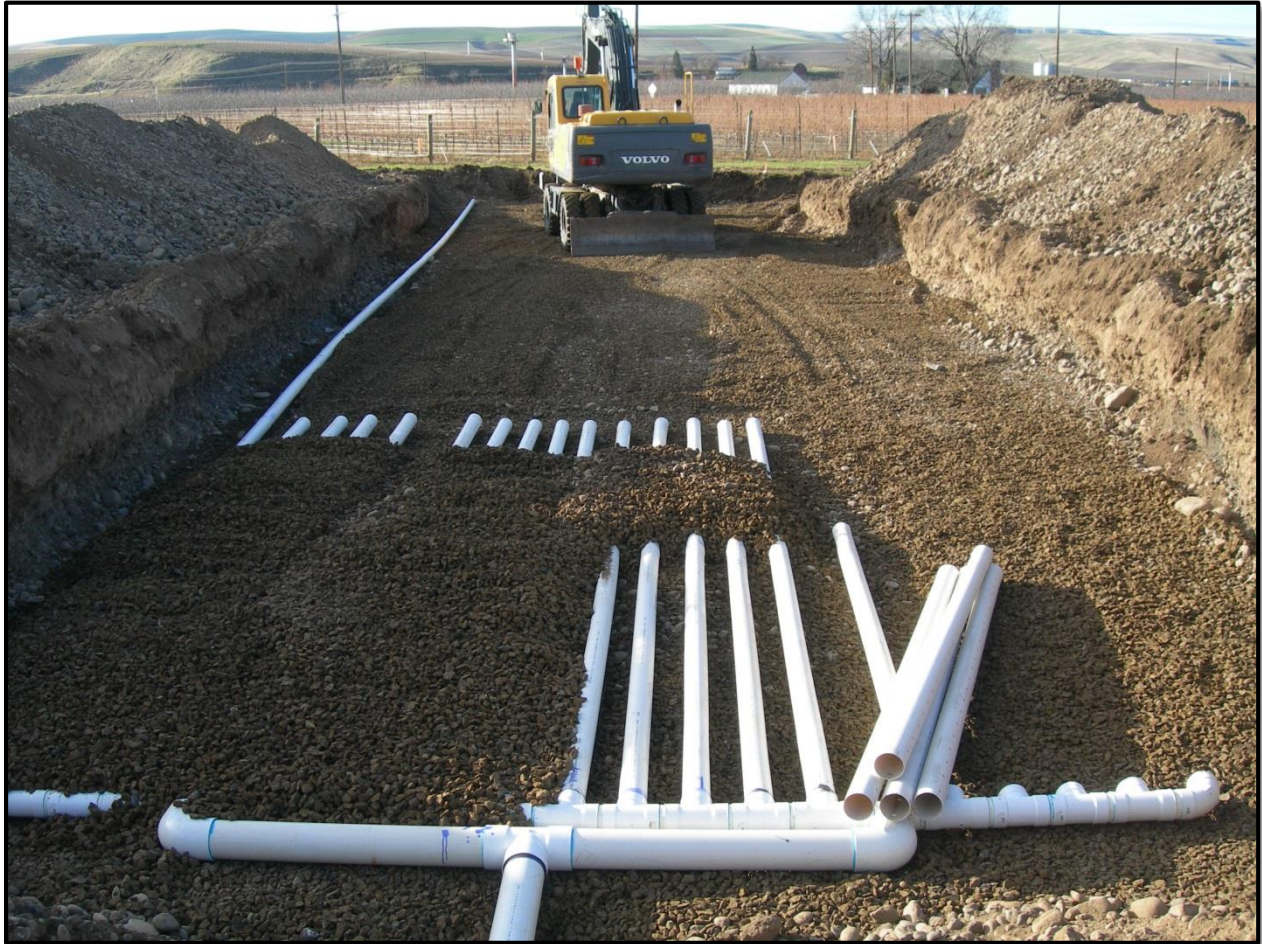
Figure 16 - Photograph of infiltration gallery #2 (IG2) being installed at the Johnson Aquifer Recharge site. IG2 is 4-inch perforated drain field pipe installed over washed gravel and buried in ~1 foot of washed gravel with geo-textile fabric on top of the gravel. See Appendix C for designs.

During Phase II, four different infiltration gallery (IG) designs were installed at the Johnson site to evaluate each design's performance, longevity, and cost-benefit. IG #1 was constructed of 4 corrugated 4-inch perforated pipe, IG #2 was constructed of 20 4-inch drain field pipe, IG #3 was 4 4-inch drain field pipe inside Stormtech stormwater chambers and IG #4 was a single 4-inch drain field pipe inside Atlantis stormwater devices (Figures 16-18). During the first season of testing IG

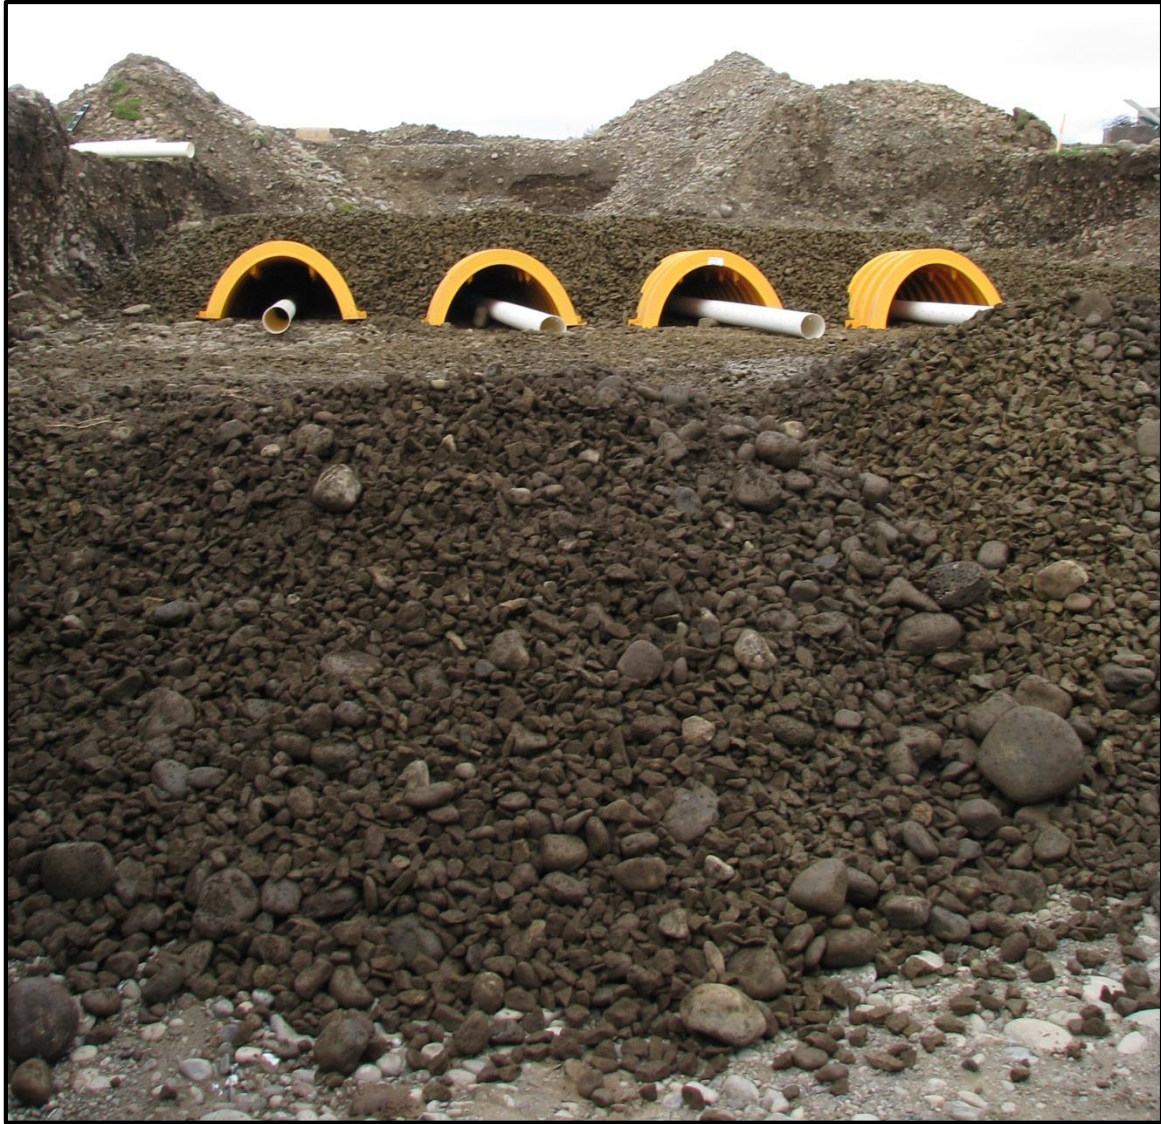
Figure 17 - Photograph of infiltration gallery #3 (IG3) at the Johnson Aquifer Recharge site. IG3 is 4-inch perforated drain field pipe installed within Stormtech stormwater chambers (yellow covers) over washed gravel and buried in ~2 foot of washed gravel with geo-textile fabric on top of the gravel. See Appendix C for designs.

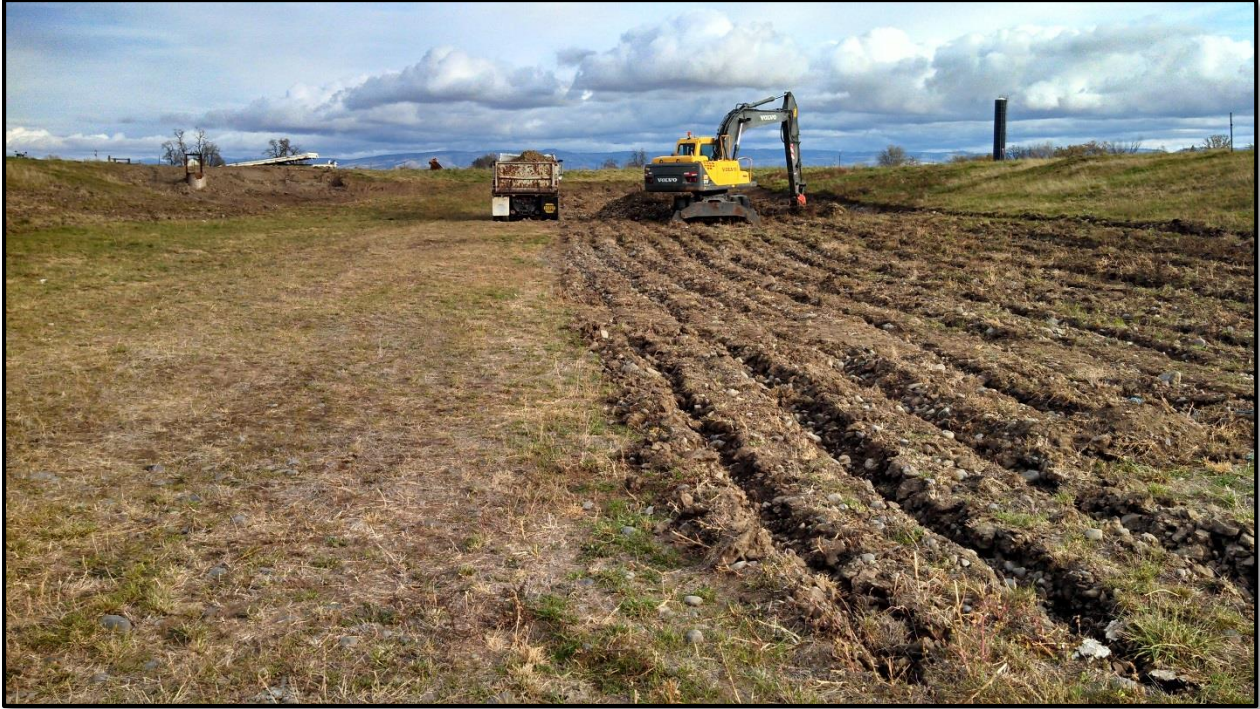
Figure 19 - NW Umapine Aquifer Recharge site during excavation and shaping of the infiltration basin. See Appendix C for design details.

The NW Umapine AR site (NW Umapine site) was constructed in the fall of 2013 using OWEB funding. The site consists of a single infiltration basin approximately 100 ft x 200 ft (Figures 19 and 20). The site is supplied by a new approximately 1,000-ft long lateral pipeline installed off of HBDIC's Richartz's pipeline. The site was designed to operate at a recharge rate of 2-3 cfs. During the WY2014 recharge season the site averaged 2-2.5 cfs.

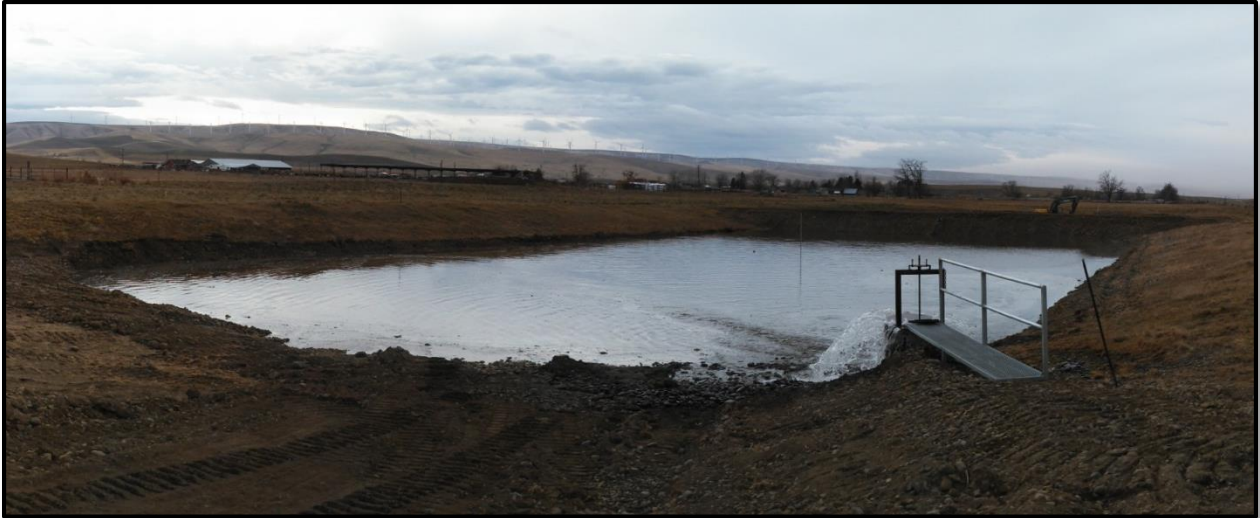
Figure 20 - NW Umapine Aquifer Recharge site operating during the WY2014 recharge season.

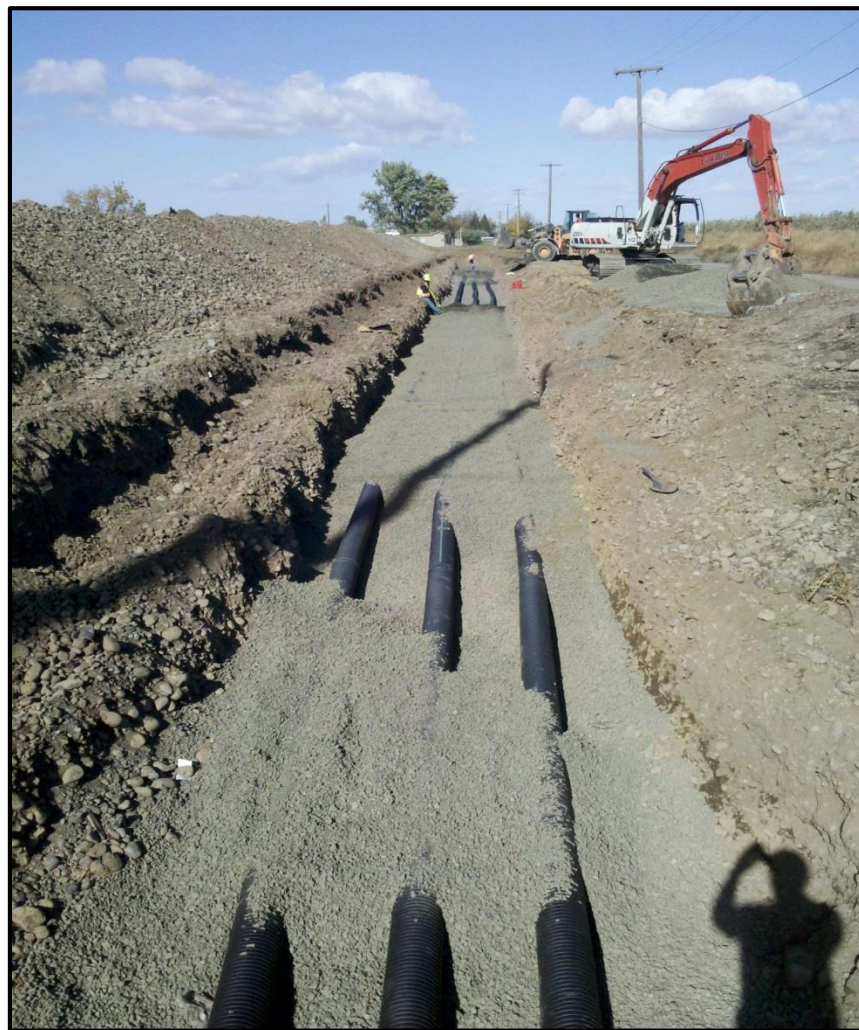
Figure 21 - The Trumbull Aquifer Recharge site under construction in October 2012. The site is approximately 300 feet long with three 8-inch" pipes running the entire length. See Appendix C for designs.

The Trumbull AR site (Trumbull site) was constructed in October 2012 using a combination of BPA and OWEB funding. The site consists of three 8-inch perforated pipes buried 6 feet bgs and extending approximately 300 feet in length from the source water discharge and inline flow meter (Figure 21). The perforated pipes sit on top of approximately 1-2 foot of cleaned gravel and are overlaid with approximately 0.5-1 feet of cleaned gravel (See Appendix C for designs). Recharge water is delivered through the HBDIC system. The Trumbull site's water source is at the structure that splits the HBDIC canal into the Hyline pipeline and the Richardz ditch. The site has its own turnout and valve so it can operate independent of the ditch or pipeline. The site was designed to operate at a recharge rate of between 2 to 3 cfs. The site was operated during the WY2014 recharge season at an average rate of 1.5 cfs. The lower than expected rate is hypothesized to be due to down-gradient control by springs and groundwater mounding.

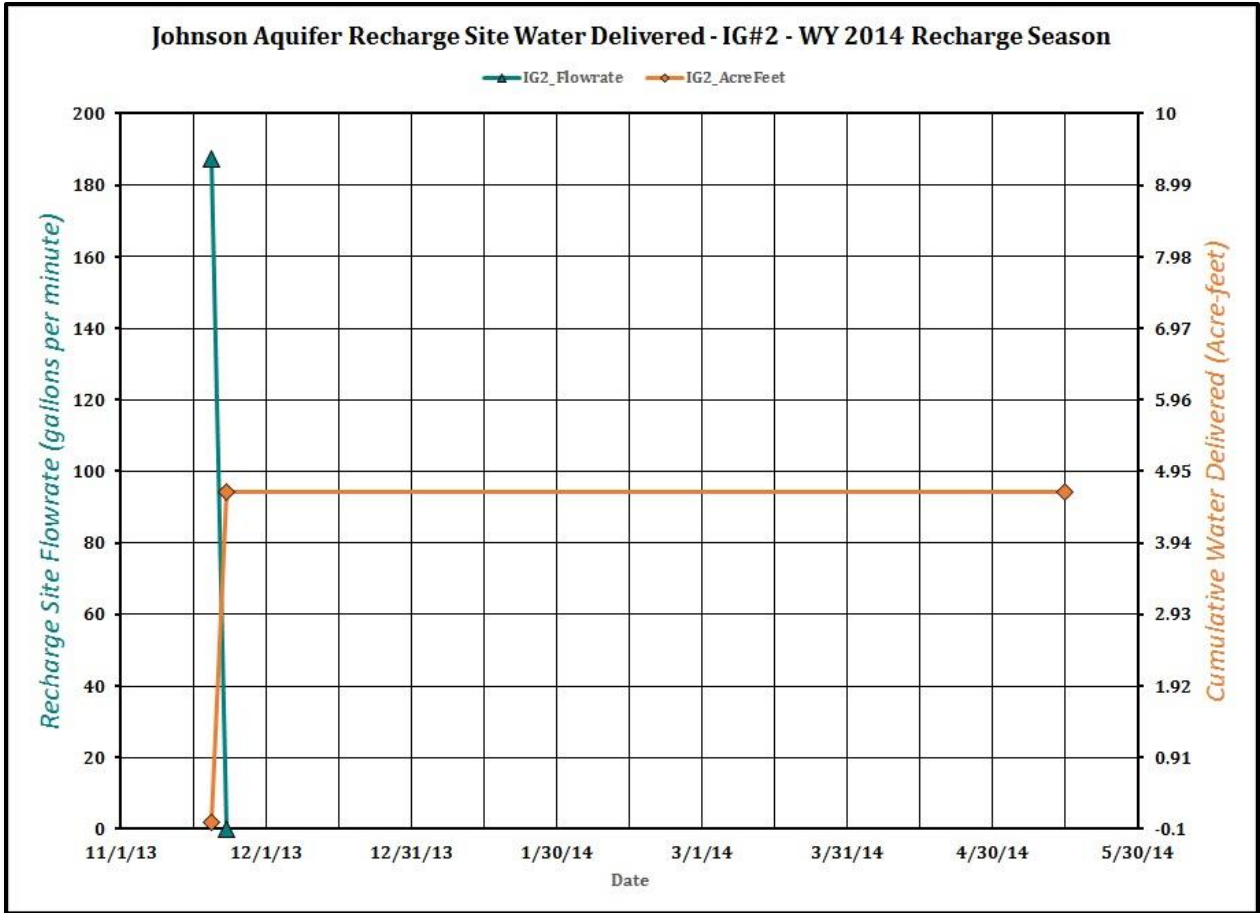
Figure 31 - Hydrograph for the Johnson site showing inflow rates and cumulative water delivered to infiltration gallery #2.
