**Lampson Levee Setback and Habitat Restoration
OWEB Grant # 211-6050**

Walla Walla River, River mile 48, Map Coordinates: T5N, R36E, Sections 18 and 19

Proposed Conditions
 Lampson Construction Drawings

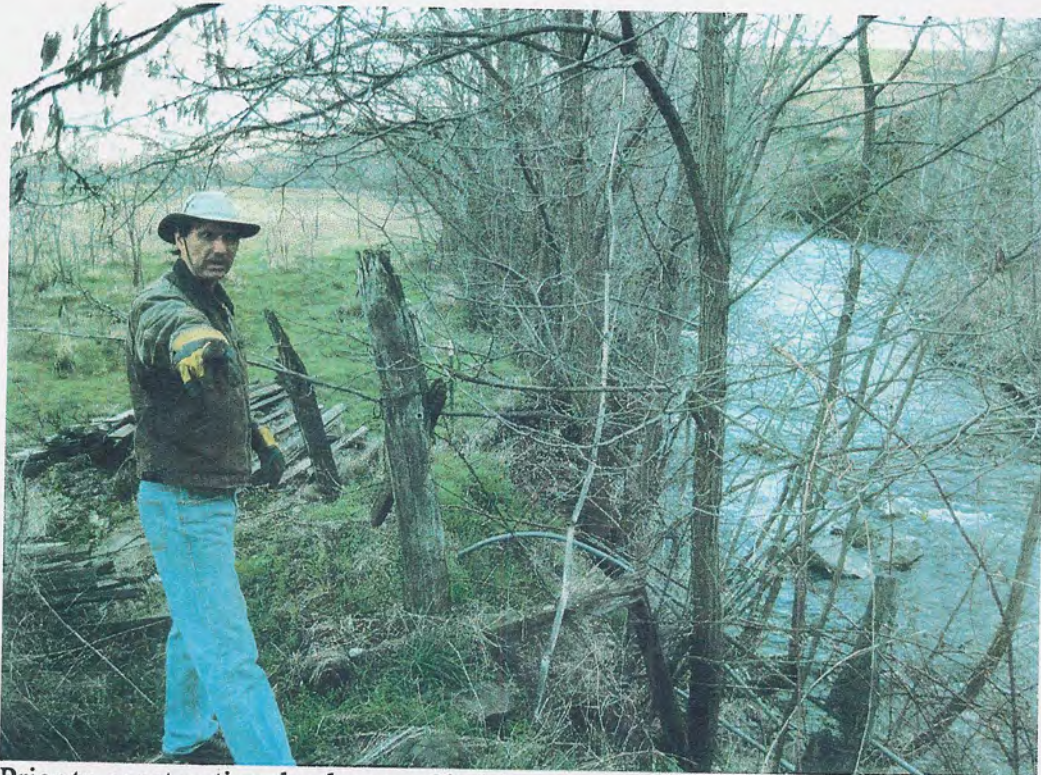
Prior to construction, landowner Clark Lampson stands on edge of eroding riverbank where damaged levee will be removed as part of project, about a 10' drop to water

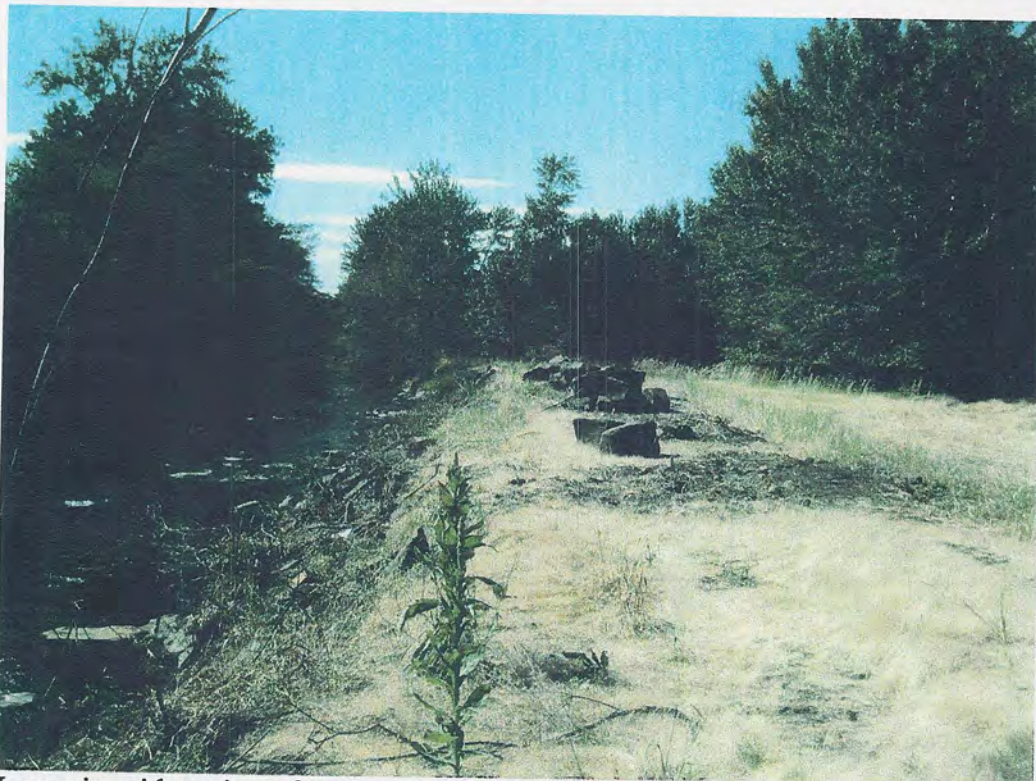
Levee in mid section of project prior to removal

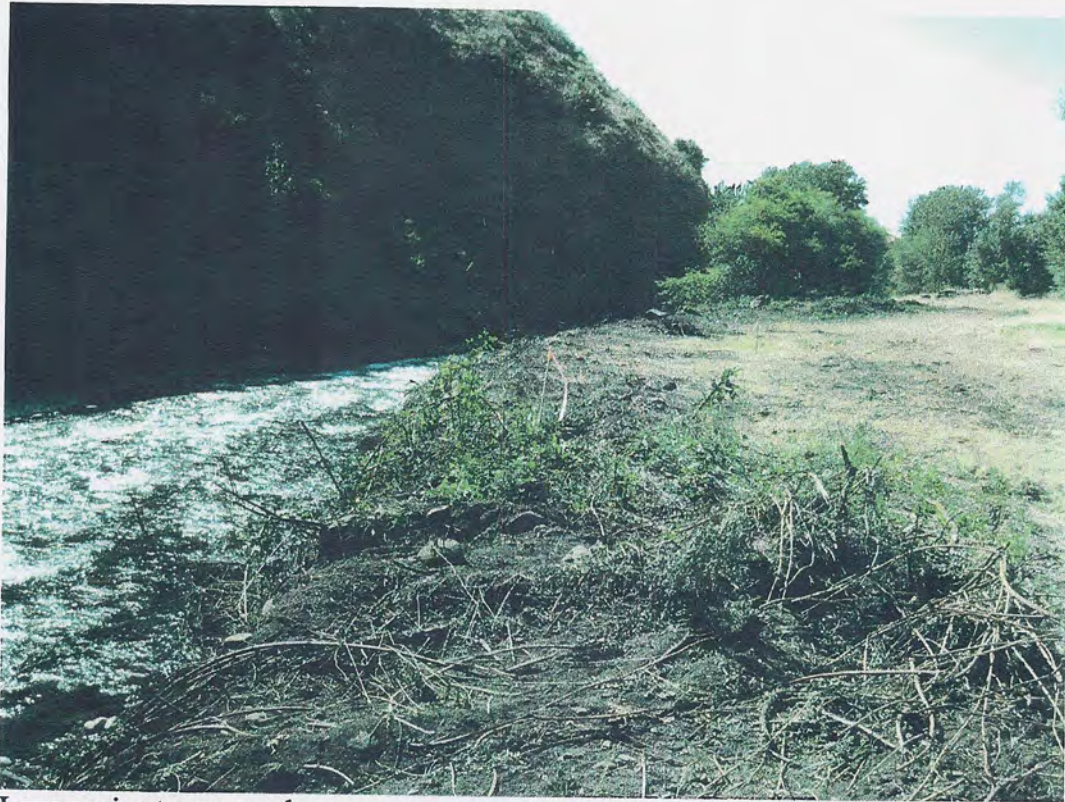
Levee prior to removal

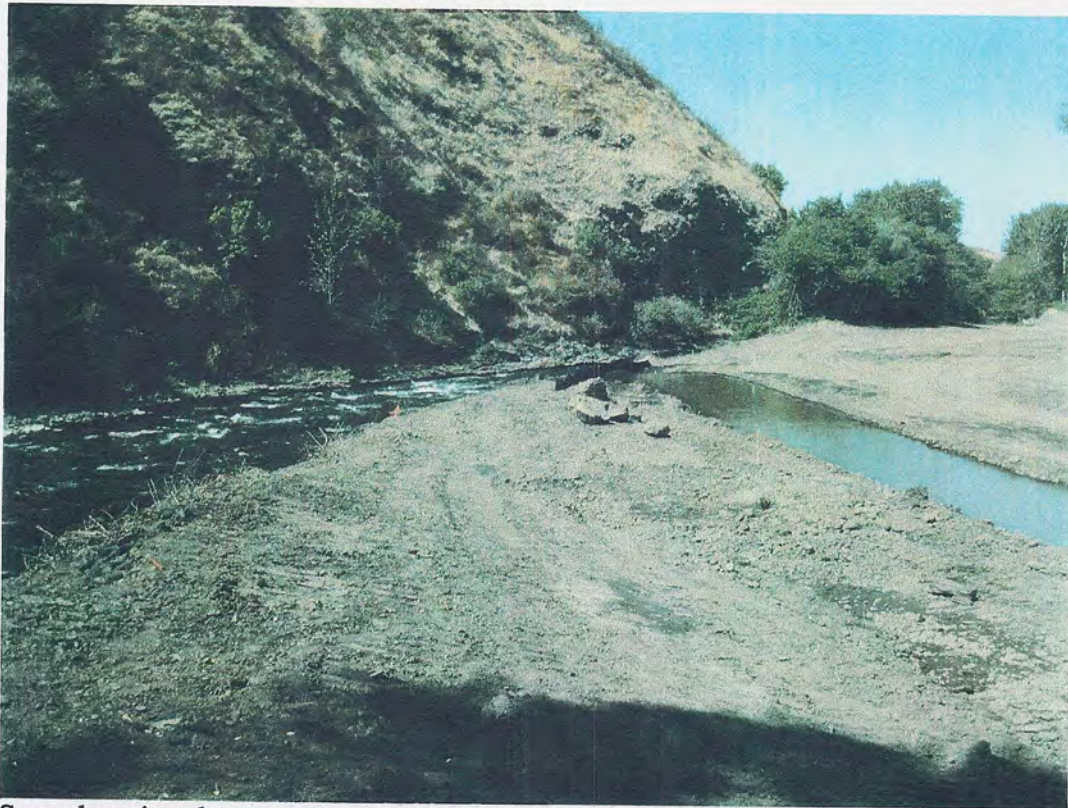
Same location, levee gone and side channel being installed

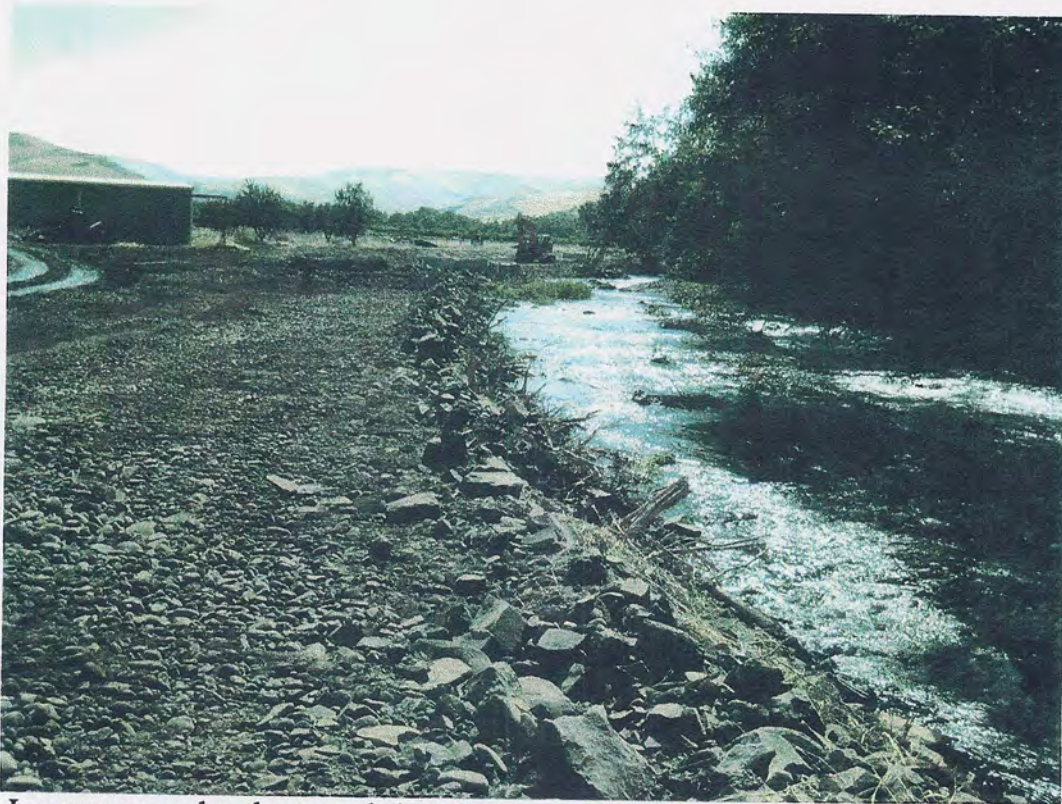
Levee removed and rootwads installed

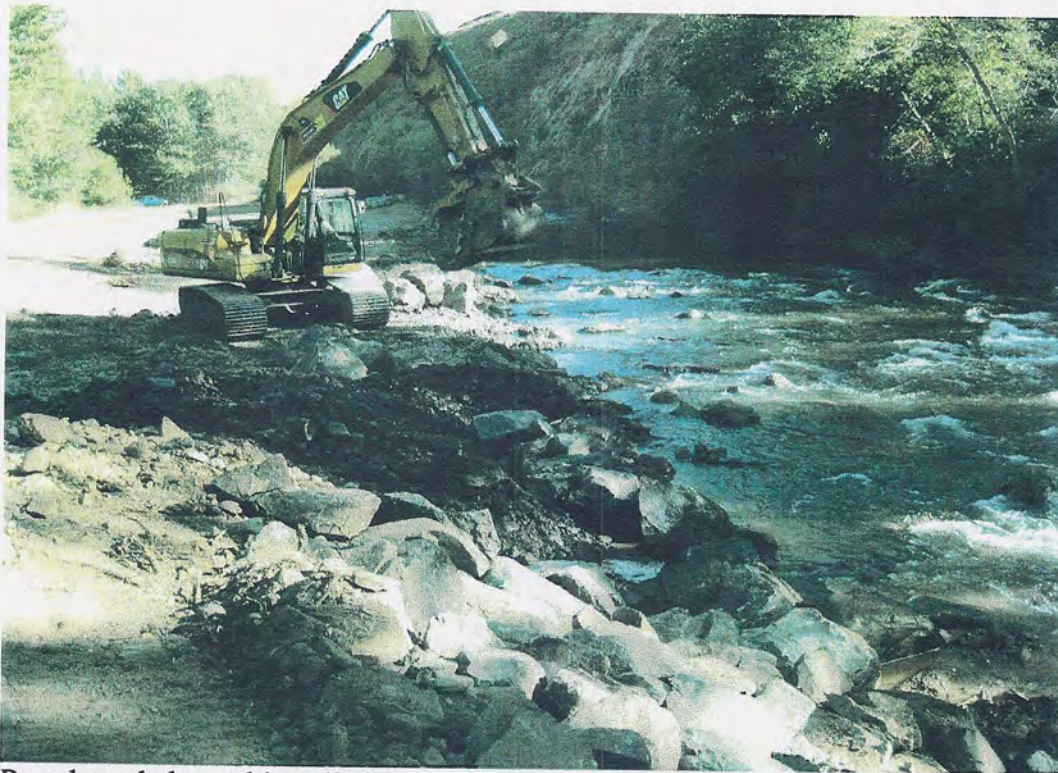
Roughened channel installed at downstream end of project to maintain grade

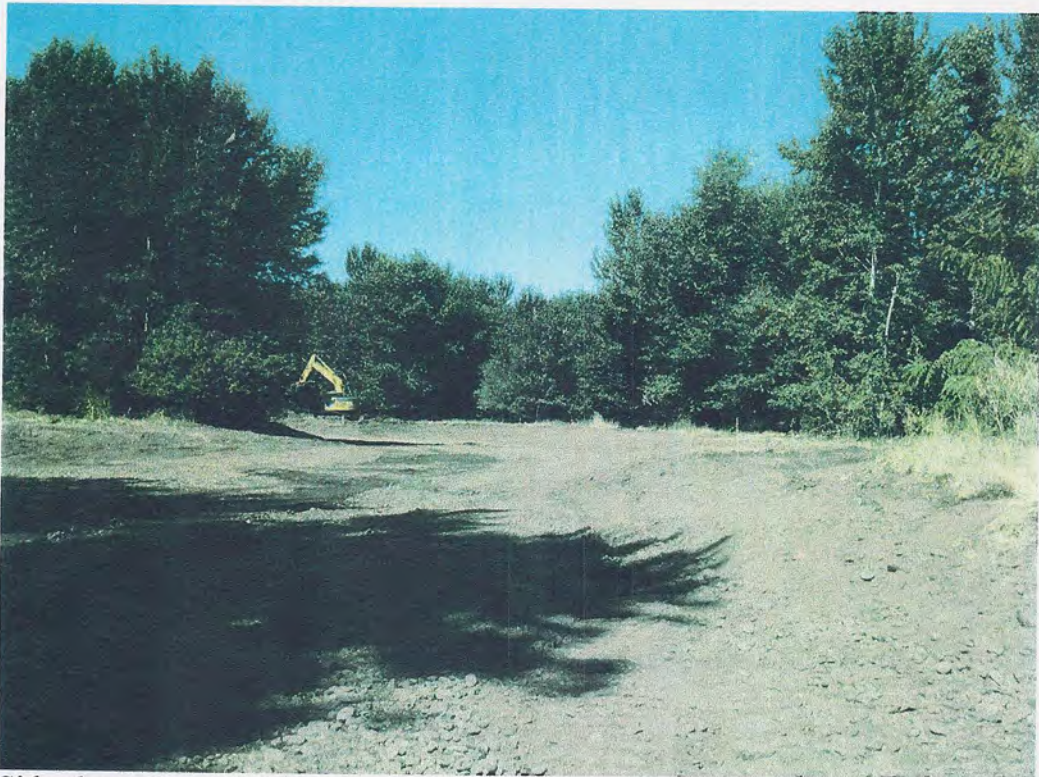
Side channel area is being excavated. Existing vegetation was planted in late 1990s

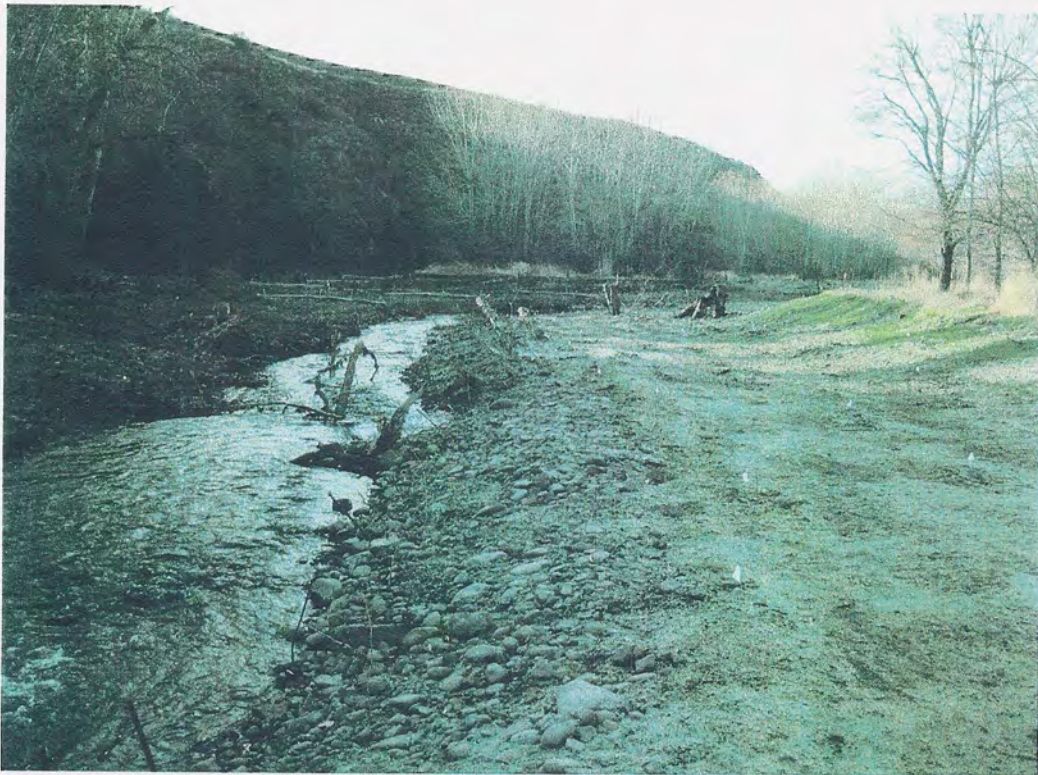
Side channel activated with river flows, note hydroseed, planted trees, and habitat logs

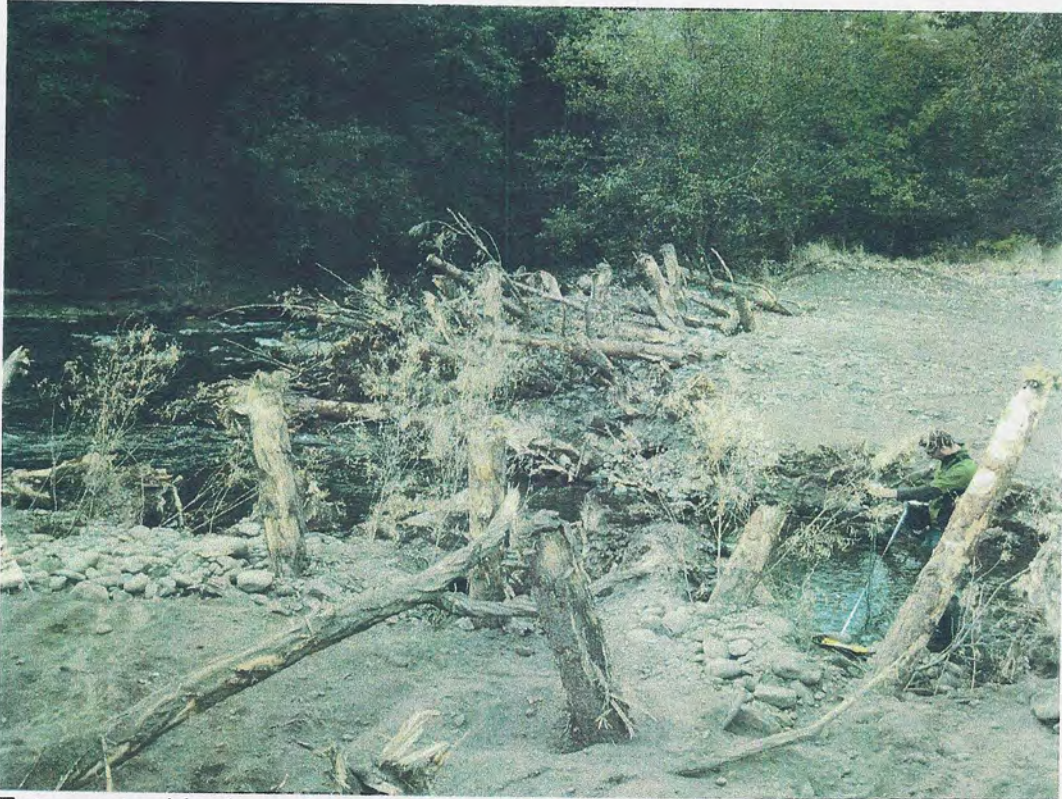
Entrance to side channel, WWBWC staff taking flow measurement for engineers

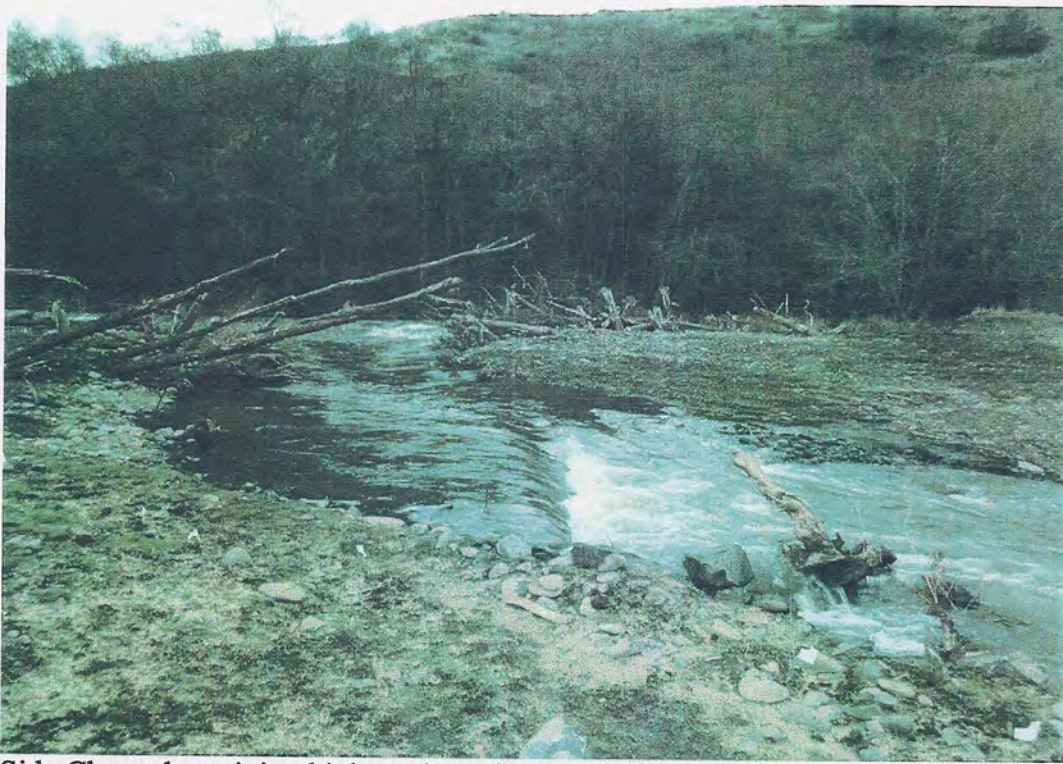
Side Channel receiving higher winter flows in February 2012

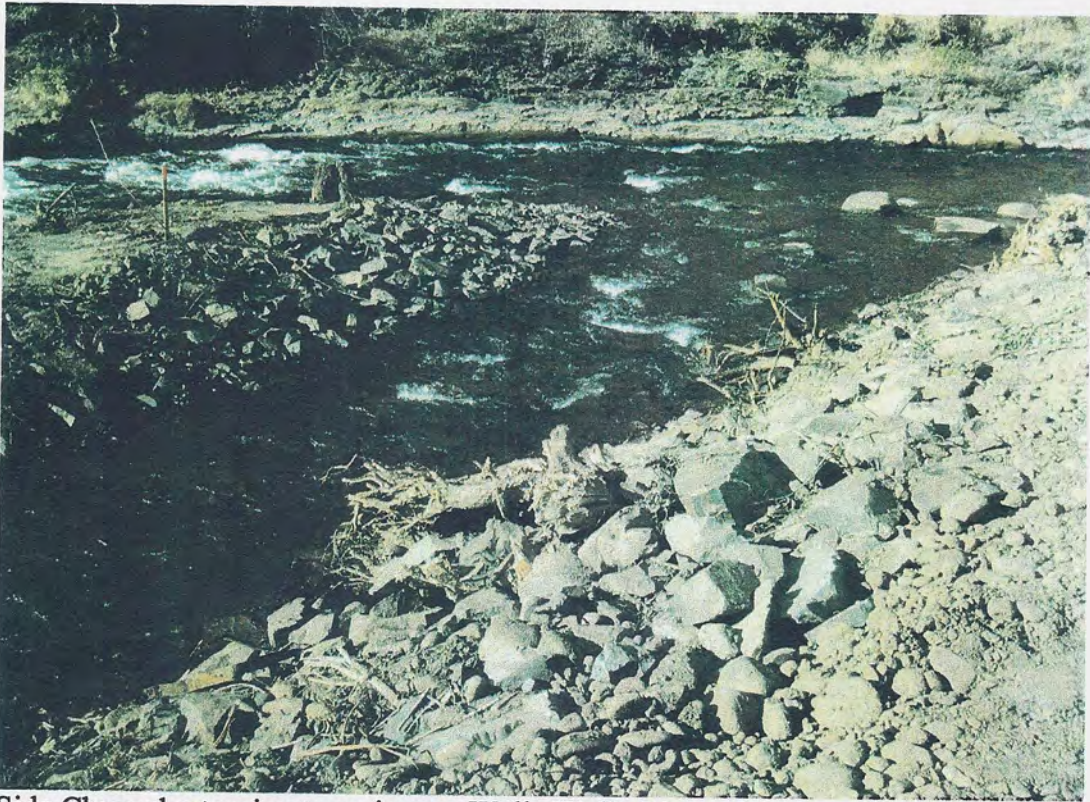
Side Channel returning to mainstem Walla Walla River

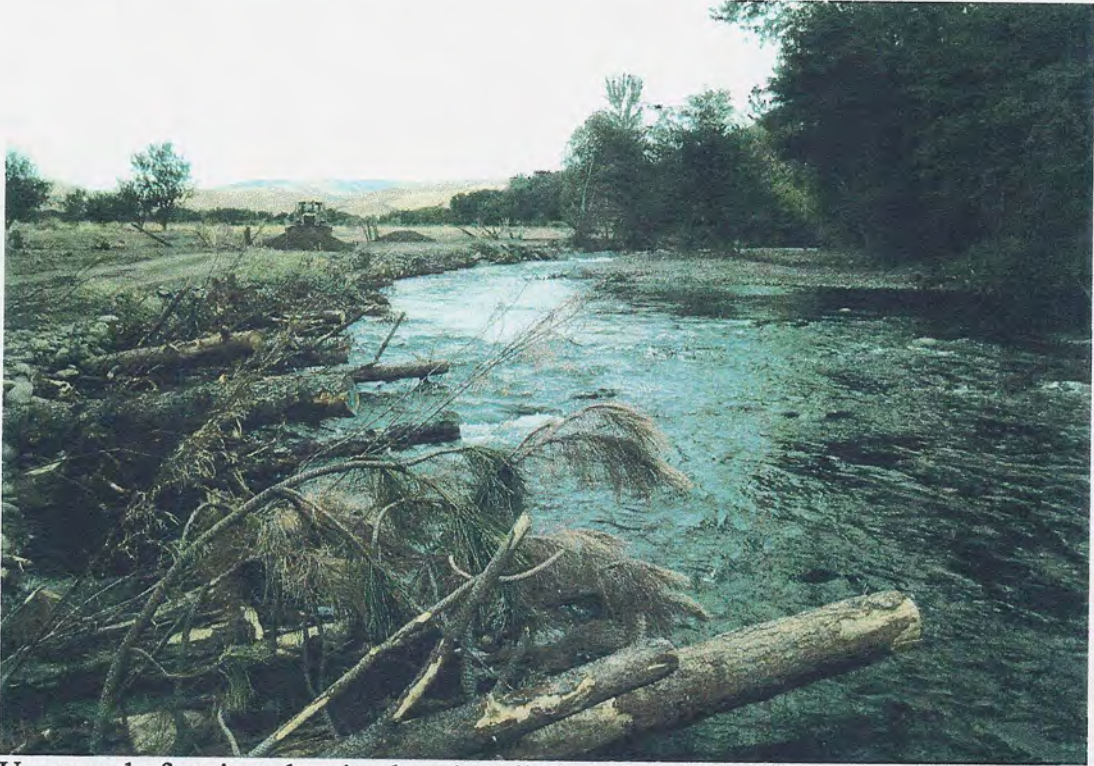
Upper end of project showing logs installed and habitat rocks
